Report 5: Coastal Monitoring Gippsland Lakes/90 Mile Beach Local Coastal Hazard Assessment Project

March 2014

Project Name	Gippsland Lakes/90 Mile Beach Coastal Hazard Assessment	
Client	Department of Environment and Primary Industries	
Client Project Manager	Ashley Hall	
Water Technology Project Manager	Warwick Bishop	
Report Authors	Warwick Bishop, Tim Womersley	
Job Number	2363-01	
Report Number	R05	
Document Name	2363-01R05v05_Monitoring.docx

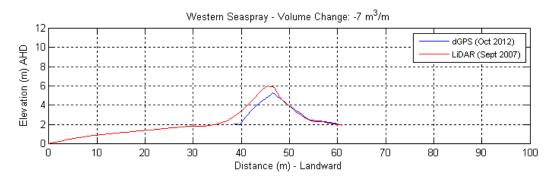
Figure 2-2 Western Seaspray Coastal Profile

The survey profile results for Western Seaspray are plotted in Figure 2-2, with the survey start-end coordinates provided in Table 2-1. Figure 2-3 shows a photo looking landward at the profile location. The results show there has been erosion of the dune crest and volume between 2007 and 2012.

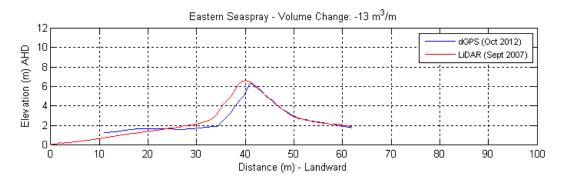
Figure 2-4 Eastern Seaspray Coastal Profile

The survey profile results for Eastern Seaspray are plotted in Figure 2-4, with the survey start-end coordinates provided in Table 2-2. Figure 2-5 shows a photo looking landward at the profile location. The results are very similar to Western Seaspray and show there has been erosion of the dune crest and volume between 2007 and 2012. Both the Seaspray profiles show good agreement with the LiDAR survey on the back-dune side, providing confidence in the accuracy of the measurements.

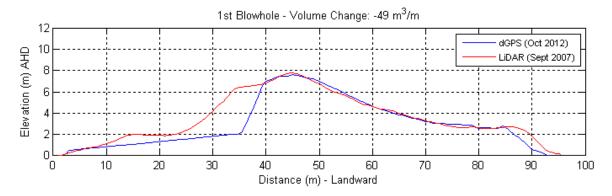
Figure 2-6 1st (western) Blowhole Coastal Profile

The survey profile results for the First Blowhole are plotted in Figure 2-6, with the survey start-end coordinates provided in Table 2-3. Figure 2-7 shows a photo looking landward at the profile location. The results show there has been significant erosion of the foredune and some erosion on the backface (lakeside) of the dune between 2007 and 2012. This is consistent with the photo image that shows clear dune cut and vegetation falling down the face of the dune.

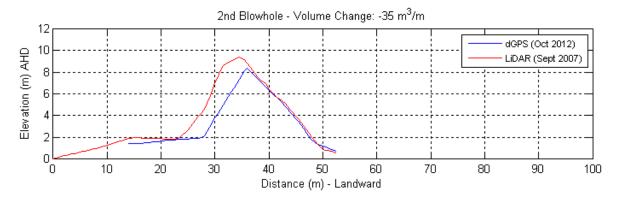
Figure 2-8 2nd (eastern) Blowhole Coastal Profile

The survey profile results for the Second Blowhole are plotted in Figure 2-8, with the survey startend coordinates provided in Table 2-4. Figure 2-9 shows a photo looking landward at the profile location. The results show there has been significant erosion of the foredune between 2007 and 2012. This is consistent with the photo image that shows clear dune cut and vegetation falling down the face of the dune.

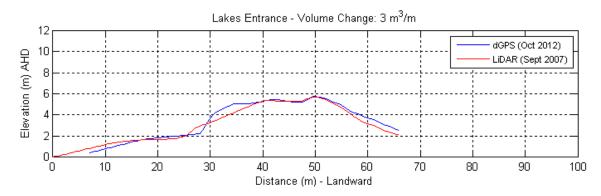
Figure 2-10 Lakes Entrance Coastal Profile

The survey profile results for Eastern Beach are plotted in Figure 2-10, with the survey start-end coordinates provided in Table 2-5. Figure 2-11 shows a photo looking landward at the profile location. The results show there has been minimal change to the dune between 2007 and 2012, with only minor redistribution of sand on the foredune and some deposition on the back face.

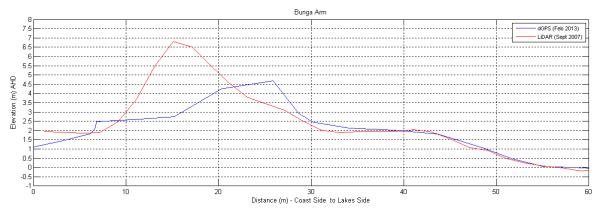
Figure 3-2 Bunga Arm Coastal Profile

The survey profile results for Bunga Arm are plotted in Figure 3-3, with the survey start-end coordinates provided in Table 3-1. Figure 3-3 shows a photo looking landward at the profile location. The results show there has been minimal change to the lakeside part of the profile, whereas the main dune has eroded significantly and begun to translate to a more inland location between 2007 and 2013. The photo shows that dune vegetation has gone and subsequently a blowout formed.

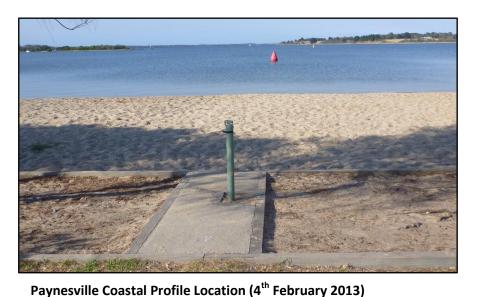
The survey profile results for Paynesville are plotted in Figure 3-4, with the survey start-end coordinates provided in Table 3-2. Figure 3-5 shows a photo looking seaward at the profile location. The results suggest there has been some loss of sand from near the lake shore between 2007 and 2013. However, this is inconclusive as the 2007 data may incorporate disturbance from the water surface.

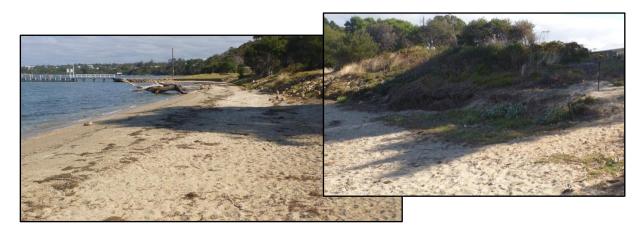
Figure 3-7 Metung Coastal Profile Location (4th February 2013)

The survey profile results for Metung are plotted in Figure 3-6, with the survey start-end coordinates provided in Table 3-3. Figure 3-7 shows a photo looking north at the profile location. The results suggest there has been some cut into the rise behind the beach between 2007 and 2013. However, the shoreline appears to be stable, or to have recovered.

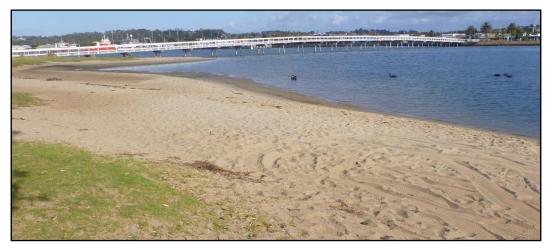
Figure 3-9 Lakes Entrance – Cunninghame Arm Coastal Profile Location (4th February 2013)

The survey profile results for Lakes Entrance are plotted in Figure 3-8, with the survey start-end coordinates provided in Table 3-4. Figure 3-9 shows a photo looking west at the profile location. The results suggest there has been minimal change to the beach, with perhaps some accretion between 2007 and 2013.

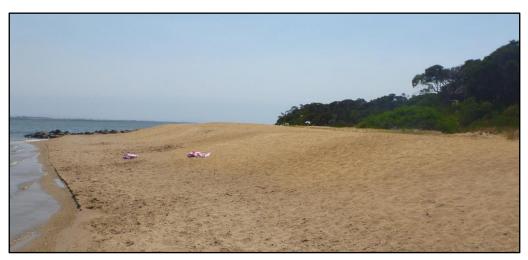
Figure 3-11 Loch Sport A Coastal Profile Location (4th February 2013)

The survey profile results for Loch Sport A are plotted in Figure 3-10, with the survey start-end coordinates provided in Table 3-5. Figure 3-11 shows a photo looking east at the profile location. The results suggest there has been erosion from the upper sections of the profile and accretion in the lower sections between 2007 and 2013. Whilst not verified, it appears that the beach profile may have been recently altered due to artificial nourishment.

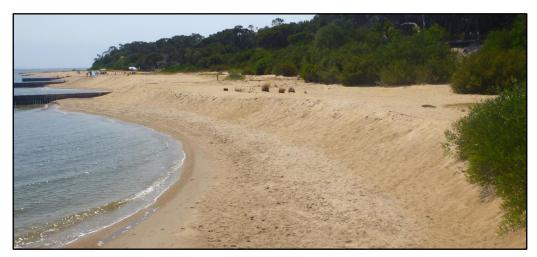
Figure 3-13 Loch Sport B Coastal Profile Location (4th February 2013)

The survey profile results for Loch Sport B are plotted in Figure 3-12, with the survey start-end coordinates provided in Table 3-6. Figure 3-13 shows a photo looking east at the profile location. The results suggest there has been significant build-up of the profile between 2007 and 2013. Whilst not verified, it appears that the beach profile may have been altered due to artificial nourishment.
