# **Report 4: Lakes Shoreline Erosion Hazard**

## **Gippsland Lakes/90 Mile Beach Local Coastal Hazard Assessment Project**

**April 2014**

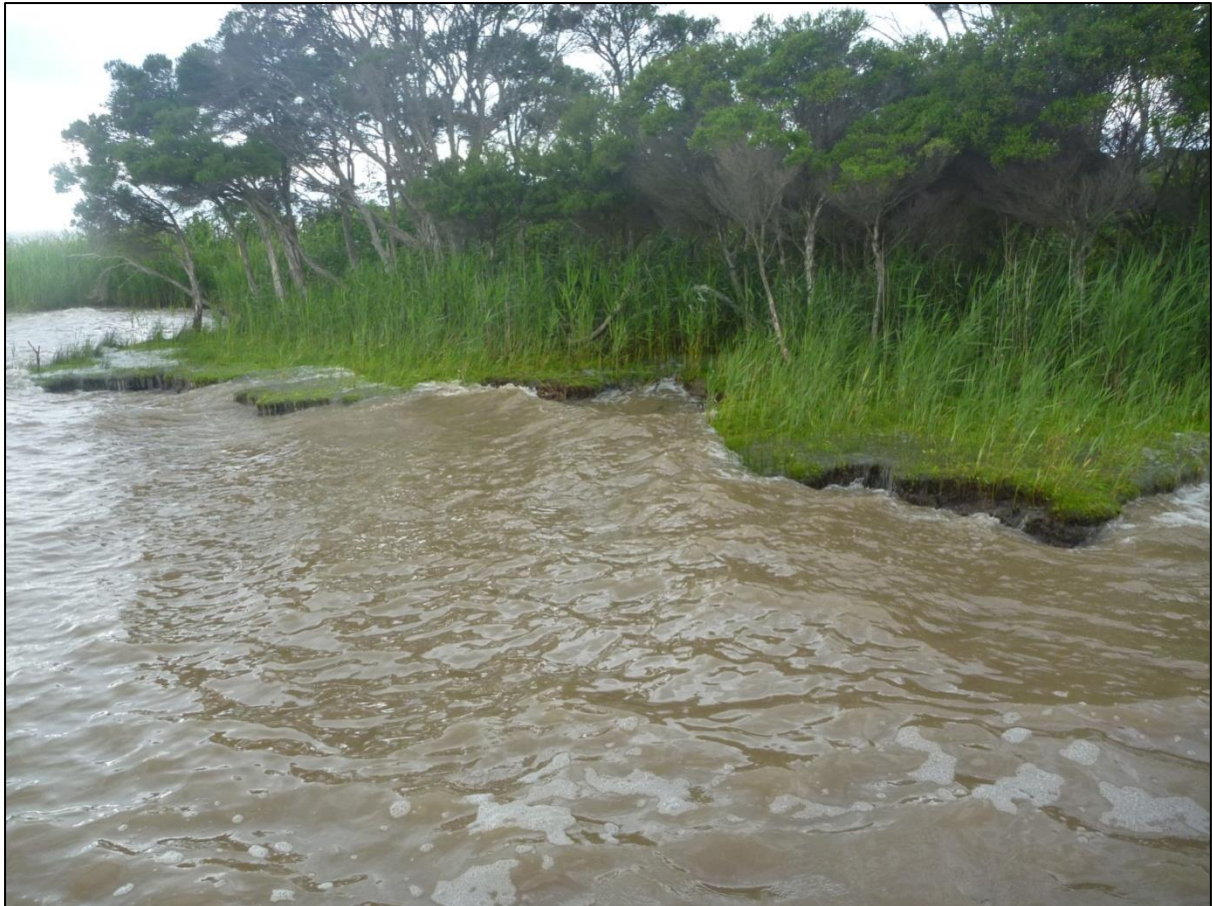
**Figure 2-6 View of the Latrobe River silt jetties from Lake Wellington showing the retreat of shoreline vegetation and exposure of underlying sediments (taken in December 2011)**

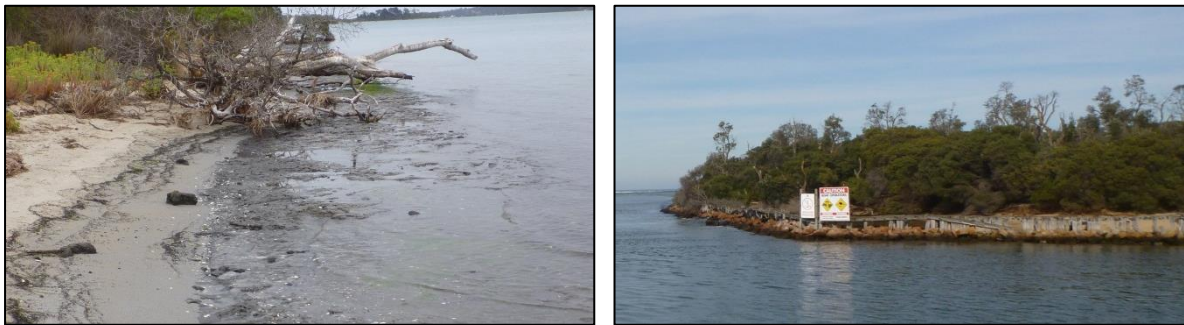
**Figure 4-1** An example of a Sandy/Semi-consolidated Silt Shoreline (Left) and an Artificially Engineered Shoreline within the Gippsland Lakes

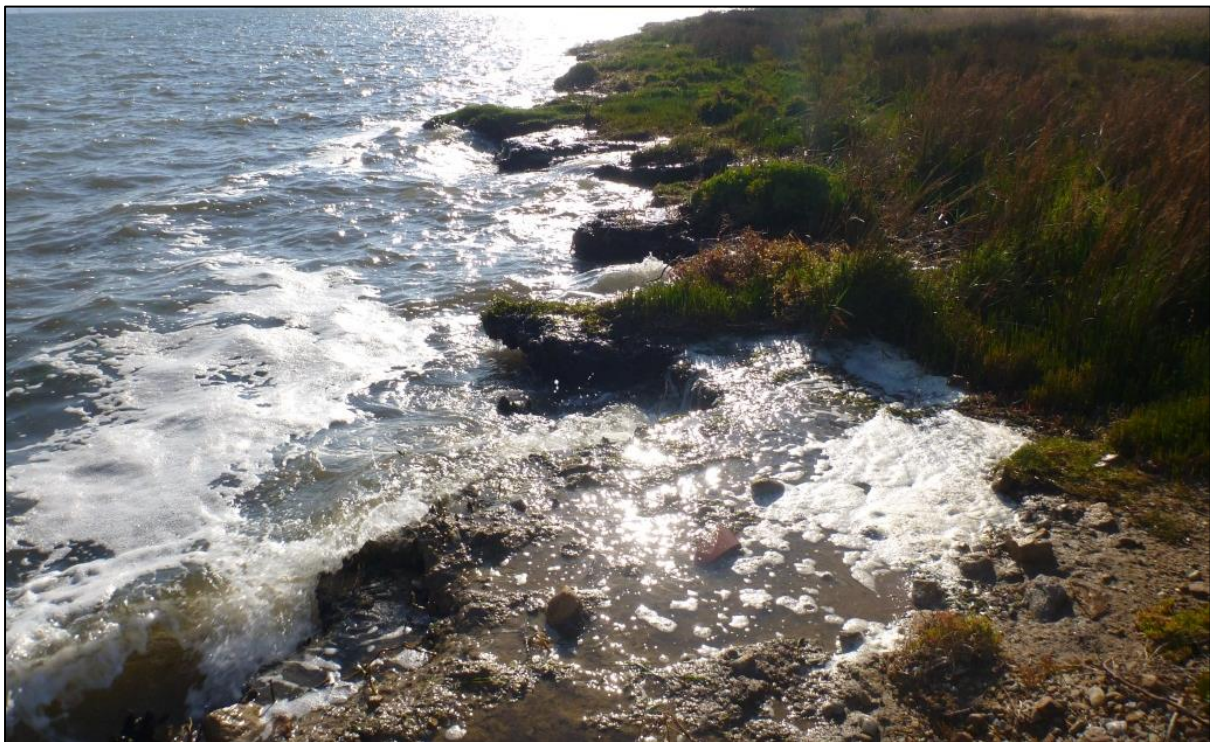
**Figure 4-2** Erosive Section of Shoreline between Paynesville and Eagle Point

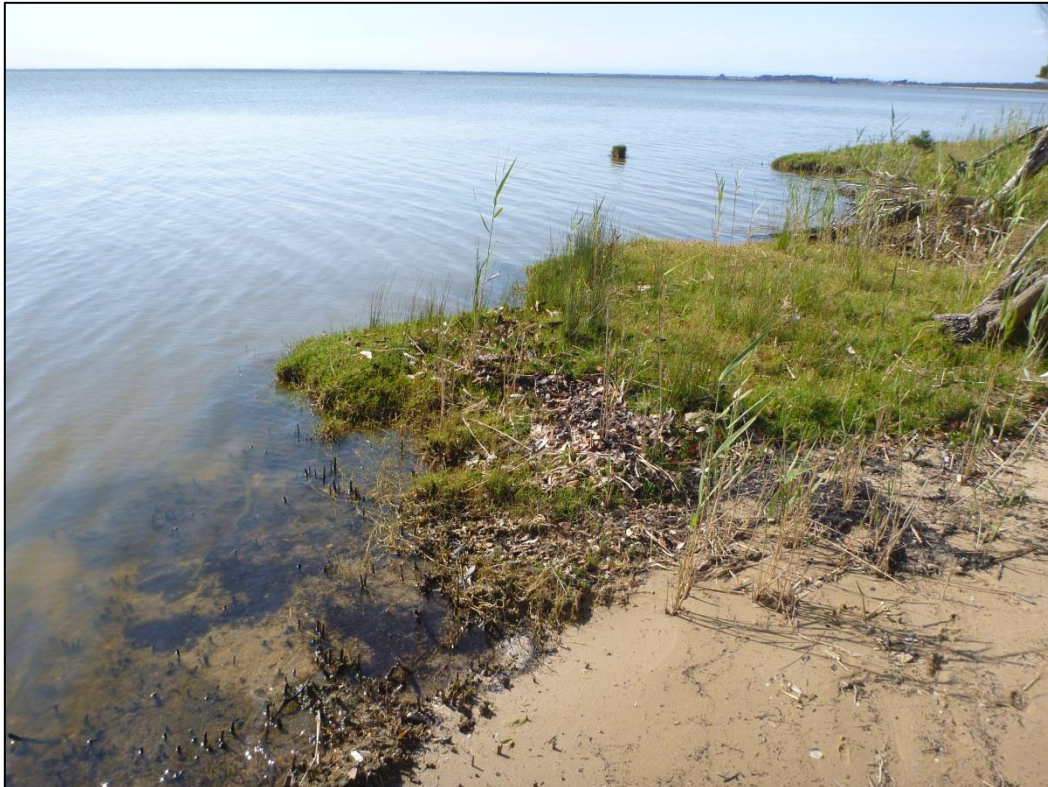
**Figure 4-5**      **Vegetation aiding in the binding of sediment along a predominantly sandy shoreline within the Gippsland Lakes**

Shoreline vegetation can influence the erosion susceptibility of a shoreline through processes such as binding of sediments, making them more resilient to erosion (Figure 4-5), or through buffering and dissipation of wave energy by semi-submersed vegetation such as reeds. The most common vegetation communities and plant species found throughout the Gippsland Lakes and their influences on erosion susceptibility are discussed in the following sections.

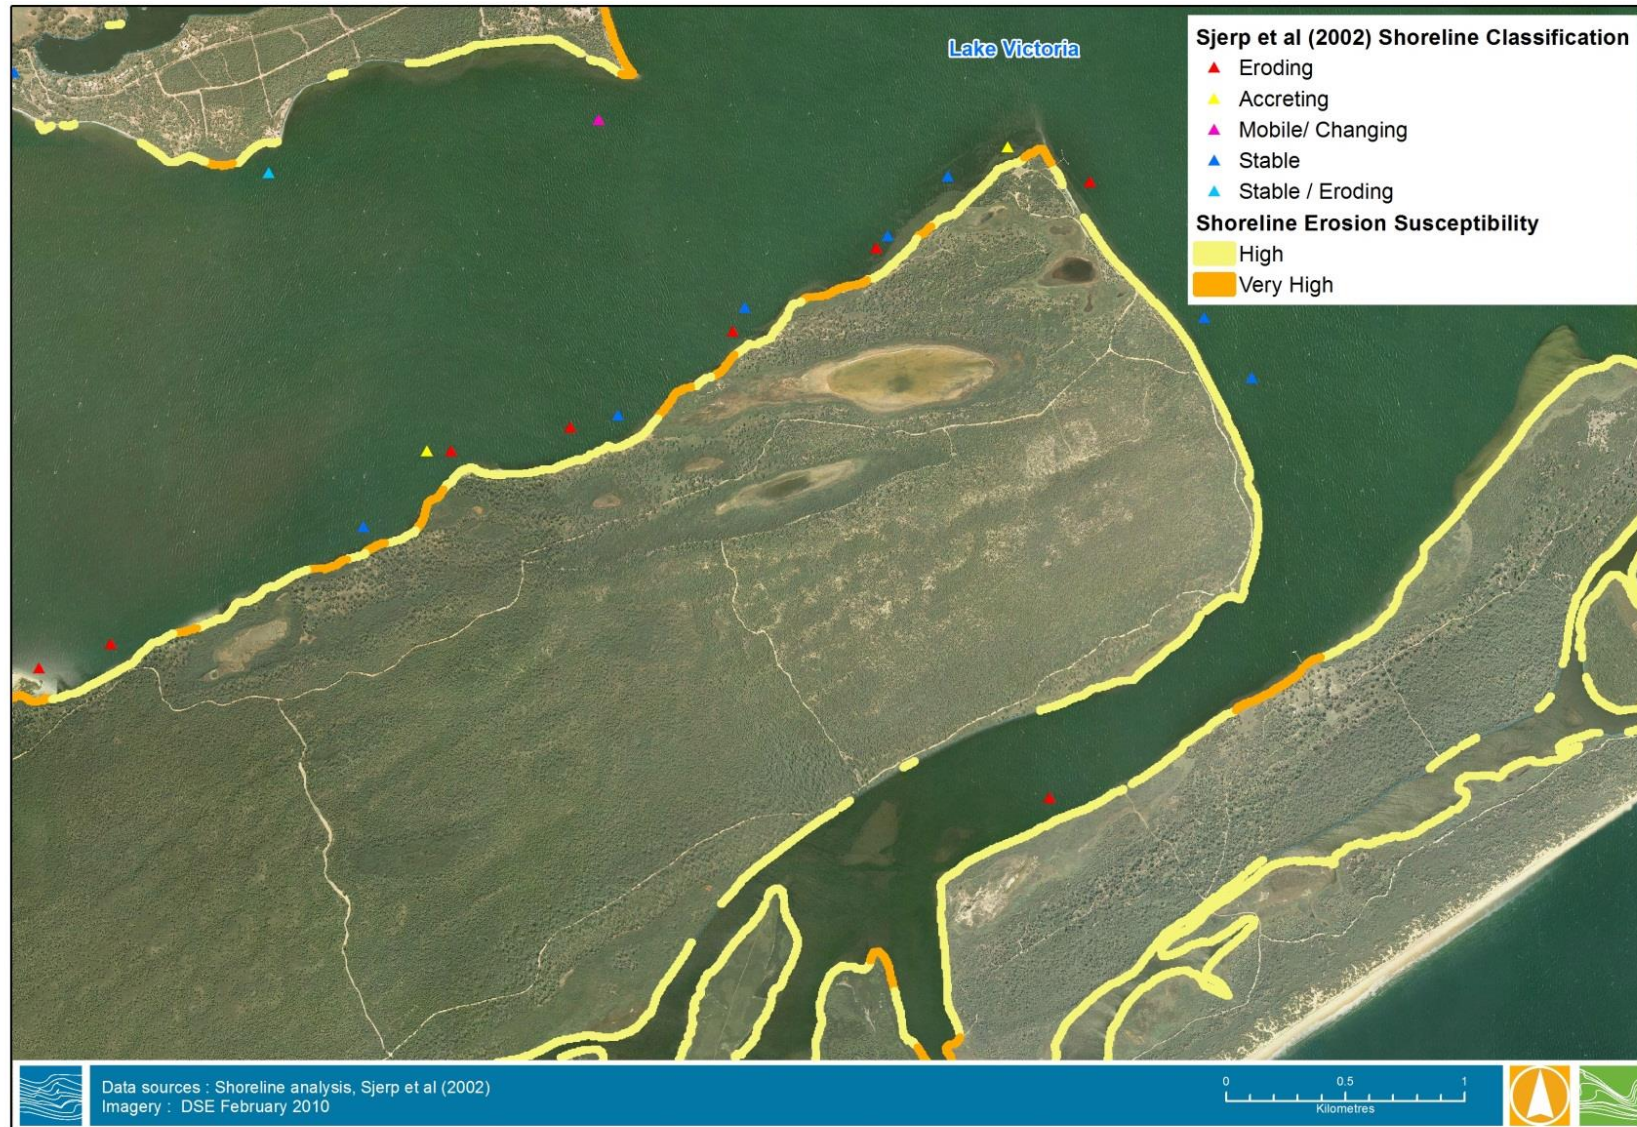
**Figure 5-3 Comparison between stability status (from Sjerp et al. (2002)) and erosion susceptibility score - Sperm Whale Head**

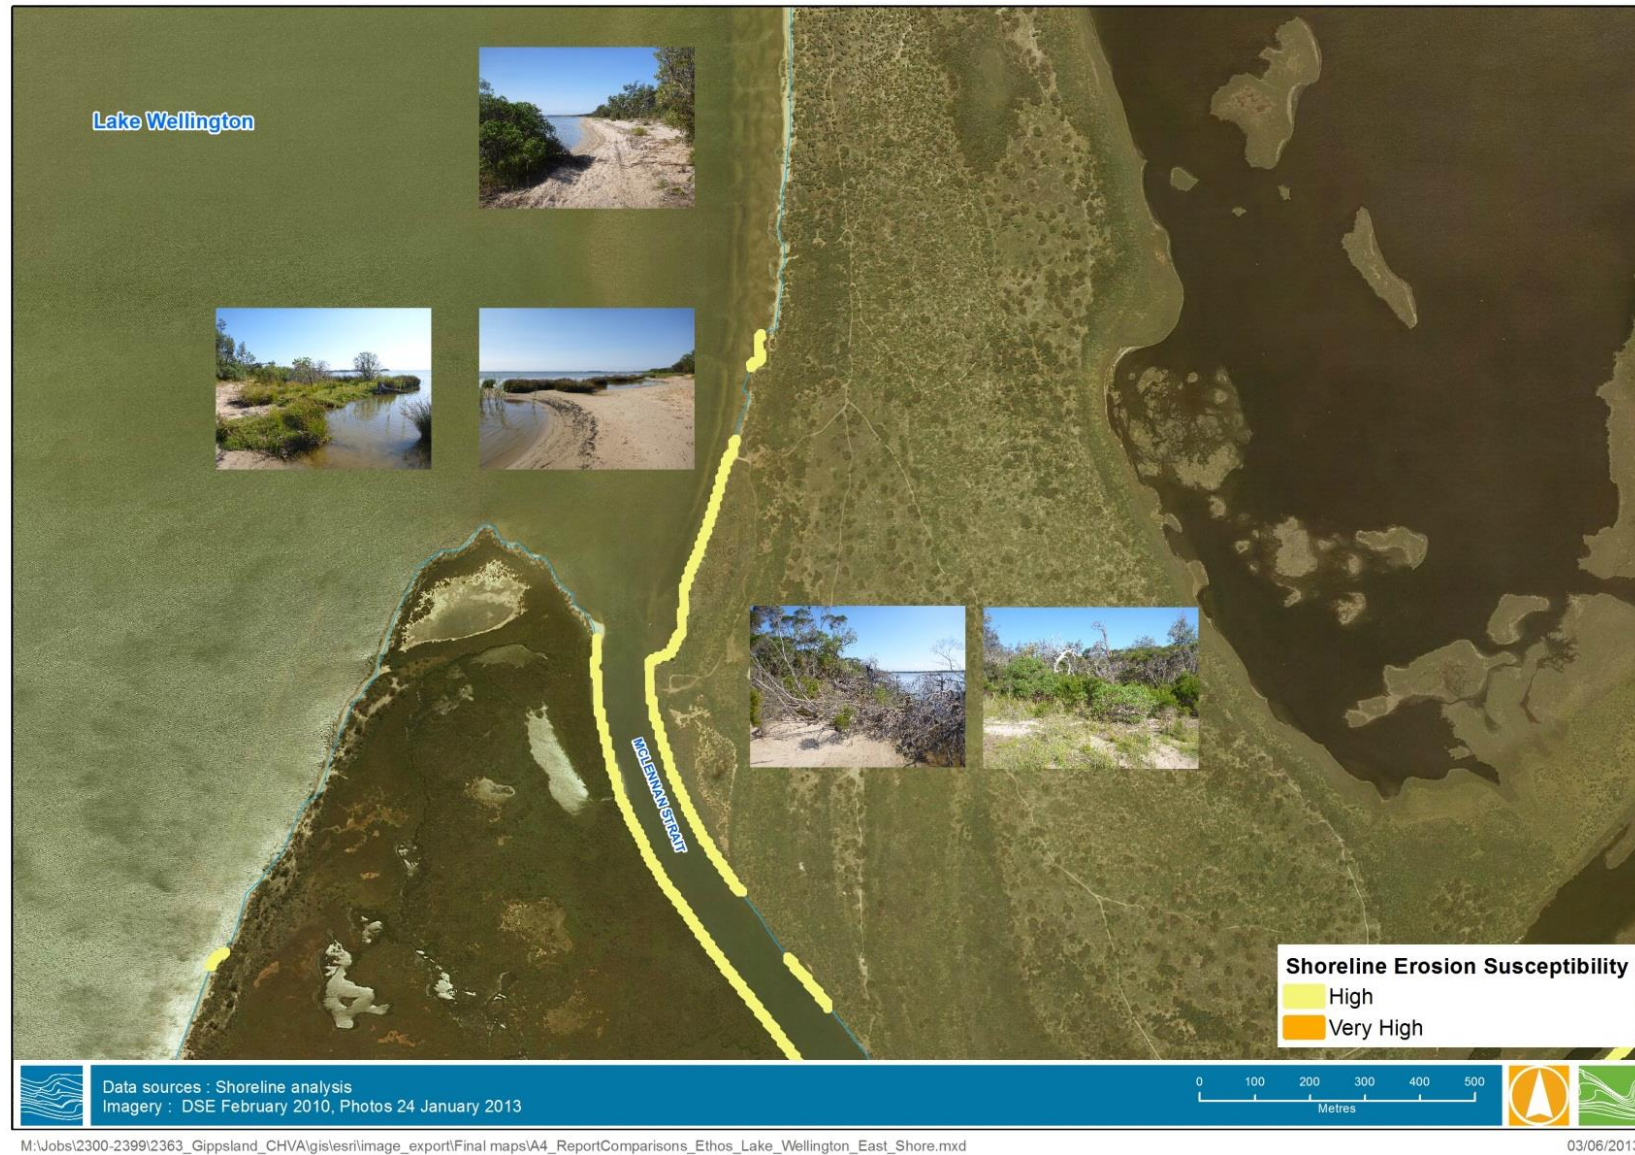
**Figure 5-4 Shoreline erosions susceptibility – Lake Wellington, eastern shore**

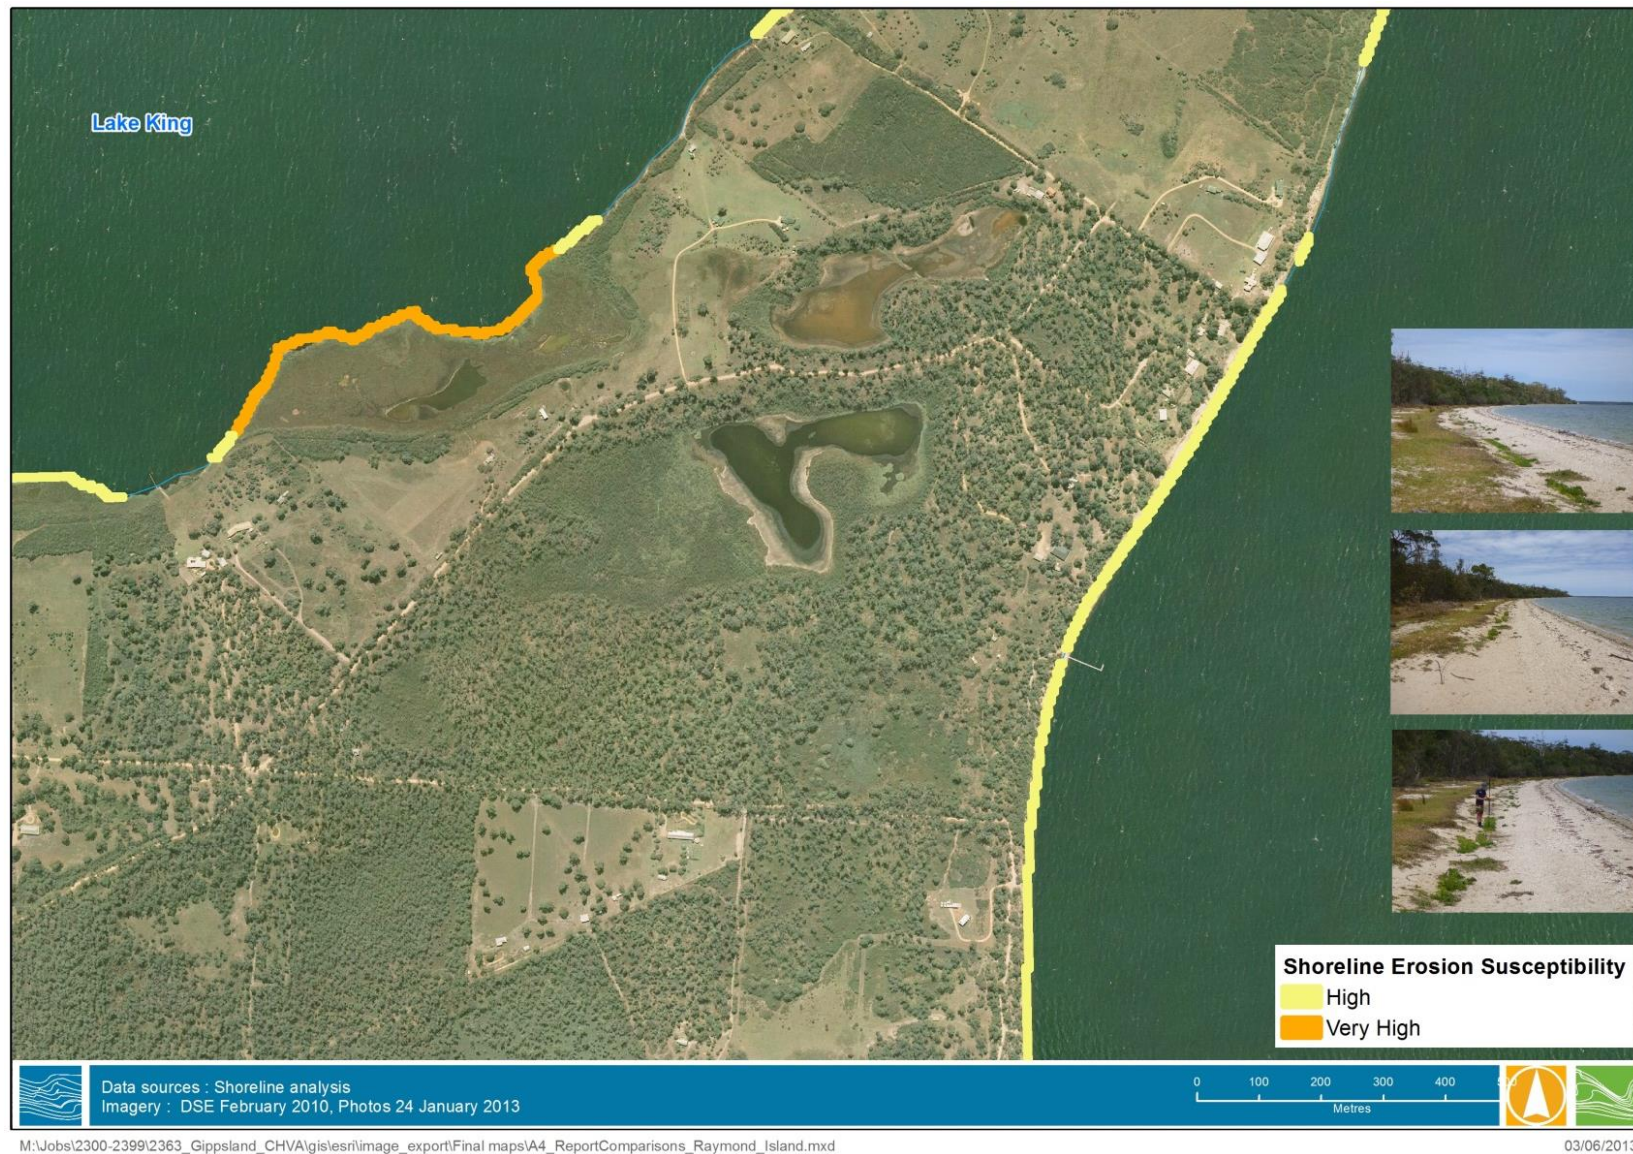
**Figure 5-5 Shoreline erosions susceptibility – Raymond Island**

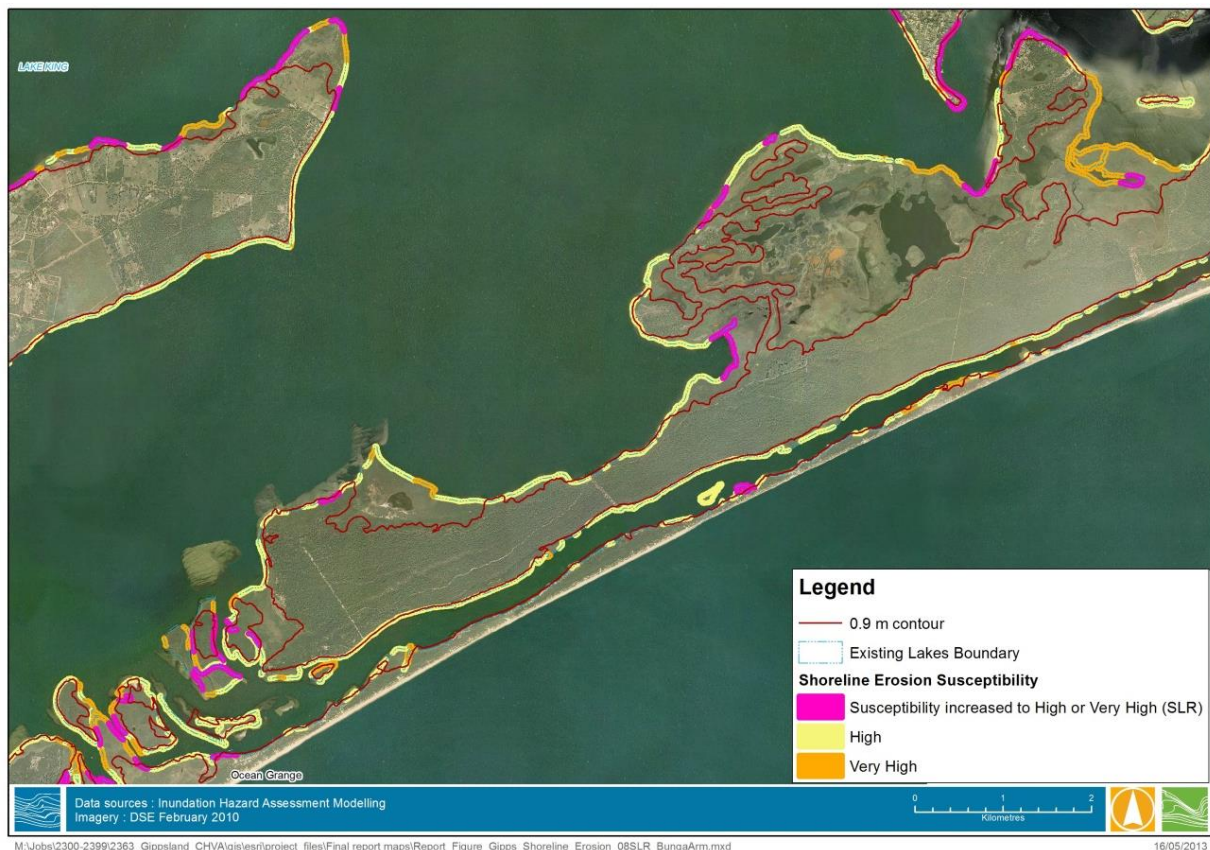
Under the sea level rise scenario there is some increase in the spatial extent of shoreline erosion susceptibility (predominantly to the south of Sperm Whale Head) but as the majority of the area is currently erosion susceptible there is effectively little change.

**Figure 6-4 Comparison of shoreline erosion susceptibility under present mean sea level conditions and with sea level rise of +0.8 m, Bunga Arm**

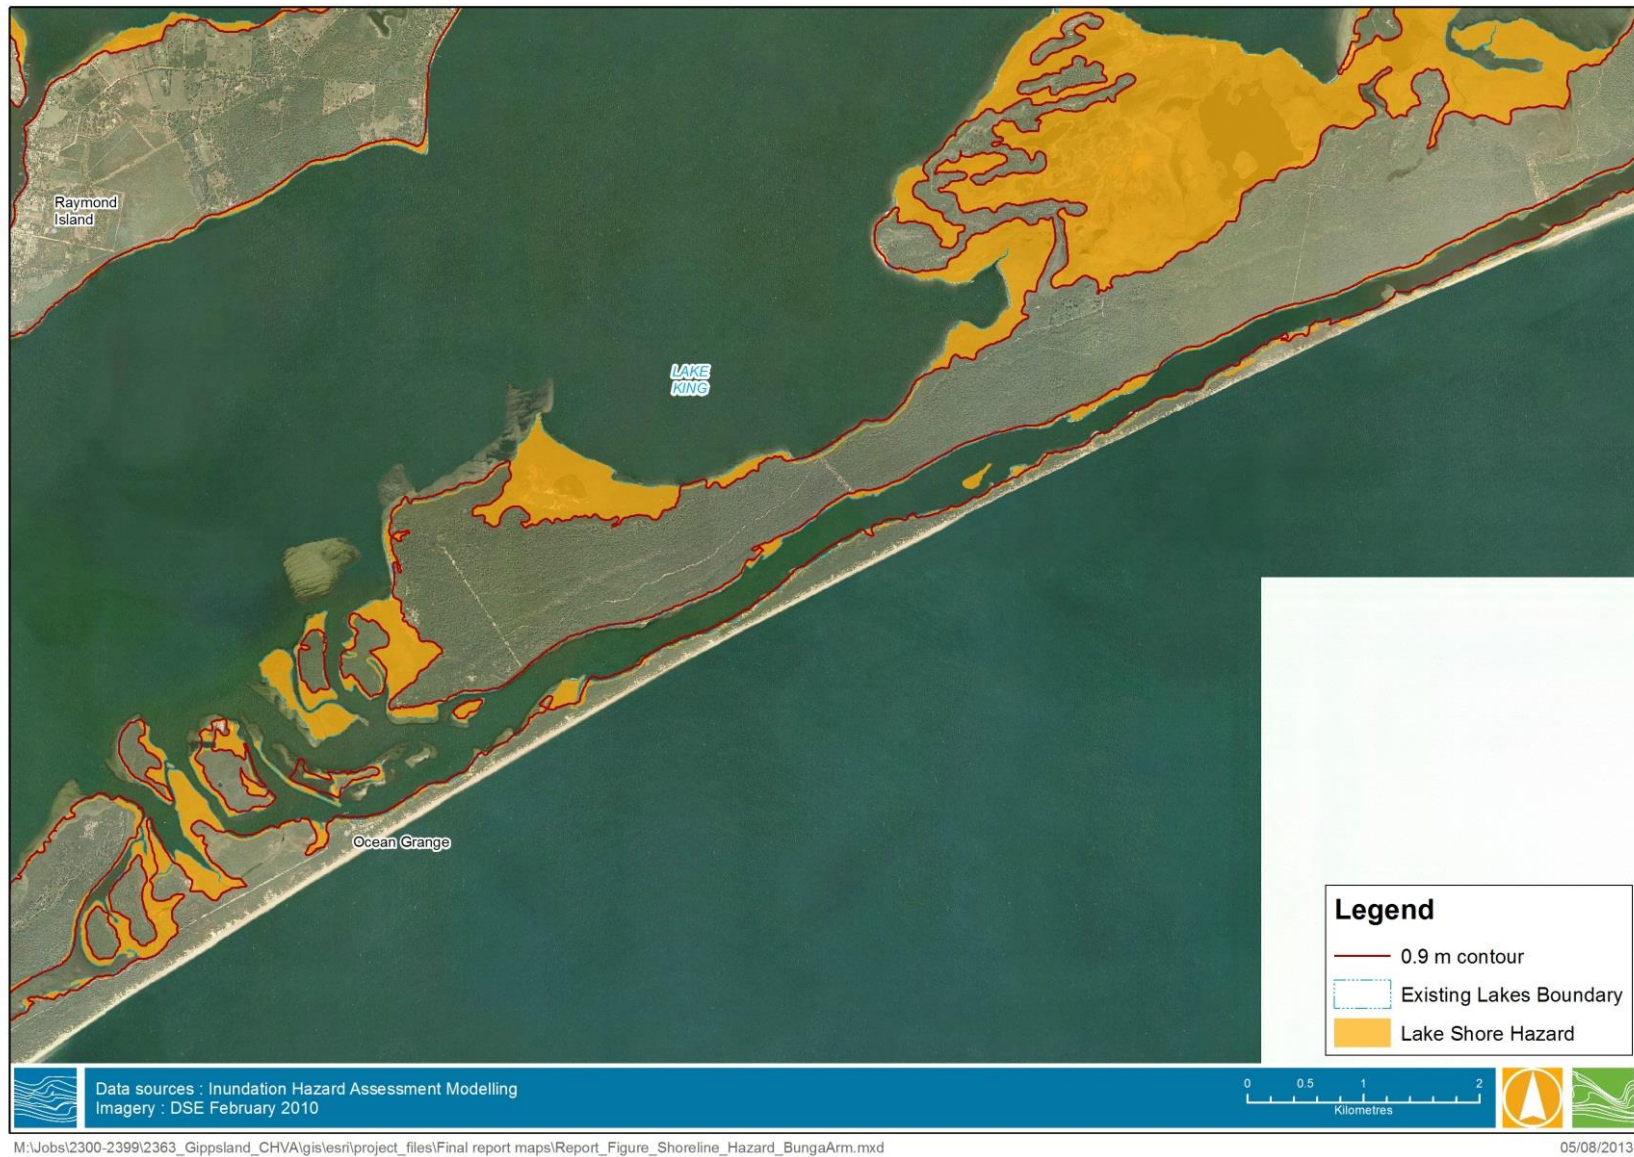
**Figure 7-2 Bunga Arm Shoreline Hazard Extent**

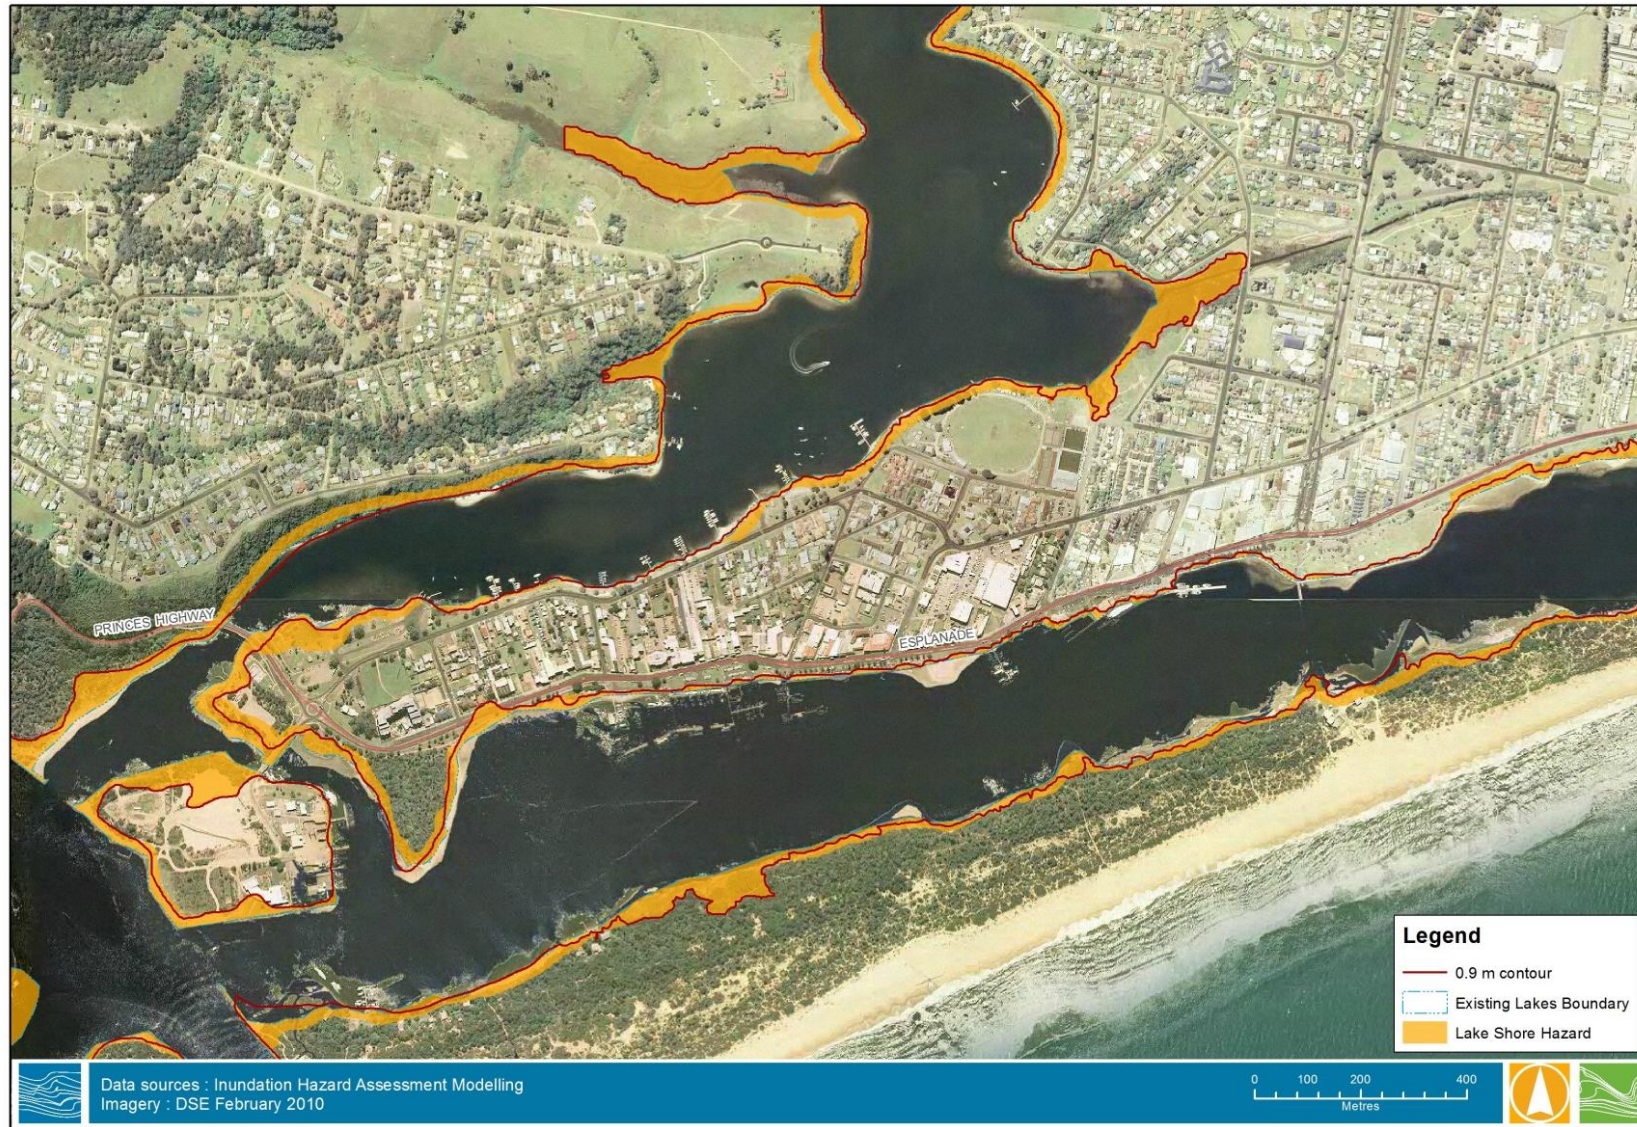
**Figure 7-3 Lakes Entrance Shoreline Hazard Extent**

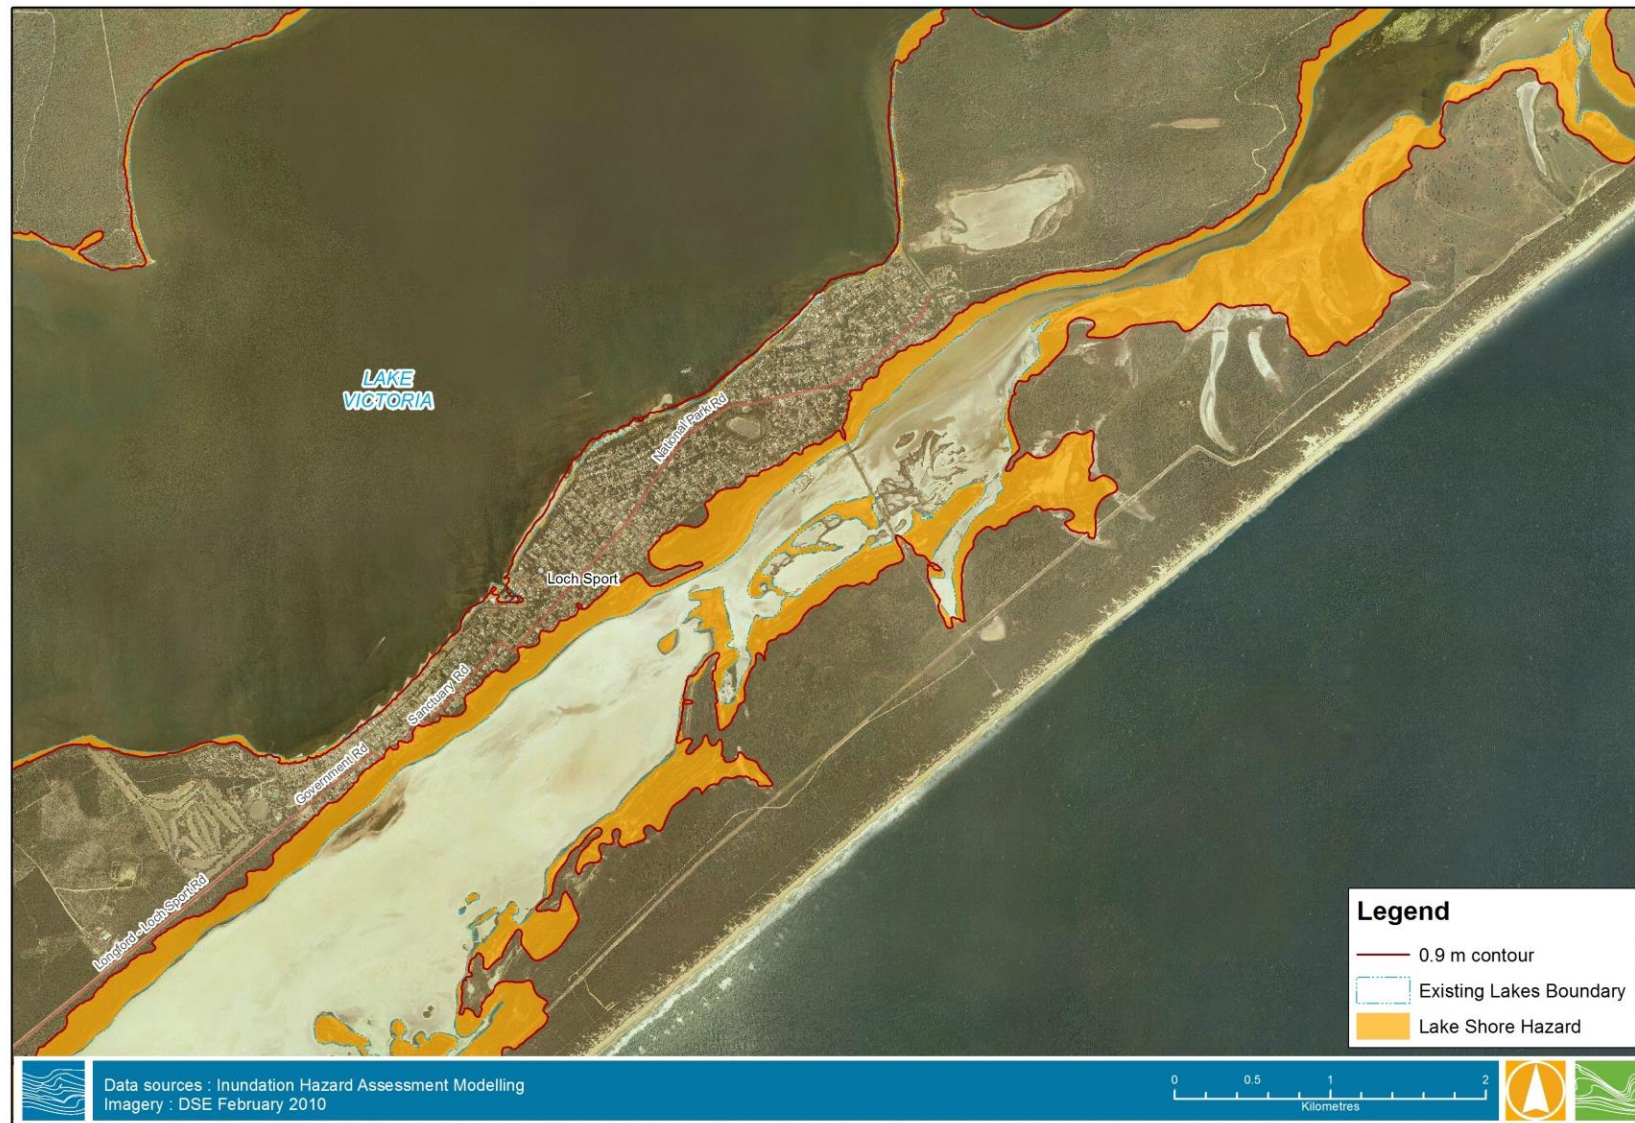
**Figure 7-4 Loch Sport Shoreline Hazard Extent**
