Observation Point to Silverleaves

Gippsland West Coastal Processes Studies

Department of Energy, Environment, and Climate Action

Reference	230689
Revision	0
Date	2 August 2024

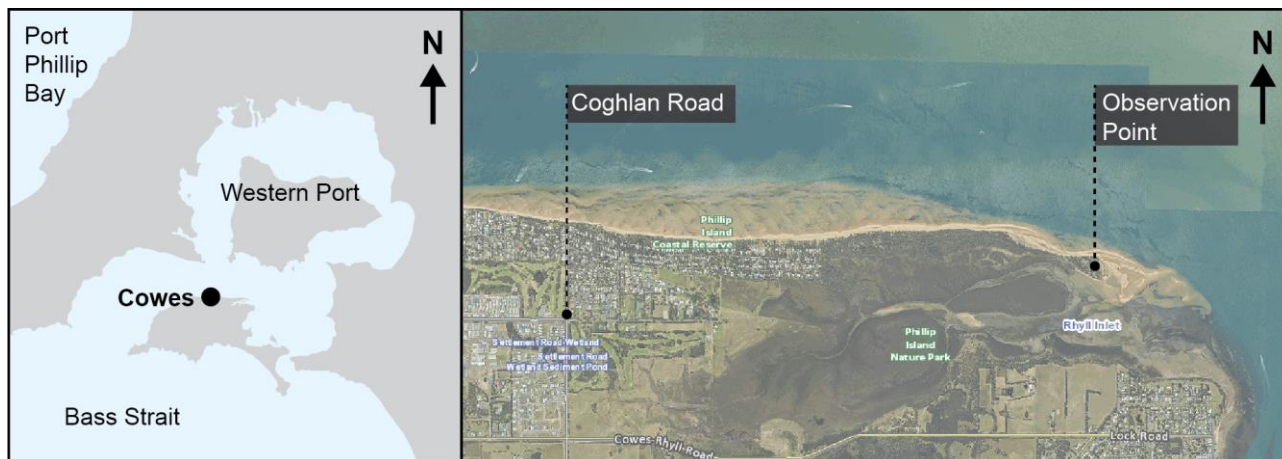
Figure 1-1: Site locality and context

(left) The location of the site in relation to Western Port. (right) Aerial view of study area (CoastKit, 2024).

FSC Range was engaged to undertake a detailed coastal processes study at East Cowes to Silverleaves area, which is located 60 km southeast of Melbourne on the northern coast of Phillip Island (Figure 1-1).

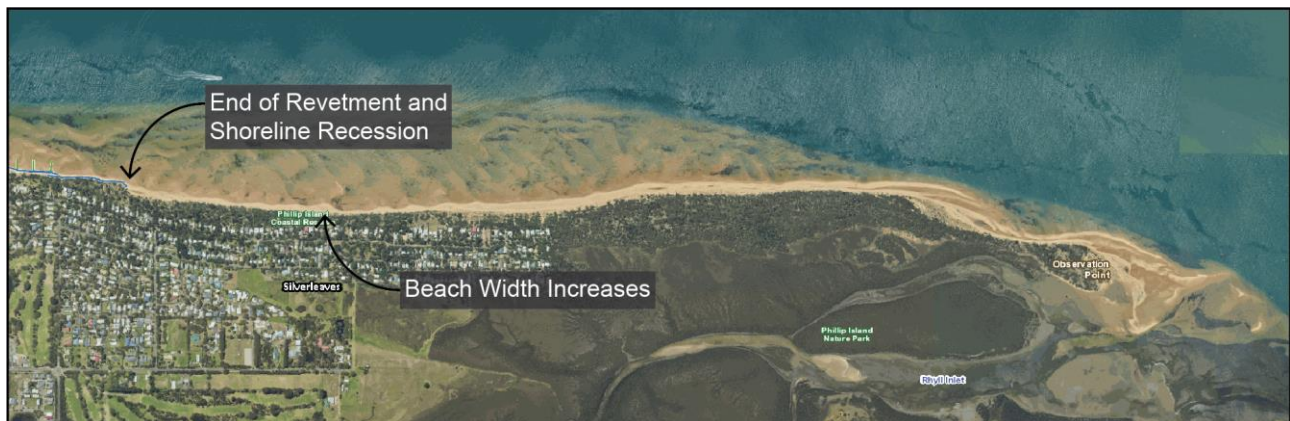
Figure 1-3: Key features of Silverleaves

There is a noticeable shift in the shoreline orientation at the end of the revetment with a narrow beach that slowly widens to the east (CoastKit, 2024).

Silverleaves approximately begins at the end of the rubble rock revetment. The shoreline here takes a sharp inward change in direction. This sharp change in direction is an erosional feature that has been present for several decades, which has increased in its rate of recession. Silverleaves in particular faces coastal erosion challenges, which poses threats to public and private assets. Foreshore protection structures were once located along this shoreline, but these have now aged and are no longer effective; all are buried or have been removed. Further east, the shoreline forms a large crescent bay where the narrow western beaches slowly transition to relatively wide beaches to the east.

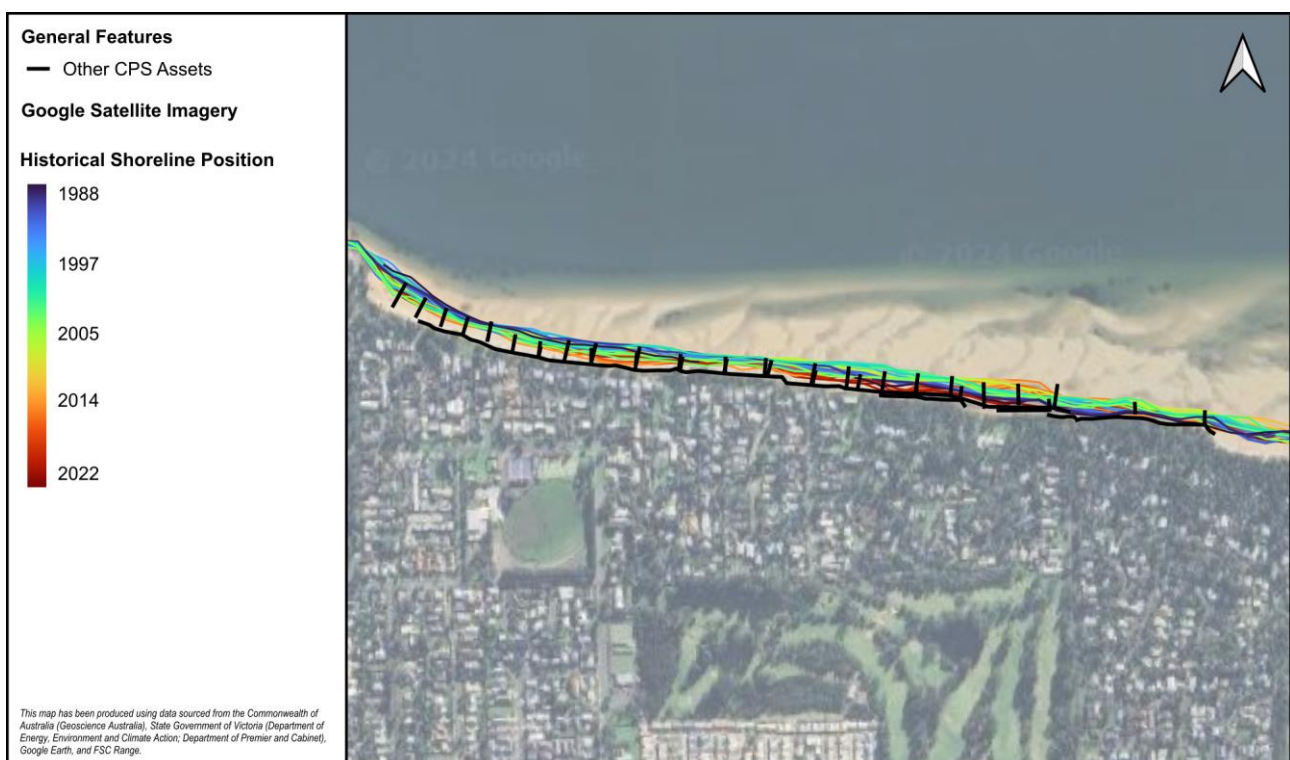
Figure 4-1: Map of shoreline position nearby CPS – East Cowes

Extracted from DEA Coastlines (2023), showing the net shoreline movement and historical shoreline position. The historical shoreline position is defined by the annual tidally corrected land-water interface (Bishop-Taylor et al., 2021).

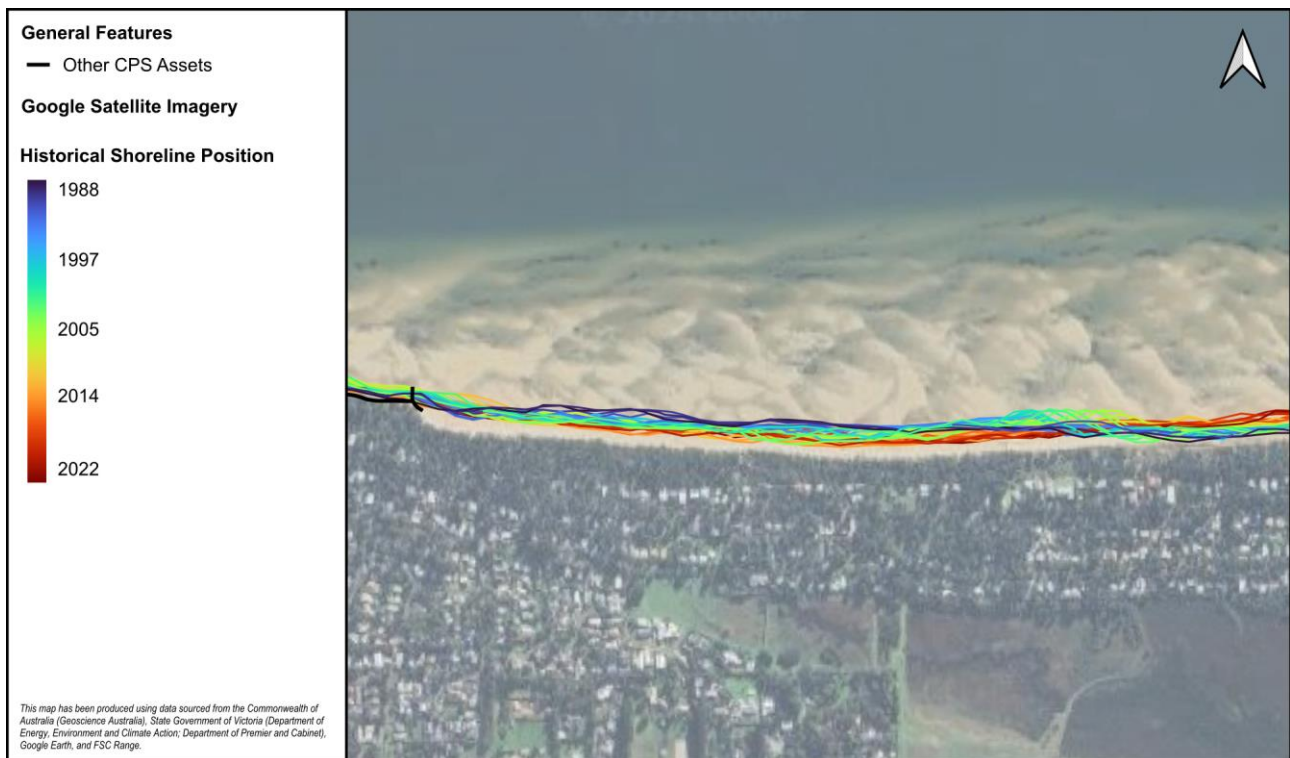
Figure 4-2: Map of shoreline position nearby CPS – Silverleaves

Extracted from DEA Coastlines (2023), showing the net shoreline movement and historical shoreline position. The historical shoreline position is defined by the annual tidally corrected land-water interface (Bishop-Taylor et al., 2021).

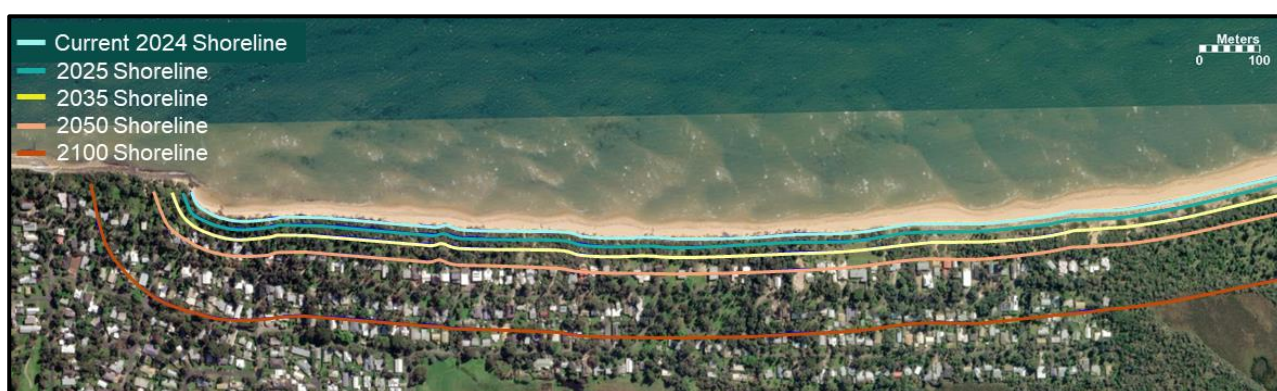
**Figure 7-7: Possible future shoreline setback extents for Silverleaves**

Planning Horizon	Year	SLR (m)	Shoreline Setback (m) Likelihood		
			95%	50%	5%
Current	2025	0.11	9	13	17
Immediate Term	2030	0.13	13	21	30
	2035	0.16	16	30	47
	2040	0.20	20	40	65
Short Term	2050	0.26	25	59	100
Long term	2100	0.80	65	165	290
