Justification of Project

Aims/Objectives

- To quantify shoreline change in Lady Bay between 1853 and 2007 across a 154yr period.
- Observe any trends occurring in shoreline change between 1853-1870, 1870-1909, 1909-1948, 1948-1994, 1994-2007.
- Determine siltation fluxes surrounding major historical engineering events.

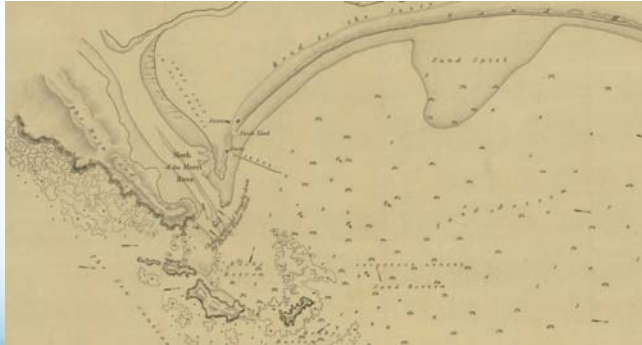
Barrow 1853

1853 RMS = 6.63

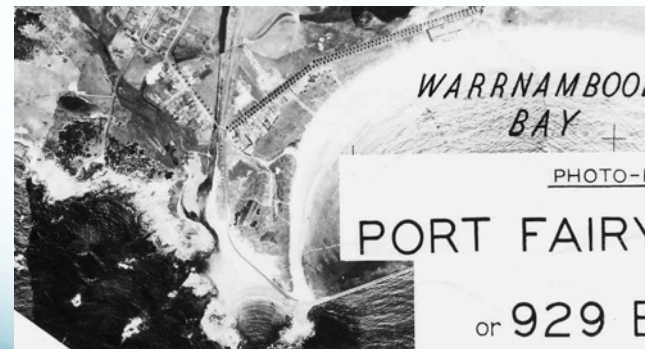
Aerial 1948

1948 RMS = 6.63

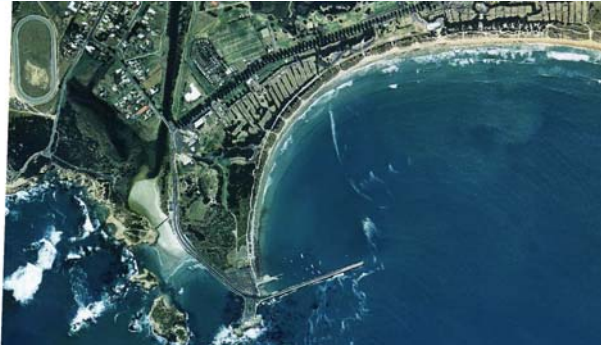
Aerial 1994

1994 RMS = 8.56

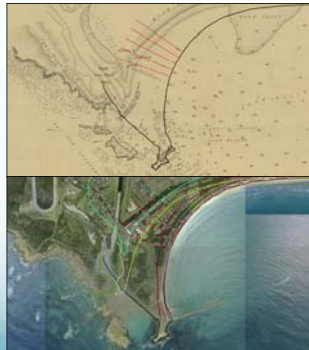
Step 4: Shoreline analysis

- 5 cast transects, 50m apart in the western zone were used to quantify shoreline change.
- Total distance between 1853 – 2007 (154 years) along the transect line to calculate the overall shift in shoreline.
- Average rate of change between each time series: 1853-1870, 1870-1909, 1909-1948, 1948-1994, 1994-2007.
- Linear regression rate for overall shoreline change over time.
