Eastern Great Ocean Road Cliff Hazards: Brief Assessment

April 2023, Jak McCarroll
Victorian Coastal Monitoring Program, DEECA

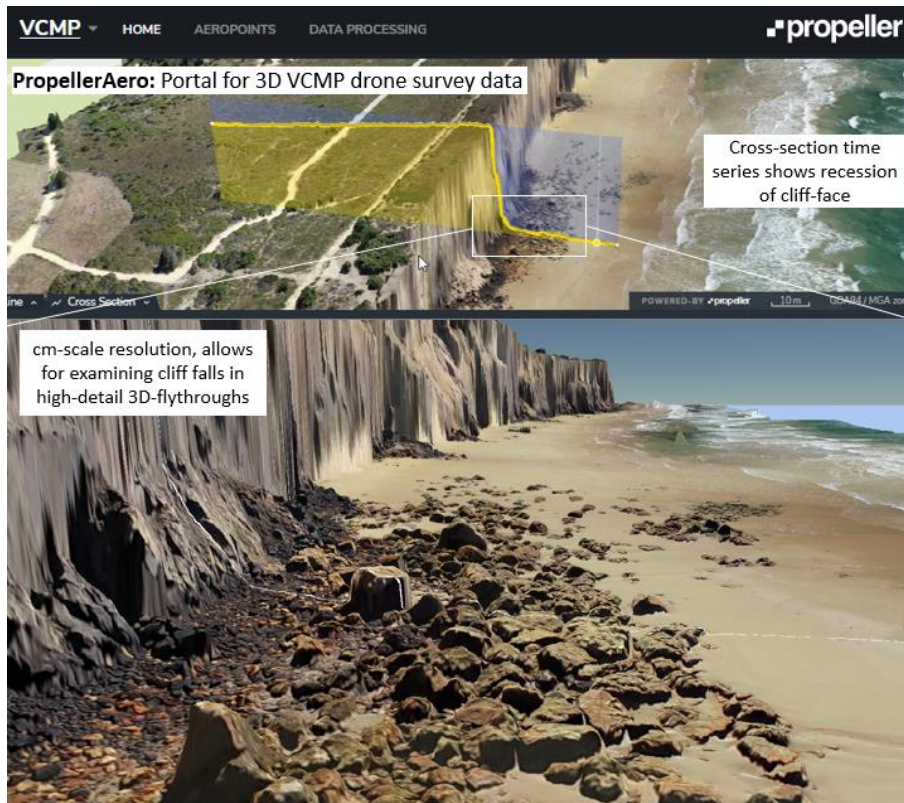
Figure 5. Example analysis from the PropellerAero data processing and hosting portal.

A summary of current coastal monitoring practices along the eastern GOR are provided in Table 4. GORCAPA and the VCMP are presently in a data sharing arrangement. The advantage of obtaining and sharing data through the VCMP is that survey outputs can be maintained on centralised portals, including PropellerAero and CoastKit (Figs. 5-6), with a range of data analysis tools and outputs available to partners and other data users across government. For example, sites surveyed by the GORCAPA survey team (e.g., Torquay to Jan Juc) are processed and hosted through the VCMP data portals (Figs. 5-6).
