Inverloch Region Coastal Hazard Assessment

Adaptation Actions Technical Assessment Report Summary October 2022

Improving our ability to plan, manage and prepare for the impacts of coastal hazards between Cape Paterson and Cape Liptrap, delivered as part of the Cape to Cape Resilience Project.

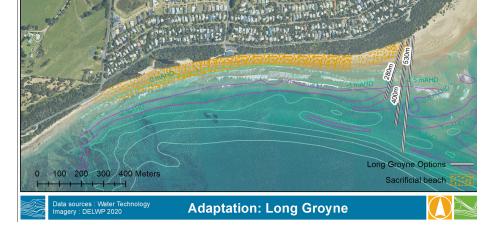
Groyne 300m to 500m is required to anchor enough sediment to realign the beach and protect the coastline at Wreck Creek. Beach nourishment volumes required to achieve this protection are unknown and the initial storm demand of approximately 100,000m3 would be required to be managed or increased as the beach realigned.

Figure 7. Conceptual design - Long groyne at Point Norman
