Port Phillip Bay Beach Nourishment Program Preliminary Assessment

Incorporating Victorian Coastal Monitoring Program
(VCMP) Data

April 2023, Jak McCarroll

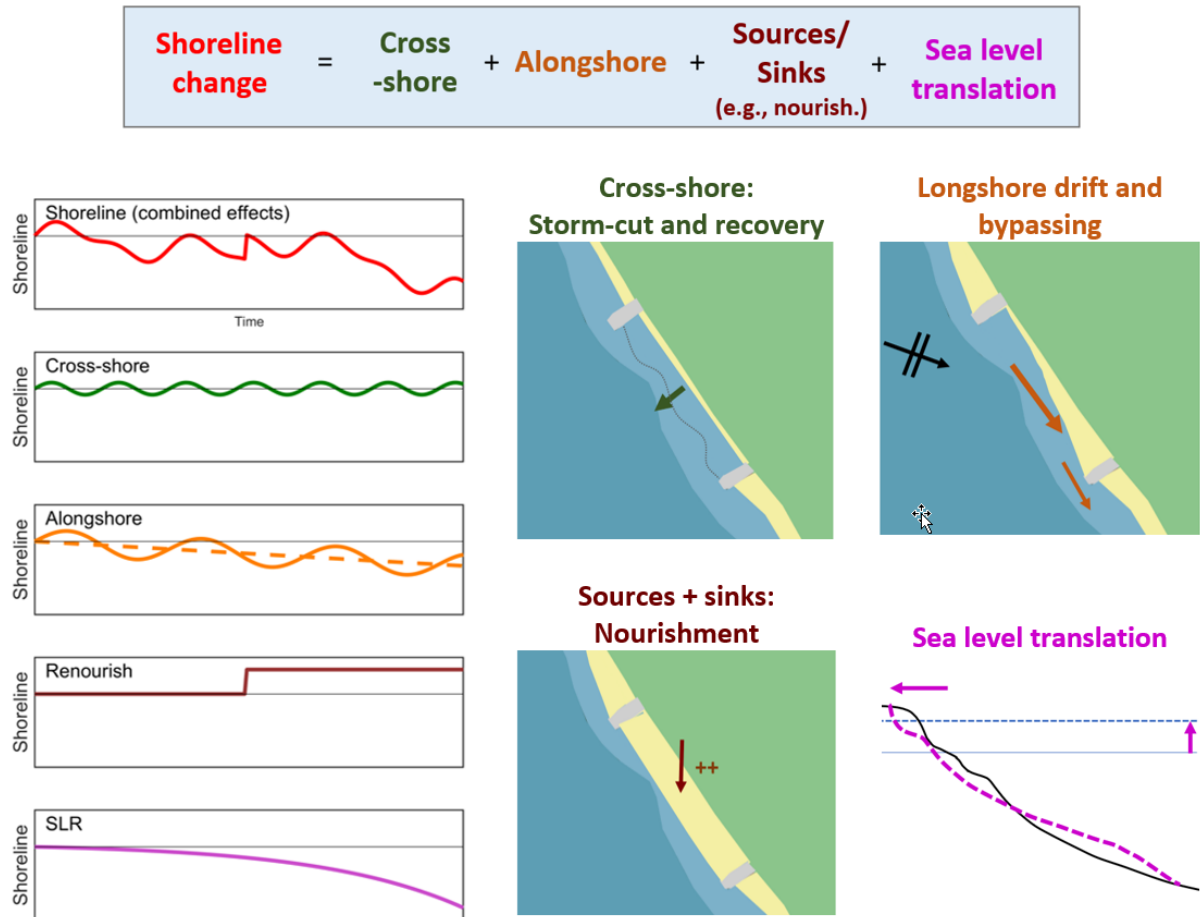
Fig. 1.1. Sediment budget components. The red “combined effects” shoreline is the sum of the components: cross-shore, alongshore, nourishment and SLR.

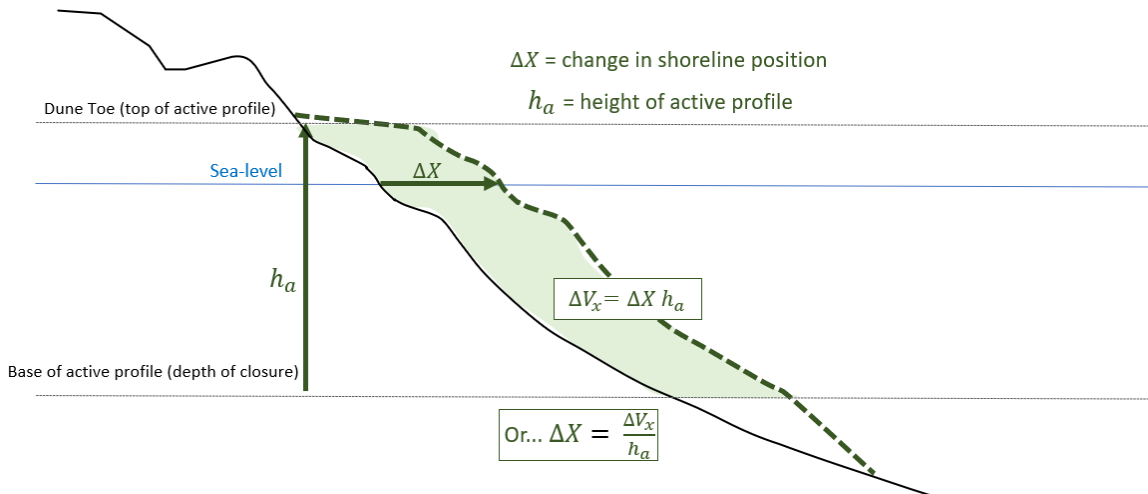
Fig. 1.2. Profile cross-section with volume change calculation. Volume change per unit alongshore is approximated as shoreline position multiplied by active profile height.

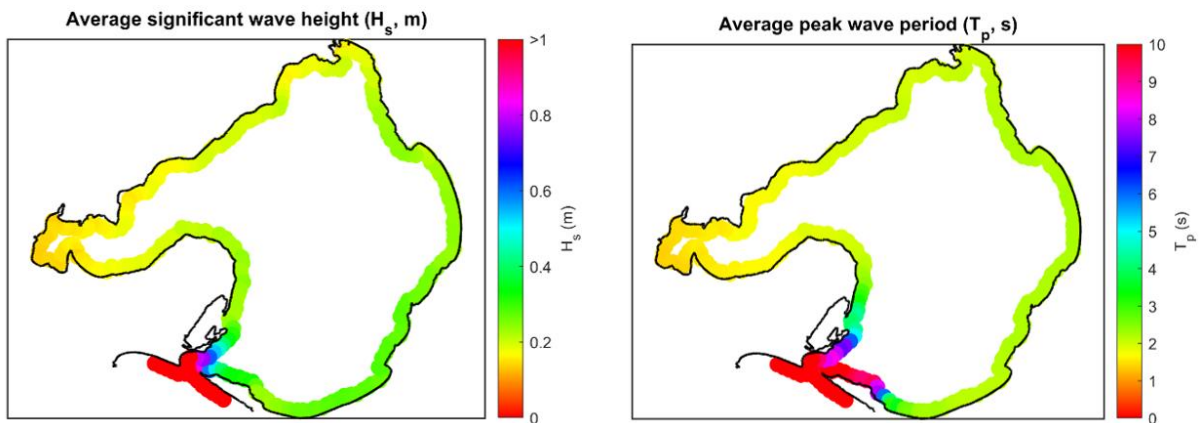
Fig. 2.2. Long-term averages for significant wave height (left) and peak period (right).

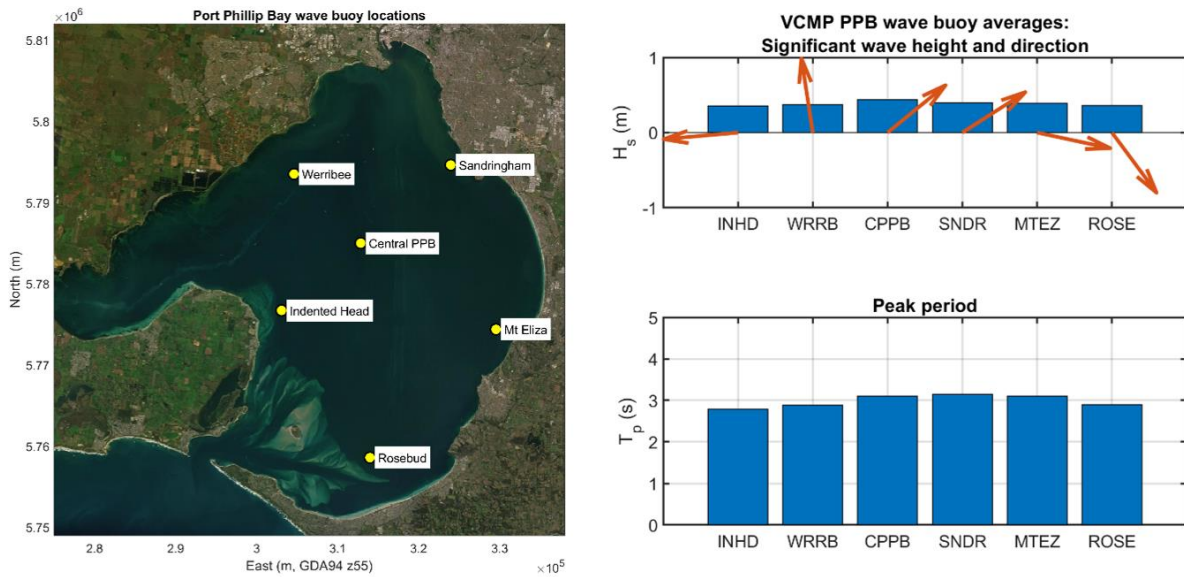
Fig. 2.4. Port Phillip Bay wave buoy locations. Site abbreviations in right panel include: Indented Head (INHD); Werribee (WRRB); Central Port Phillip Bay (CPPB); Sandringham (SNDR); Mt Eliza (MTEZ); and Rosebud (ROSE).

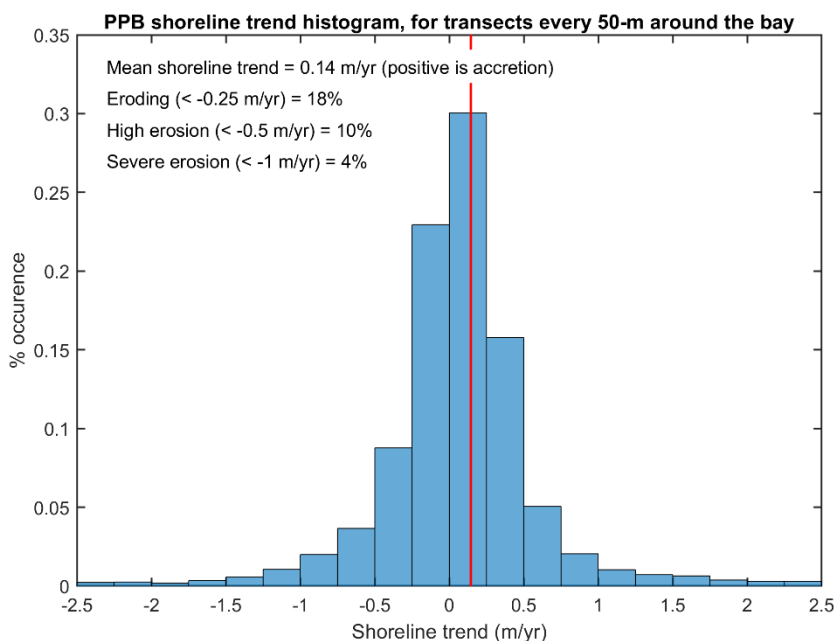
Fig. 2.6. PPB shoreline trend histogram, using DEA satellite data for 1988 – 2018, based on transects every 50-m alongshore around the bay.

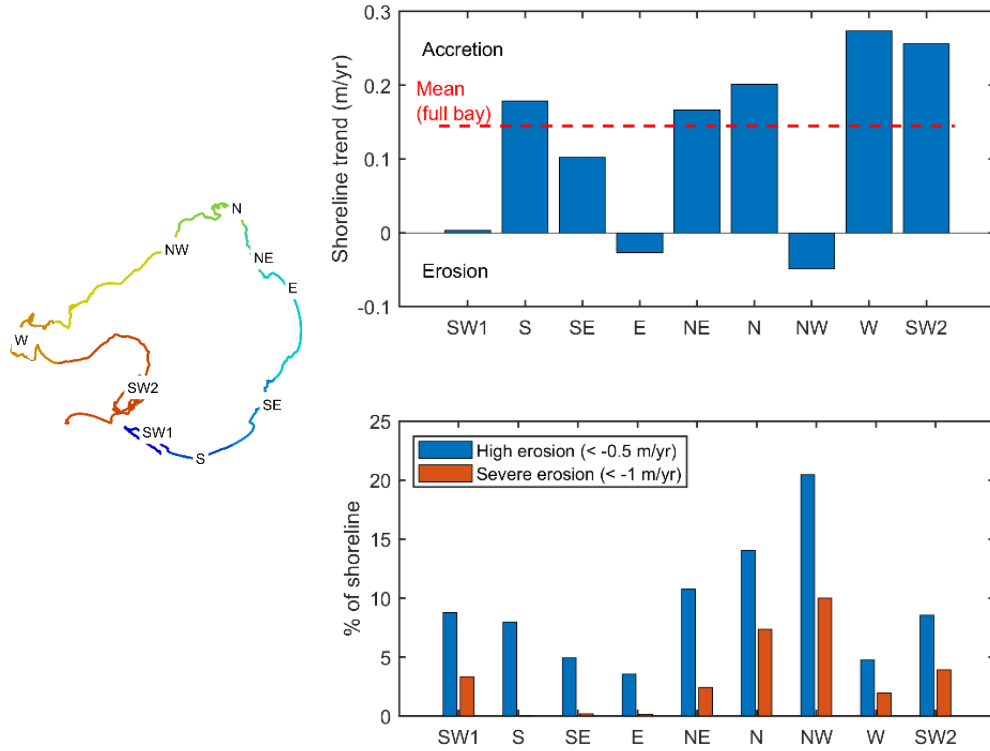
Fig. 2.7. PPB sectors, (left) map of sectors, (top right) shoreline trend by sector; and (bottom right) incidence of 'high' and 'severe erosion' by sector, based on DEA satellite data, 1988 – 2018.

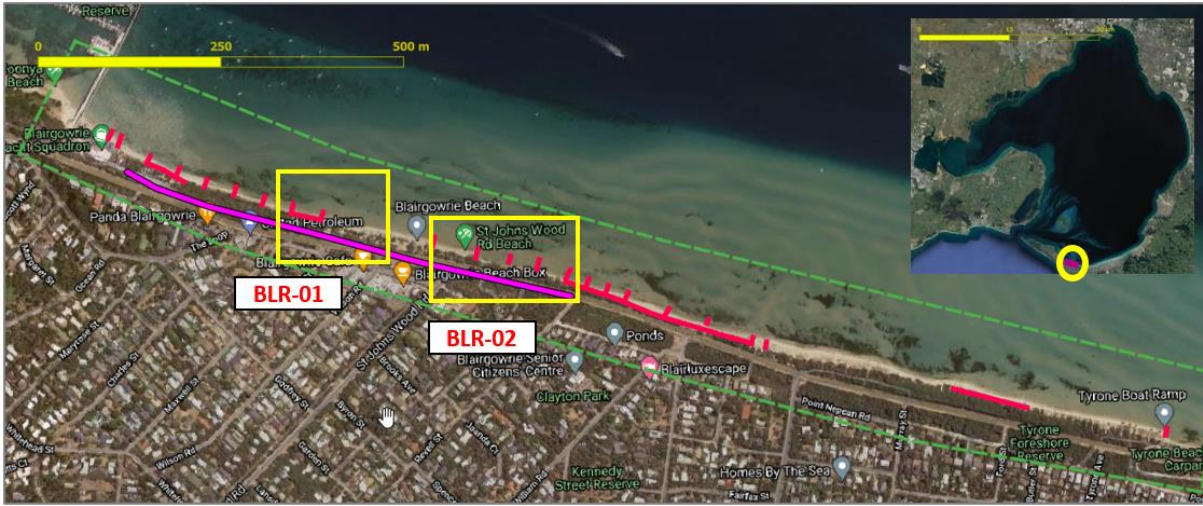
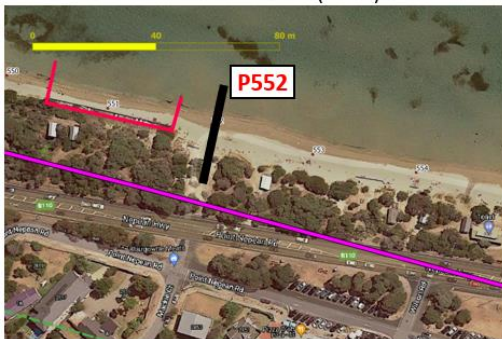
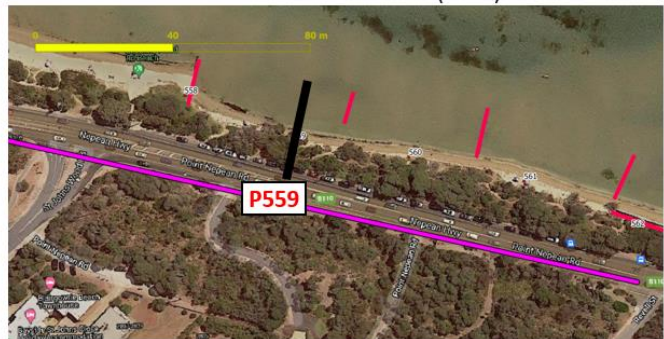
Fig. 3.1.1. Blairgowrie. Drone survey area (green dashed); structures (red); nourishment area (pink)

Blairgowrie is located on the Mornington Peninsular to the south of the bay, at the western end of 24-km long sandy embayment. The beach is low-energy and narrow, with a low dune, with varying degrees of vegetation and infrastructure built on the dune. A major road (Nepean Hwy) runs directly behind the barrier. The proposed nourishment runs from the Blairgowrie Marina, eastward for ~2-km. Within the nourishment, key sites of interest occur where erosion of the coastline may cause hazard to the road (Fig. 3.1.1), including:

Cross-shore structures: Wooden groynes, with 20 m average length, comprise an irregularly spaced groyne-field (100 – 200 m spacing), covering most of the nourishment site (Fig. 3.1.1) from the marina, eastward 1.4 km. Many of these are in poor condition and are ineffective at trapping sediment.

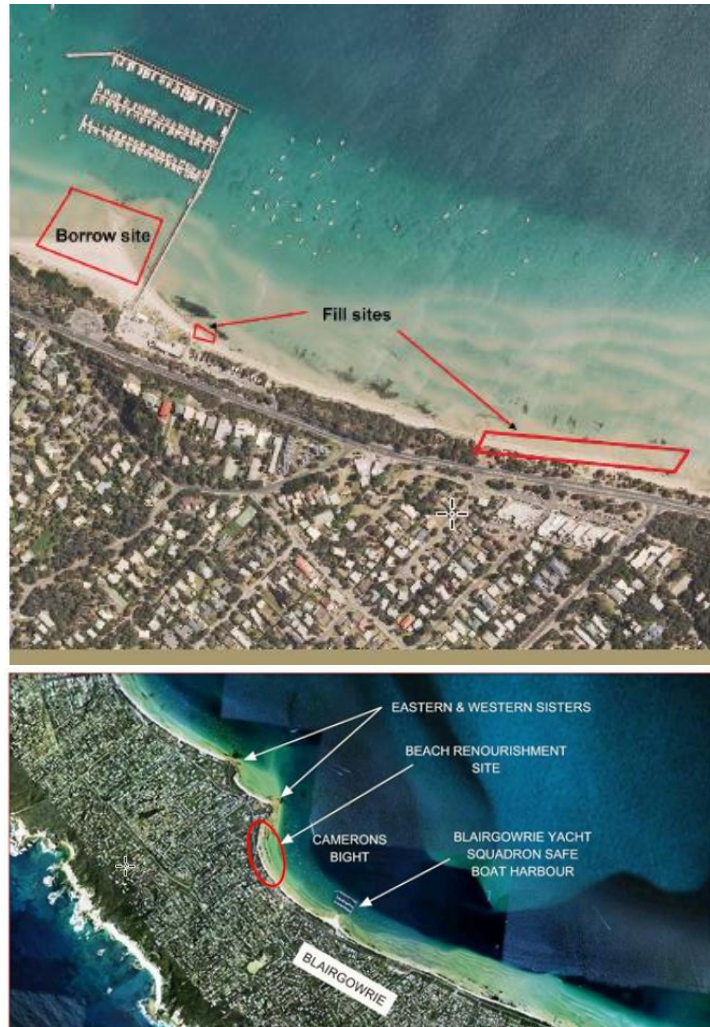
Fig. 3.1.1a. (Top) 2010 Blairgowrie renourishment of 10,000 m³ from “2010BlairgowrieRenourishmentInfo.pdf” flyer released by the Department of Sustainability and Environment; (bottom) Camerons Bight 2013 nourishment of 5,000 m³, location from Oldfield (2012).

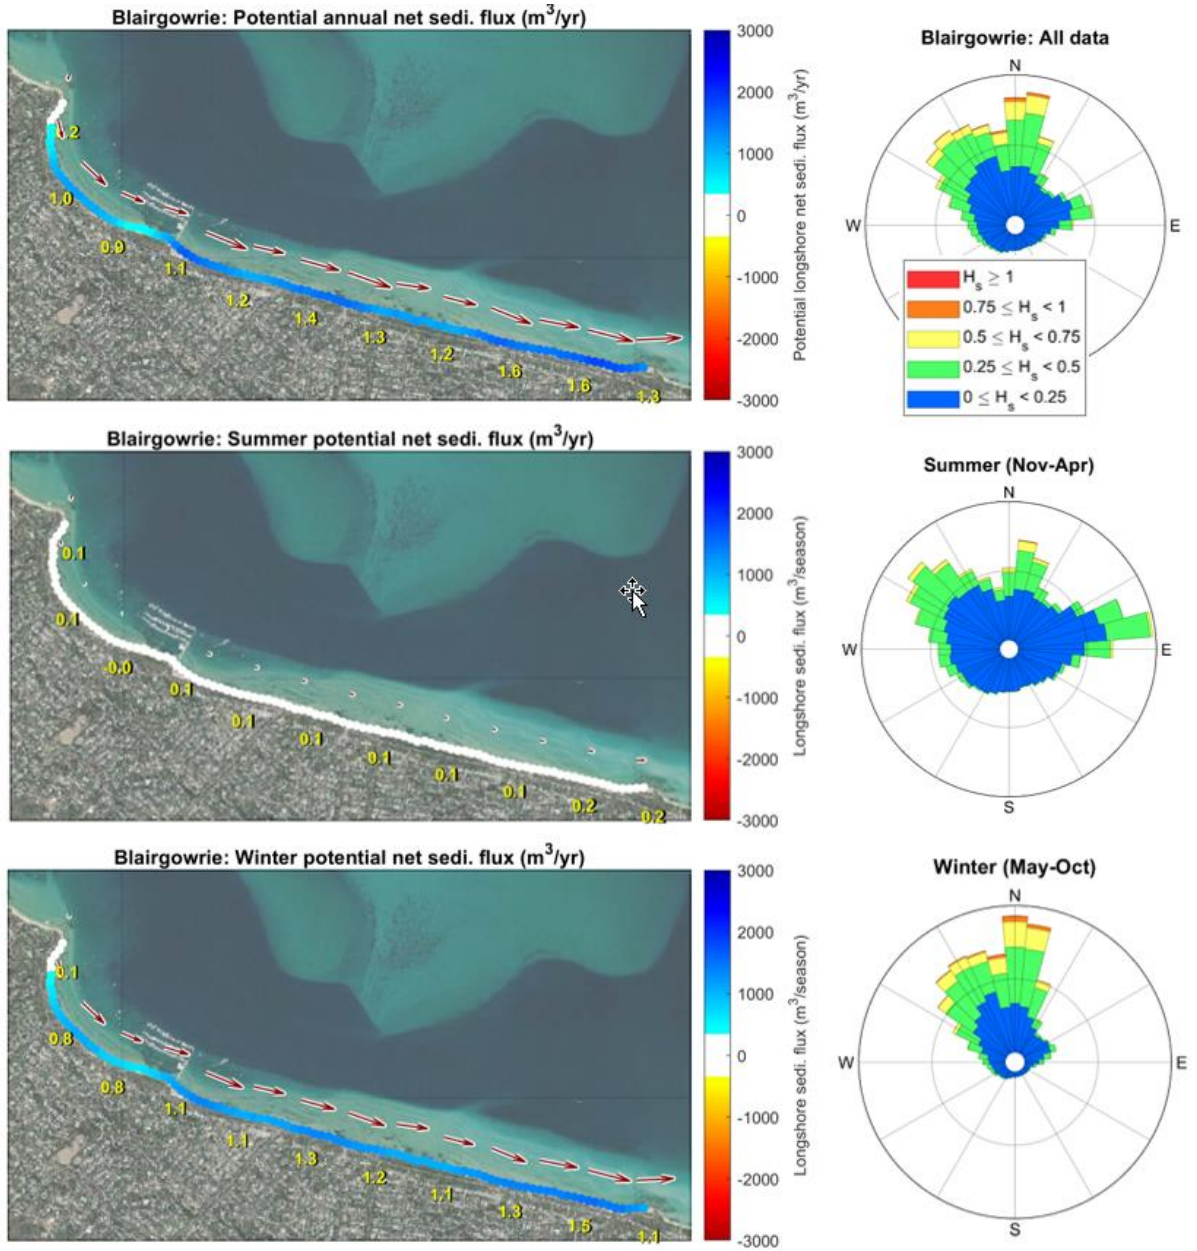
Fig. 3.1.2. Blairgowrie potential sediment flux (left) and wave roses for a model node located 500 m from shore.

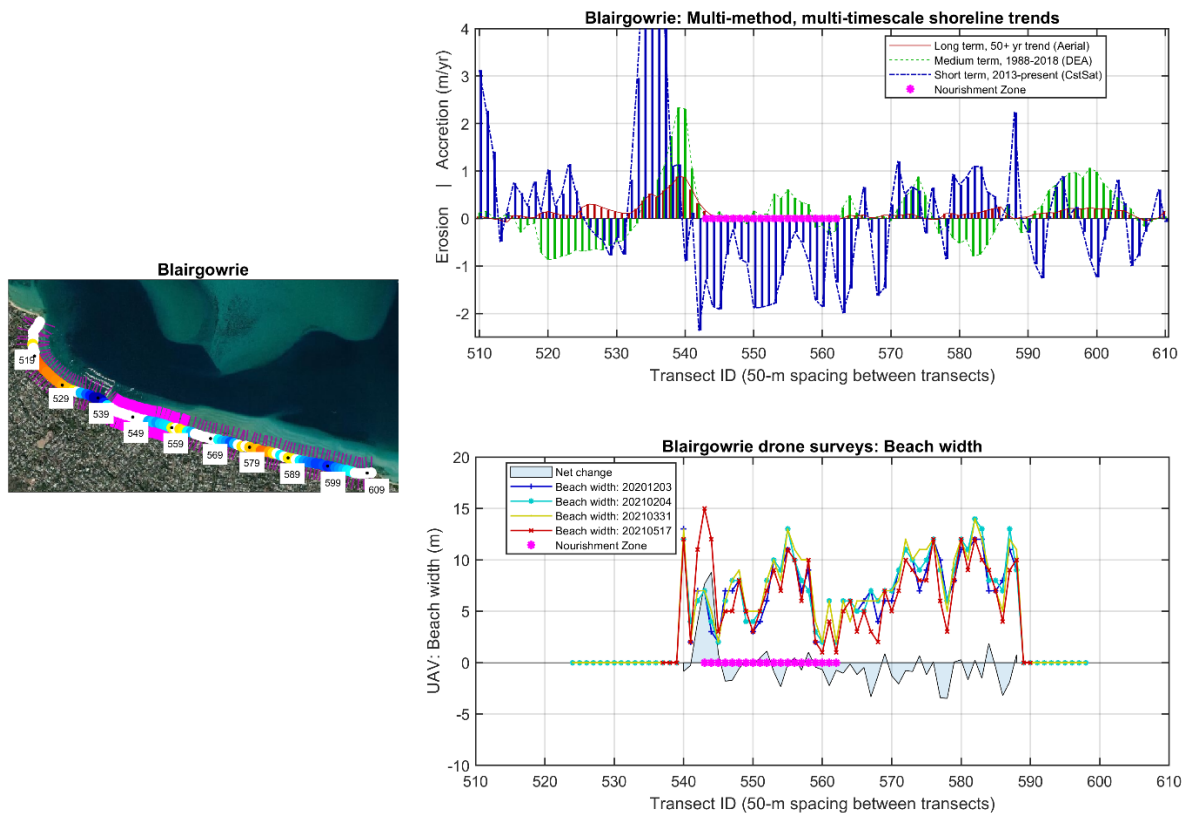
Fig. 3.1.3. Blairgowrie, (top) shoreline trends over different time scales [1930 – 1988; 1988 – 2013; 2013 – 2022]; (bottom left) site map with transect ID’s, coloured dots indicate erosion [hot colours] and accretion [cold colours]; (mid right) multi-timescale shoreline trends; and (bottom right) beach width from drone surveys.

- A zone of terminal scour is observed opposite Mackie Ct, downdrift of a groyne-field and a short seawall (transect ID - P552).
- Long- and short-term trends are neutral (Fig. 3.1.3, top-right), with a large amount of inter-annual variability (Fig. 3.1.4), with fluctuations of 10-20 m occurring over a few years. Some of these may be due to 'erosion – nourishment' cycles.

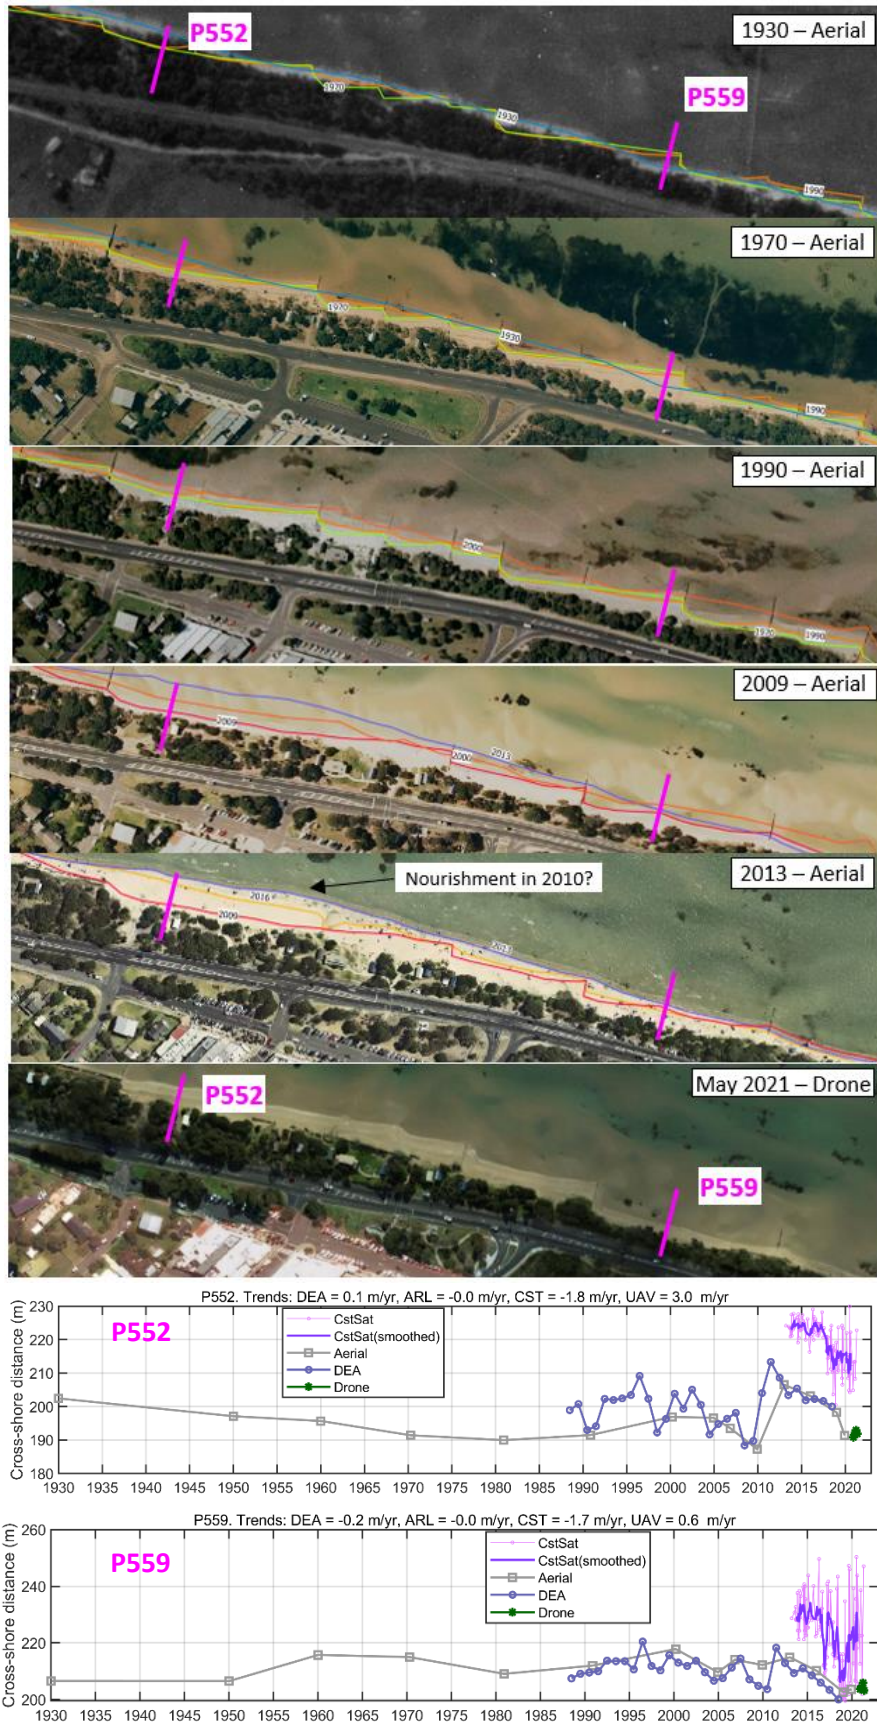
Fig. 3.1.4. Blairgowrie east of Marina nourishment target, (rows 1-5) aerial and drone image time series, (bottom row) multi-method shoreline position time series. Pink line in top panels show location of profile (P552) analysed in bottom panel.

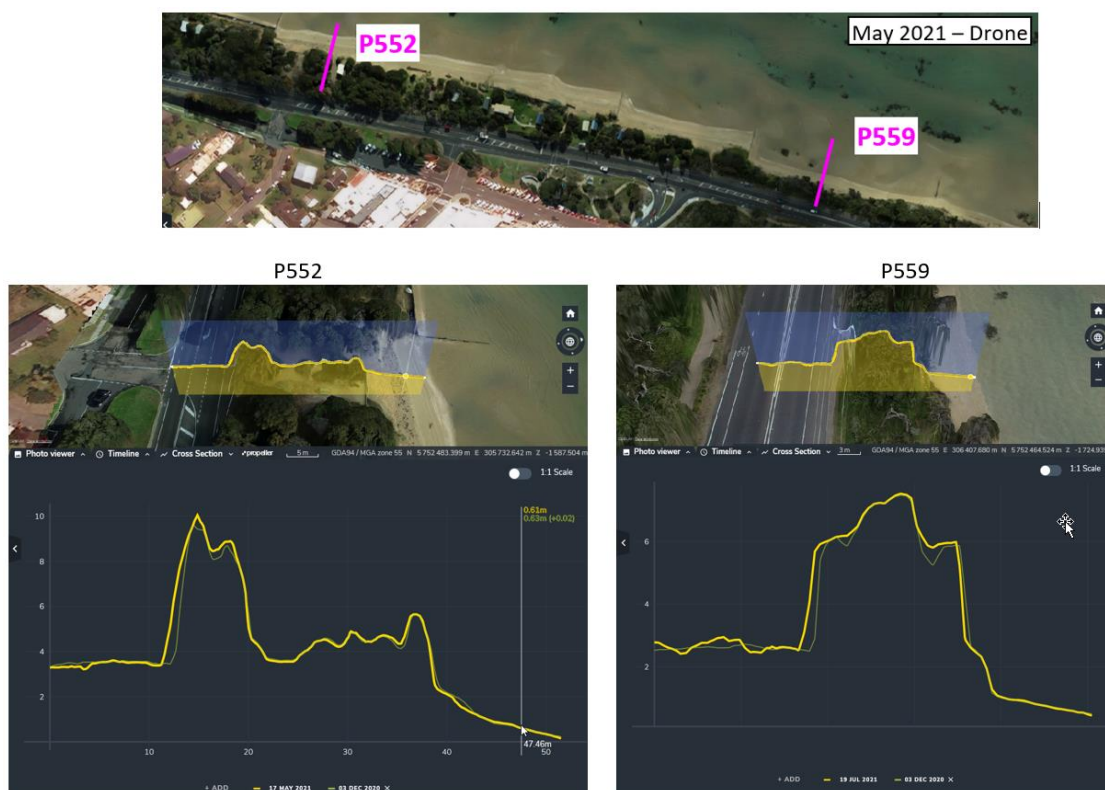
Fig. 3.1.5. Blairgowrie drone survey cross-sections for profiles P552 and P559

- At BLR-01 (P552, Fig. 3.1.5), yes, but the road is not at immediate risk. Nourishment is required in the short-term (<10 years) to reduce the erosion risk to large trees, which could present a significant hazard.
- At BLR-02 (P559, Fig. 3.1.5), yes. Pt Nepean Rd just east of St Johns Wood Rd (Fig. 3.1.5, P559) could be directly impacted by erosion within 6 years.

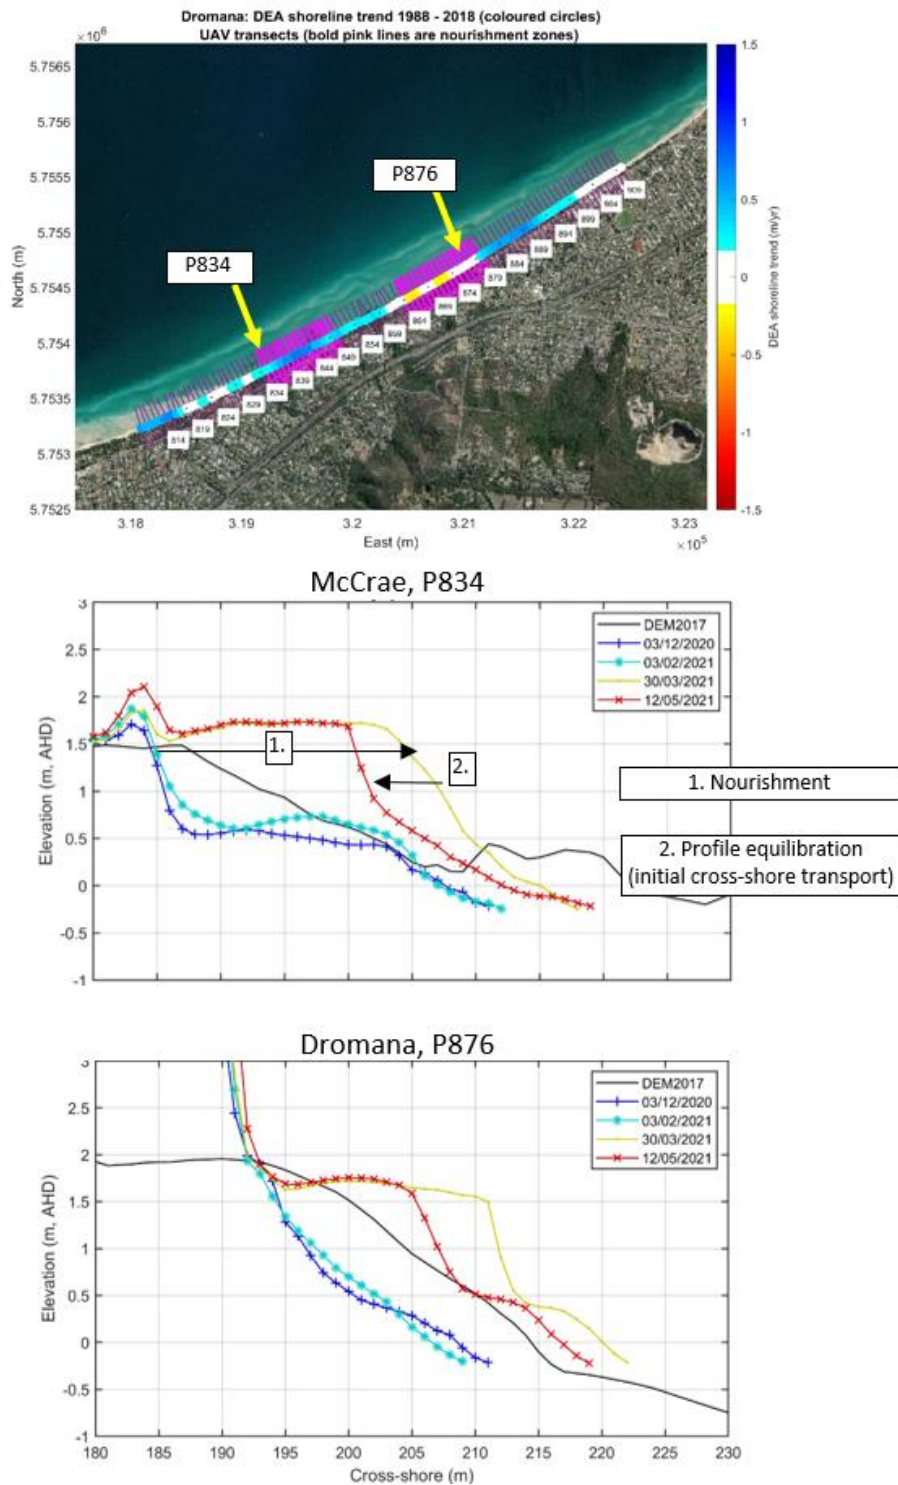
Fig. 3.2.8. Dromana-McCrae profile cross-sections extracted from drone surveys, pre- and post-nourishment.

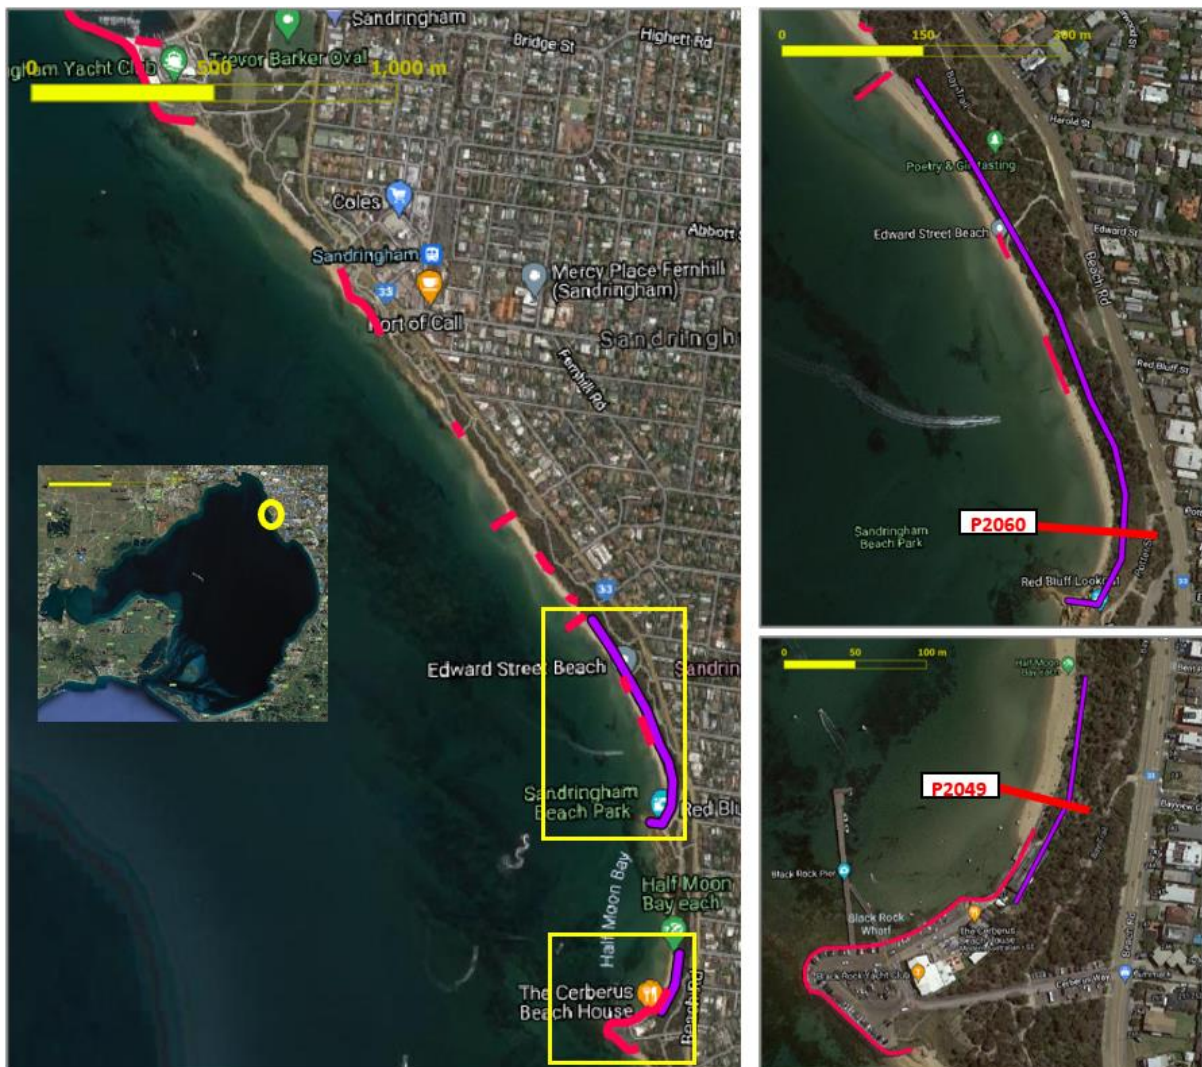
Fig. 3.3.1. Sandringham and Half Moon Bay, drone surveys cover the full extent of left panel. (Top right) South Sandringham nourishment; and (bottom right) Half Moon Bay nourishment. Red lines indicate coastal structures, pink lines are nourishment targets. Two transects indicated in right panels (P2024, P2018) are analysed in detail in Fig. 3.3.6.

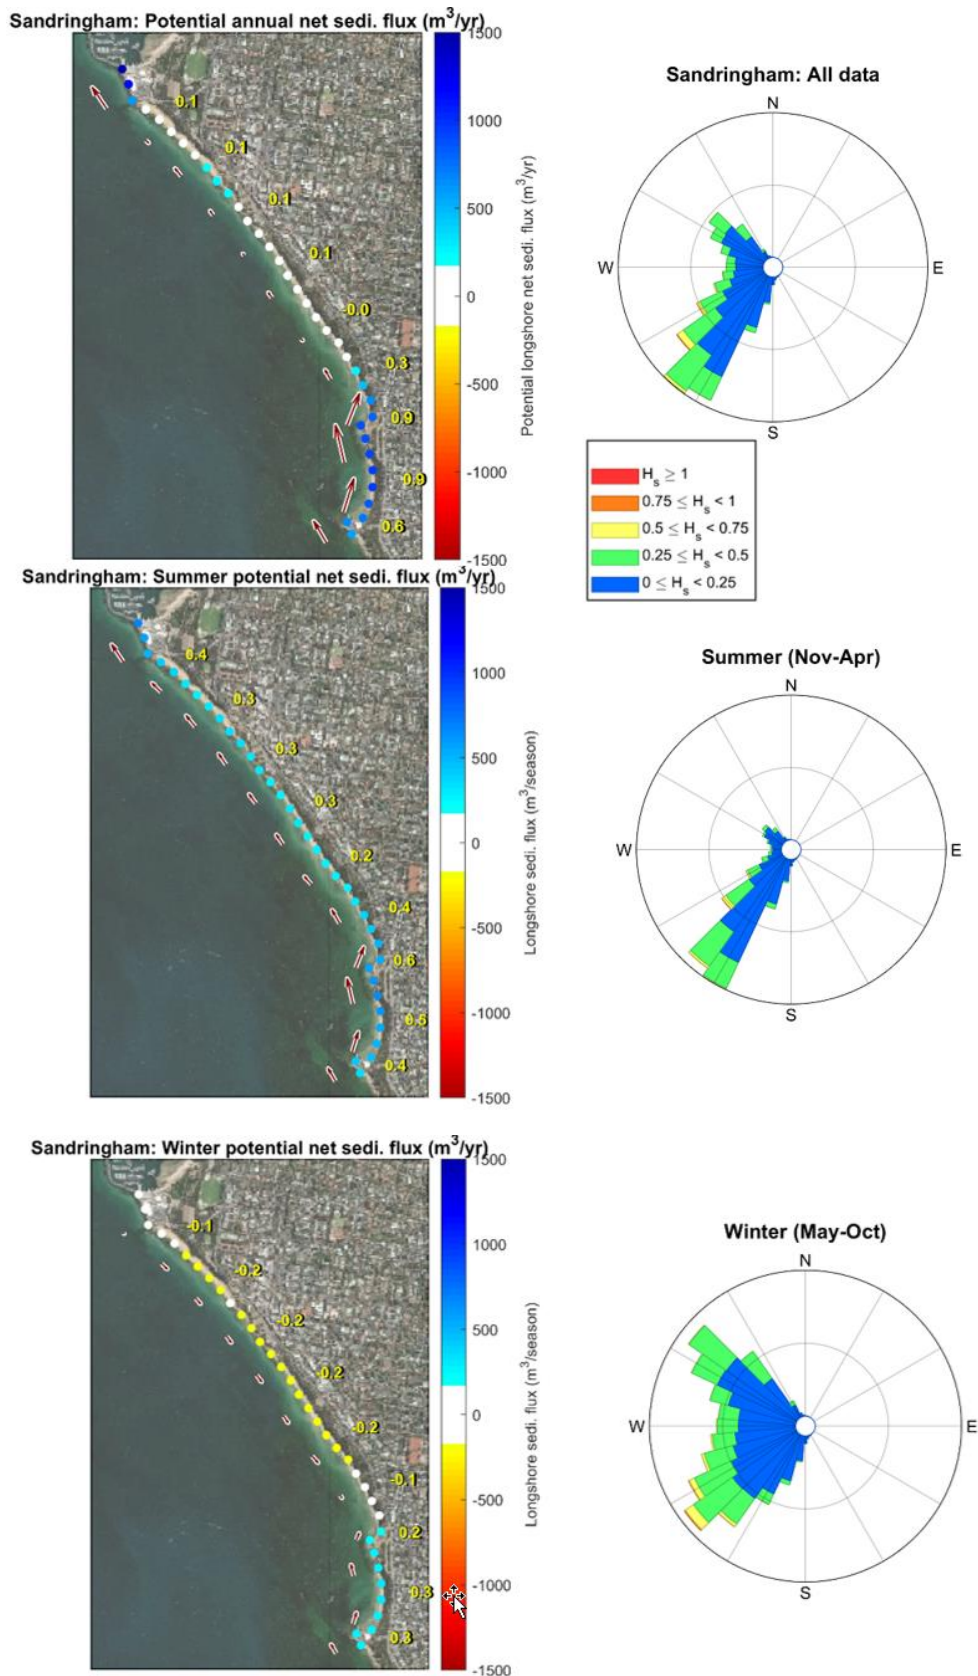
Fig. 3.3.2. Sandringham modelled wave climate (right panels) and potential longshore sediment flux (left panels). Yellow numbers in left panels are sediment flux in units of $1000 \cdot m^3/yr$.

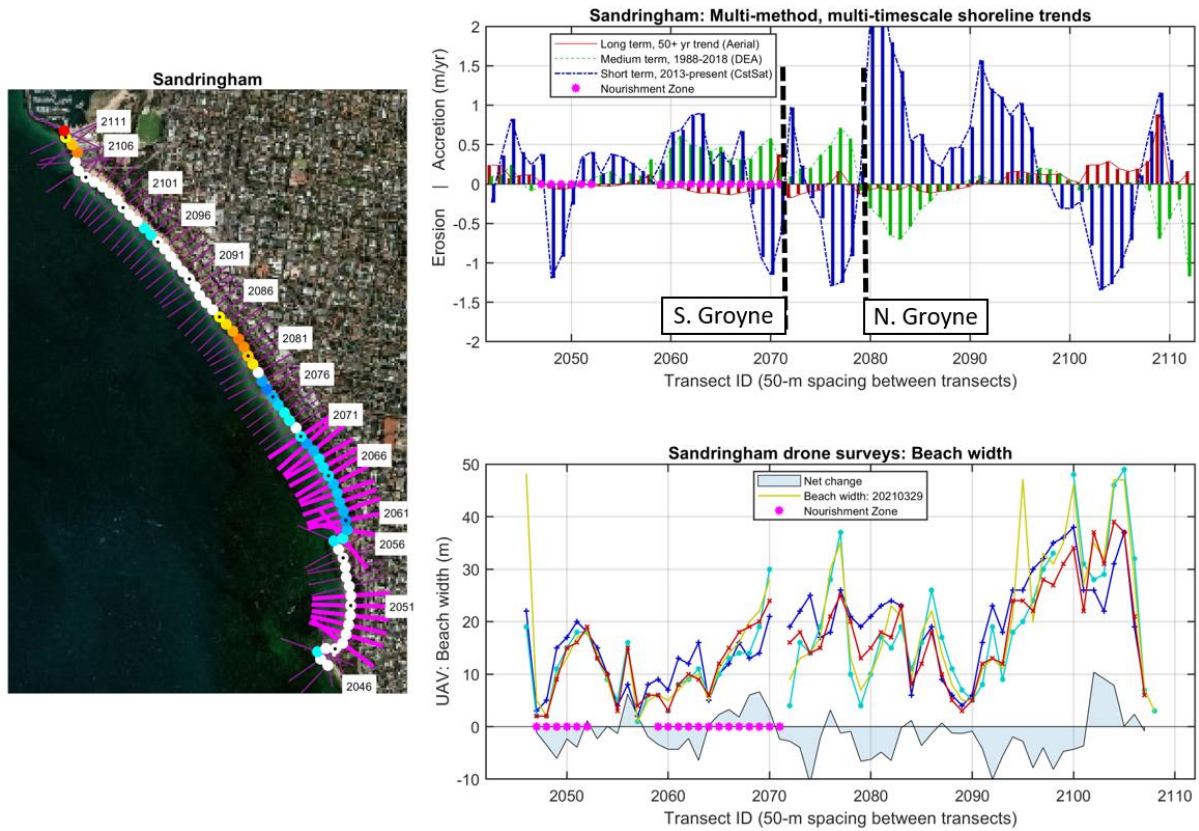
Fig. 3.3.3. Sandringham; (left) map showing transect numbers [TID], coloured dots show erosion [hot colours] and accretion [cold colours] for 1988 – 2018 satellite data; (top right) shoreline trends at different time scales for multiple datasets; and (bottom right) beach width for each drone survey (coloured lines) and net change in beach width (shaded area), where areas of large positive net change indicate nourishment zones.

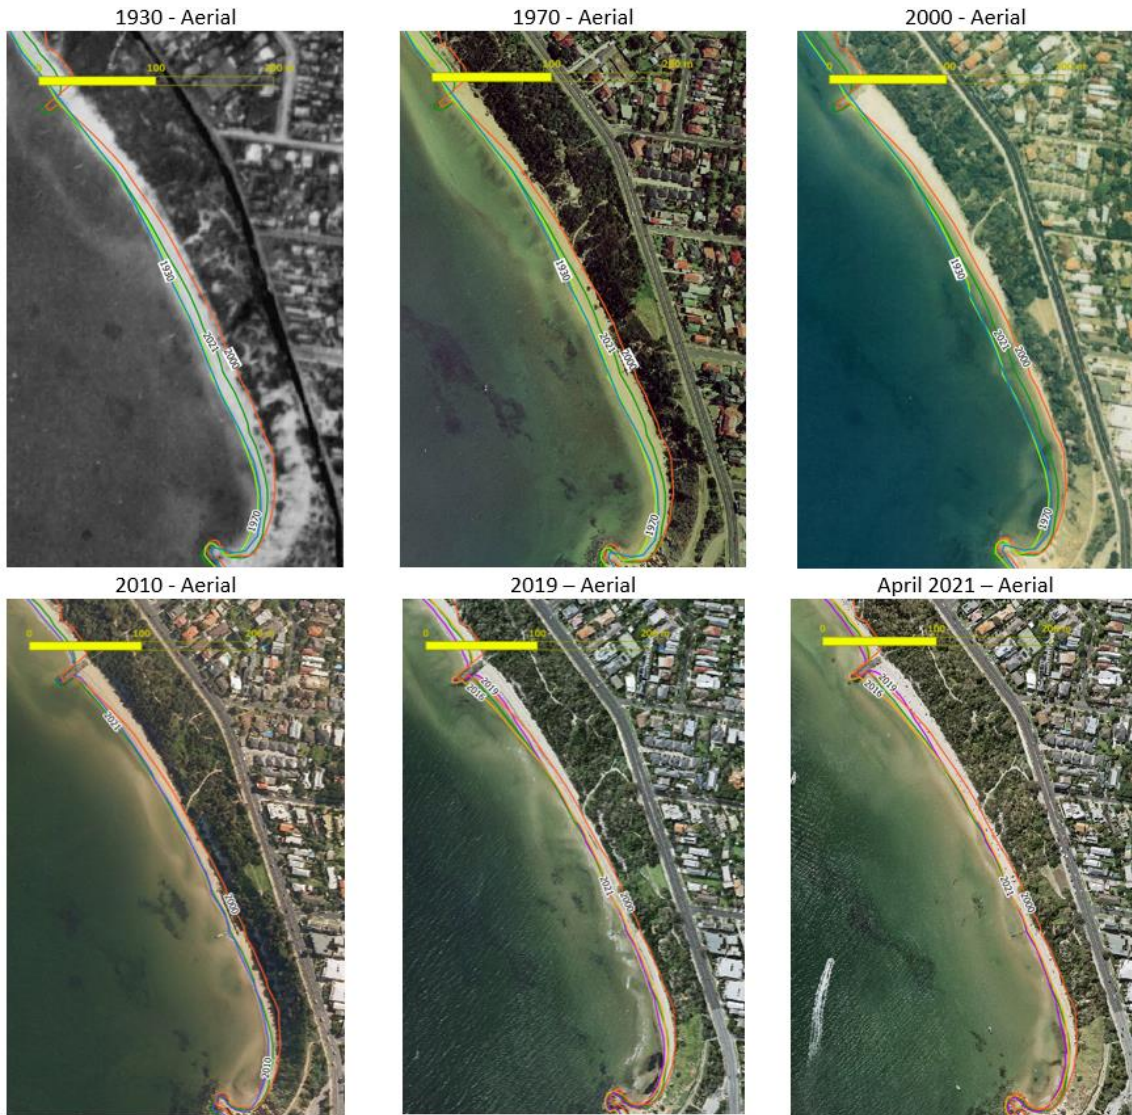
Fig. 3.3.4. Sandringham (south end) aerial photo time series (1930 – 2021).

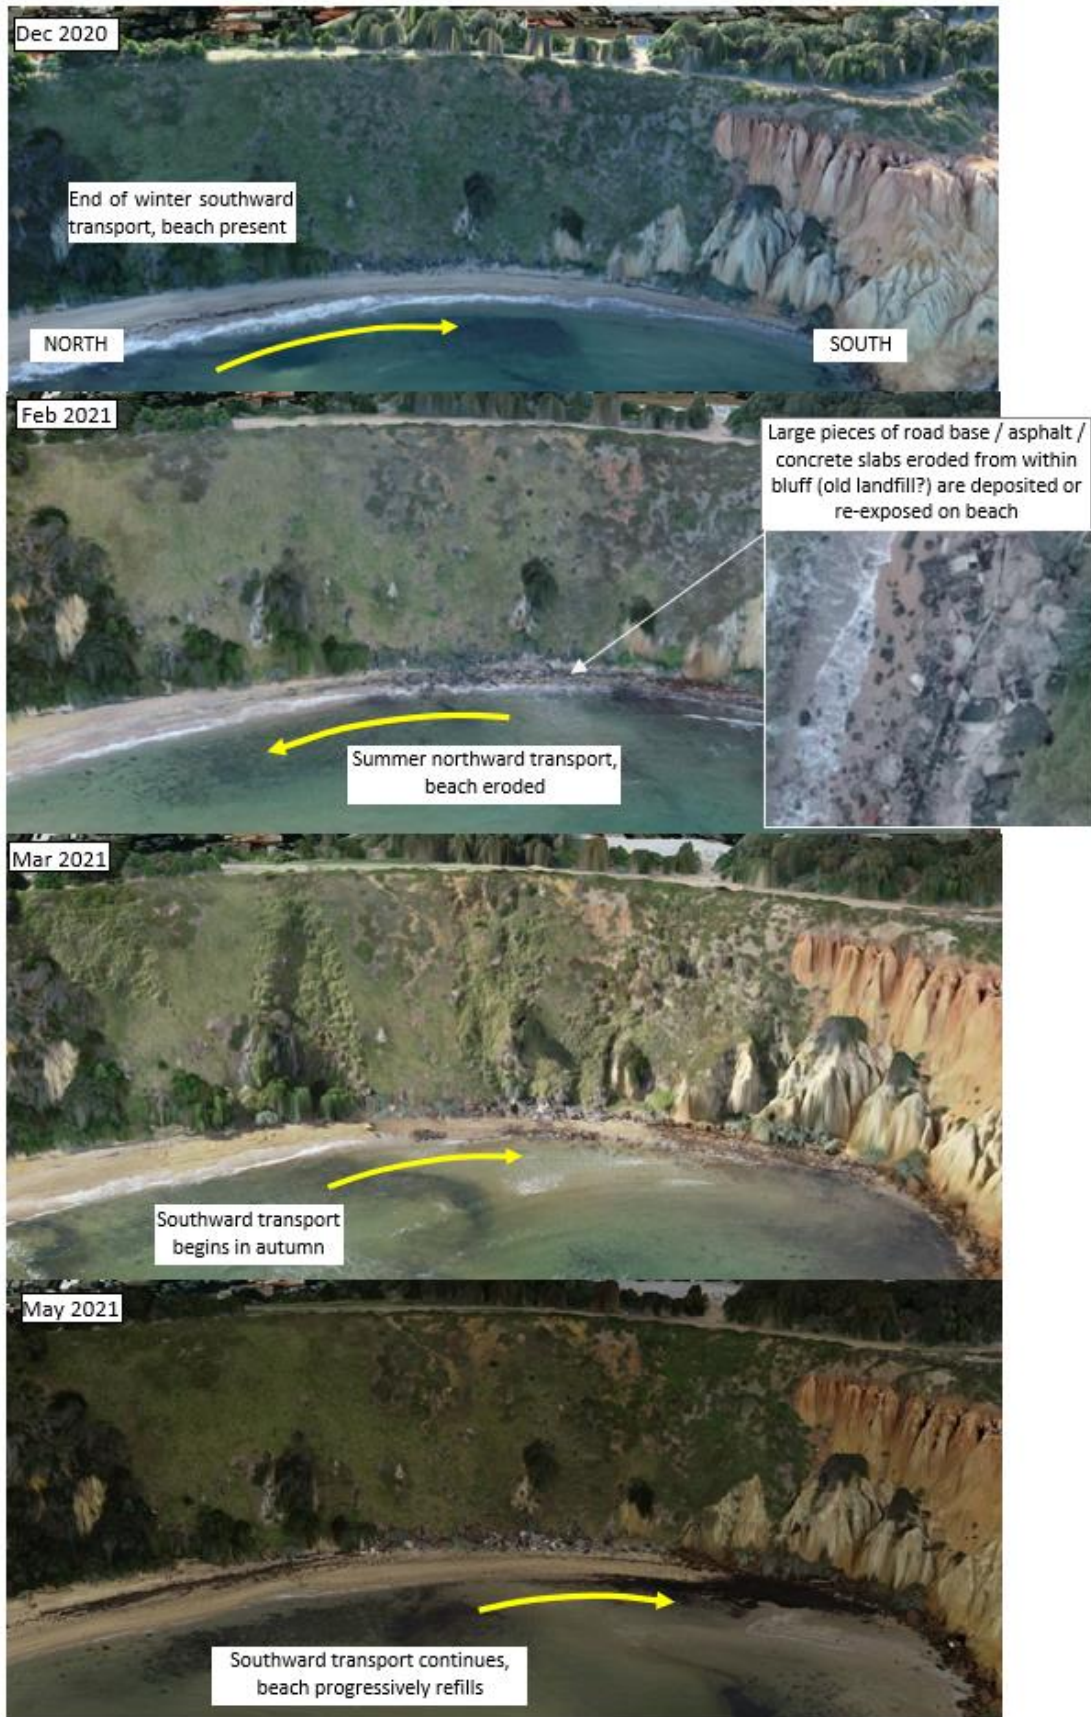
Fig. 3.3.7. Sandringham south end June 2021 nourishment site, drone 3D-orthomosaic time series. Note: The site was remediated by Bayside Council in April/May 2021 and accessible asphalt slabs were removed, some buried debris may still be present.

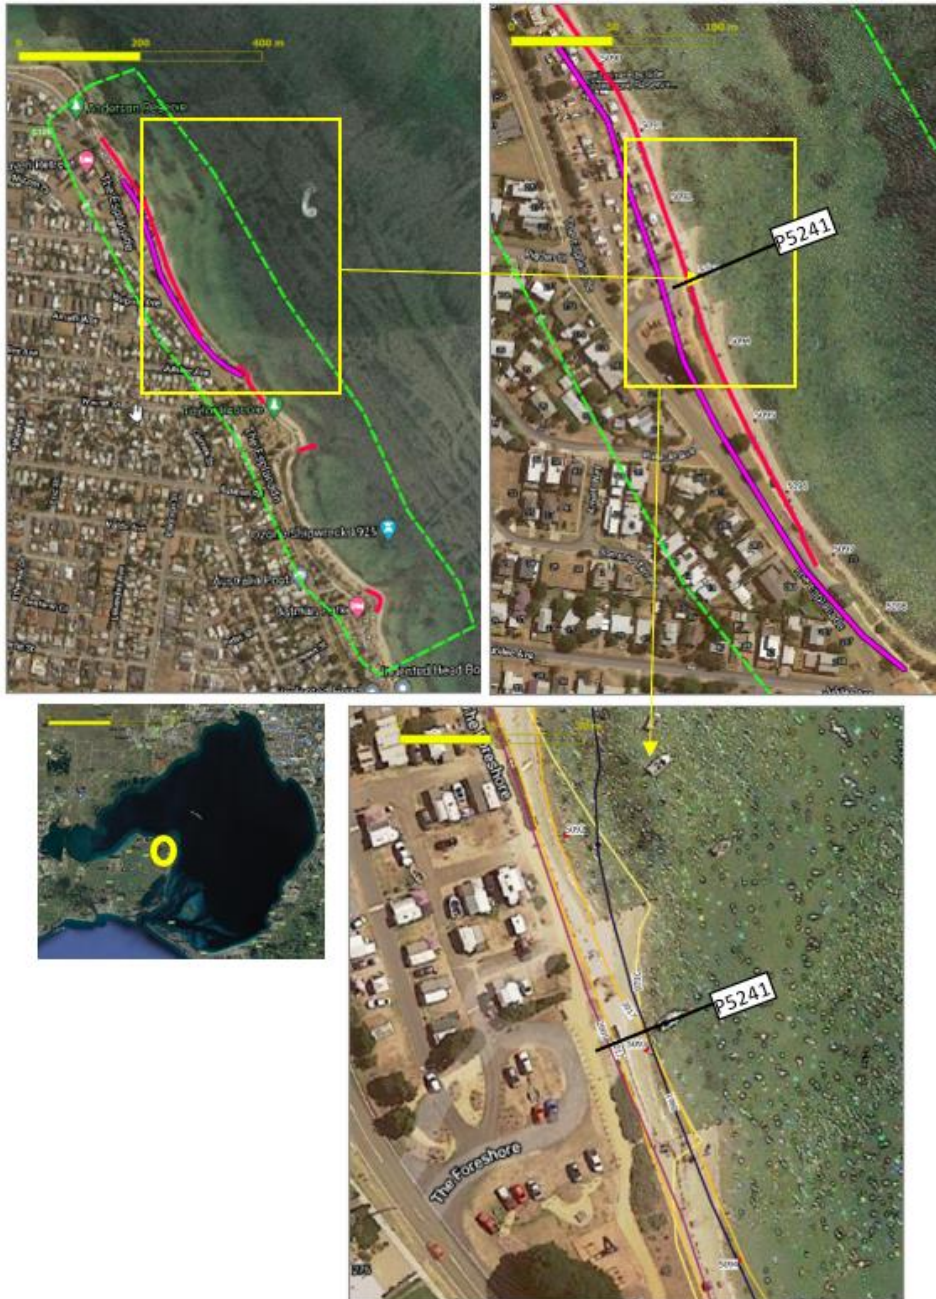
Fig. 3.4.1 Anderson reserve monitoring and nourishment site. Green dashed line is minimum area of drone survey coverage, red lines are coastal structures, pink line is nourishment zone, yellow boxes show progresses levels of zoom.

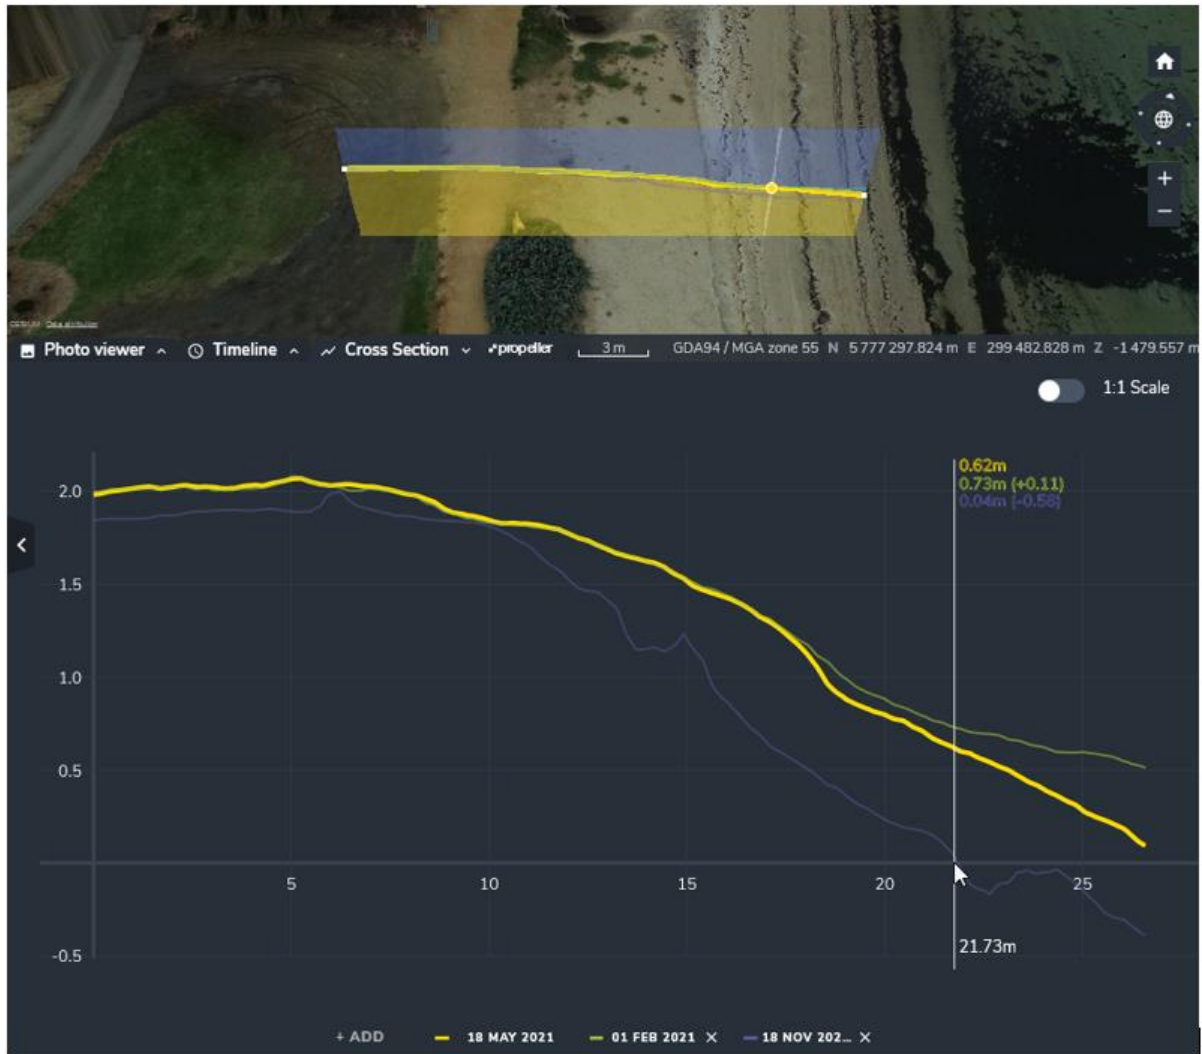
Fig. 3.4.5. Anderson Reserve, cross-section time series (top); and multi-method shoreline change time series for selected transects (bottom; see Fig. 3.4.1 for transect location).
