Port Phillip Bay Beach Nourishment Program Preliminary Assessment

Incorporating Victorian Coastal Monitoring Program
(VCMP) Data

April 2023, Jak McCarroll

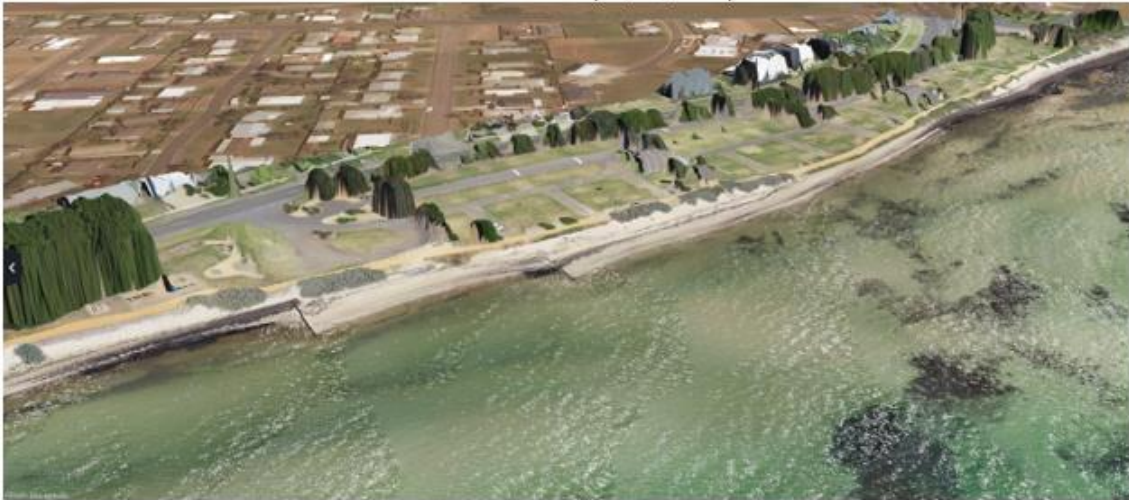
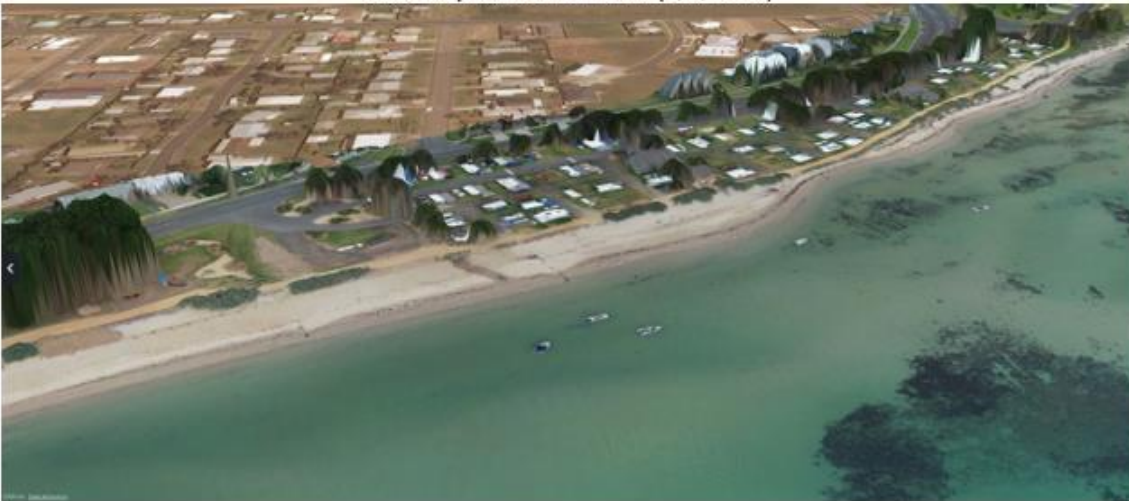
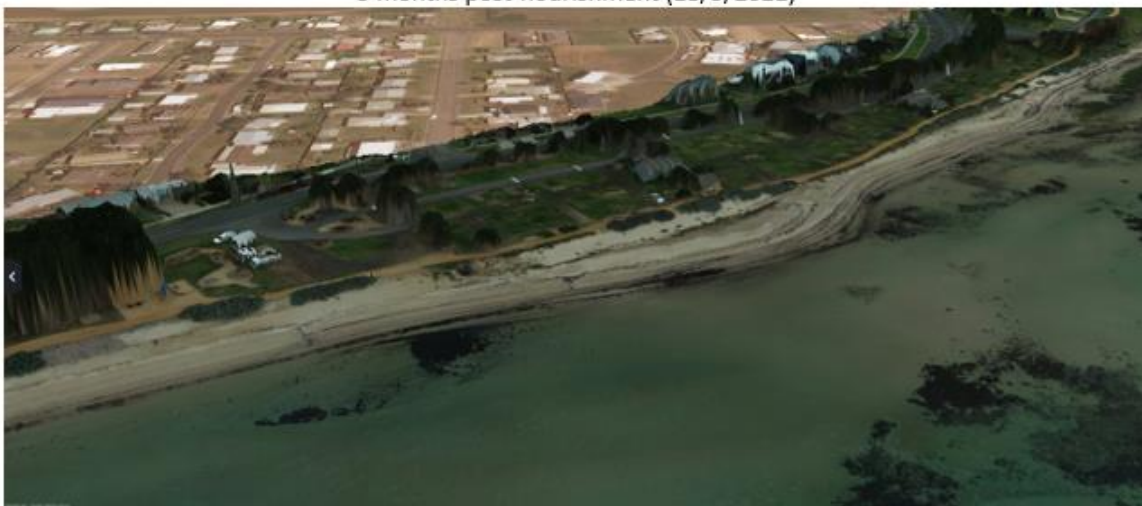
Fig. 3.4.6. Anderson Reserve, oblique view of site, looking northwest, taken pre- and post-nourishment, from orthomosaics generated from drone imagery (available on Propeller).

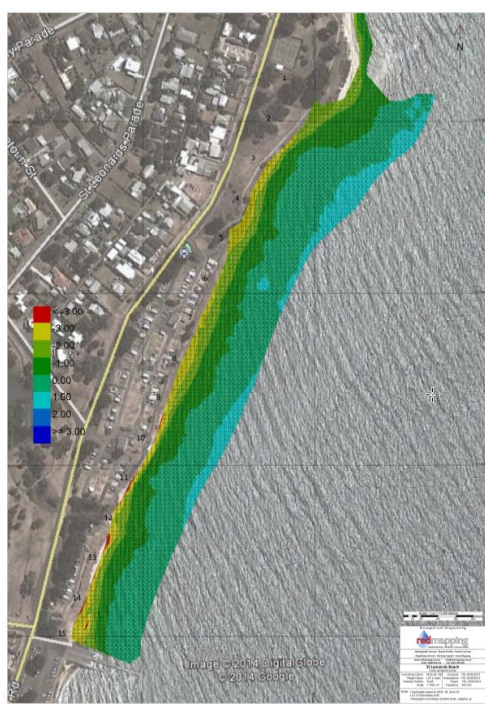
Fig. 3.5.1a. St Leonards south 2014 nourishment site.

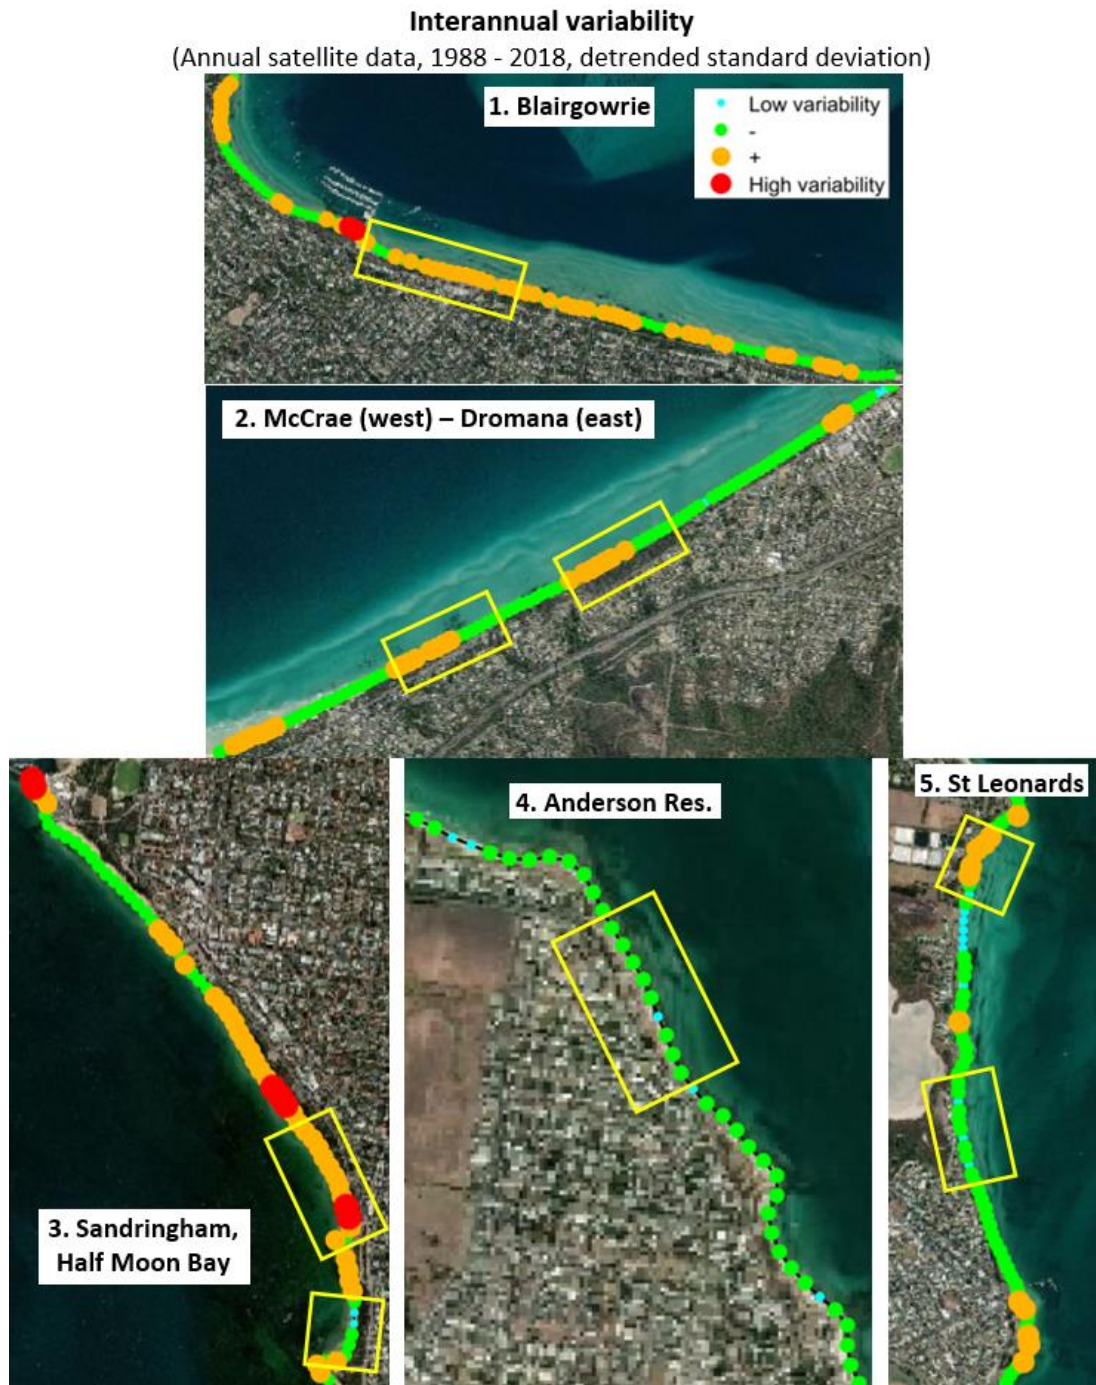
Fig. 4.2. Shoreline variability across the five sites, showing the detrended standard deviation (m) for annual DEA shorelines. Colour coding: Blue, <2 m; green, 2 to 4 m; orange, 4 to 8 m; and red, >8 m.

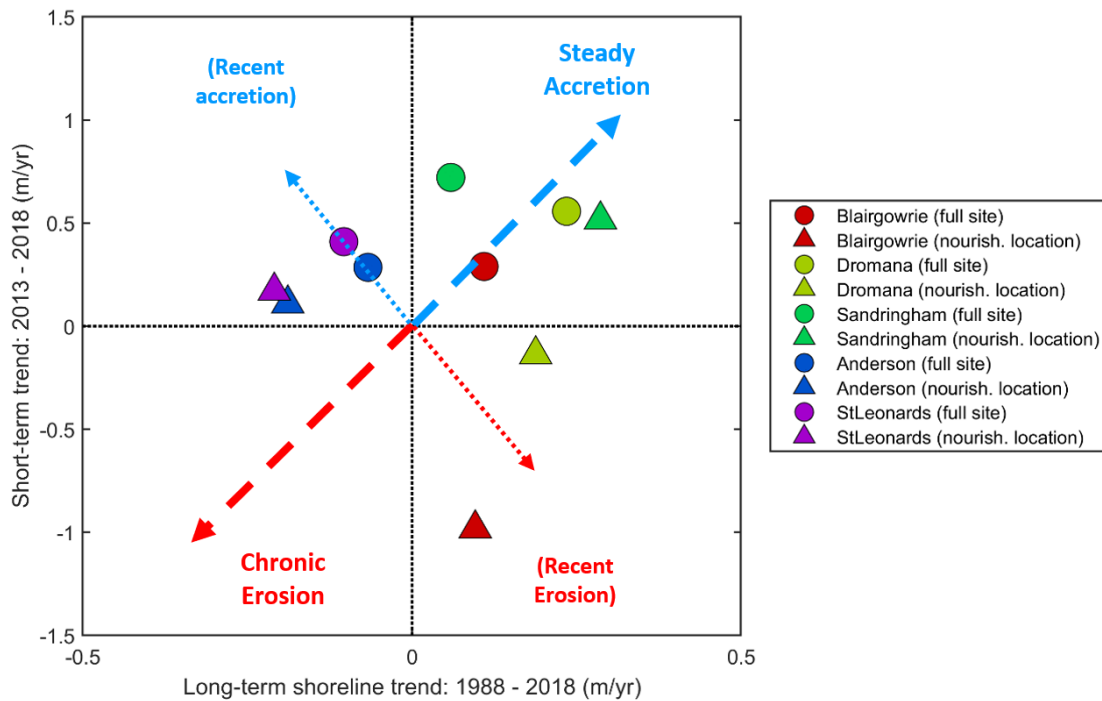
Fig. 4.4. Short-term vs. long-term trends using Digital Earth Australia annual satellite shorelines.
 Note: ‘Dromana’ in legend is Dromana-McCrae.
