Project Name	Inverloch Region Coastal Hazard Assessment – Coastal Processes & Erosion Hazard Assessment
Client	Department of Environment, Land, Water and Planning
Client Project Manager	Cass Philippou
Water Technology Project Manager	Elise Lawry
Water Technology Project Director	Dr. Andrew Mc Cowan
Authors	Elise Lawry, Christine Lauchlan Arrowsmith
Document Number	21010025_R04v03a_InverlochCHA_CoastalProcesses.docx

EXECUTIVE SUMMARY

This report details the past and current coastal processes and coastal drivers which have formed the existing coastline. The report also describes the potential impact of coastal processes on the coastal environment into the future and the influence of climate change on coastal drivers and processes. The impact of the coastal processes, current and future erosion zones and zones of coastal recession are presented and discussed within the report.

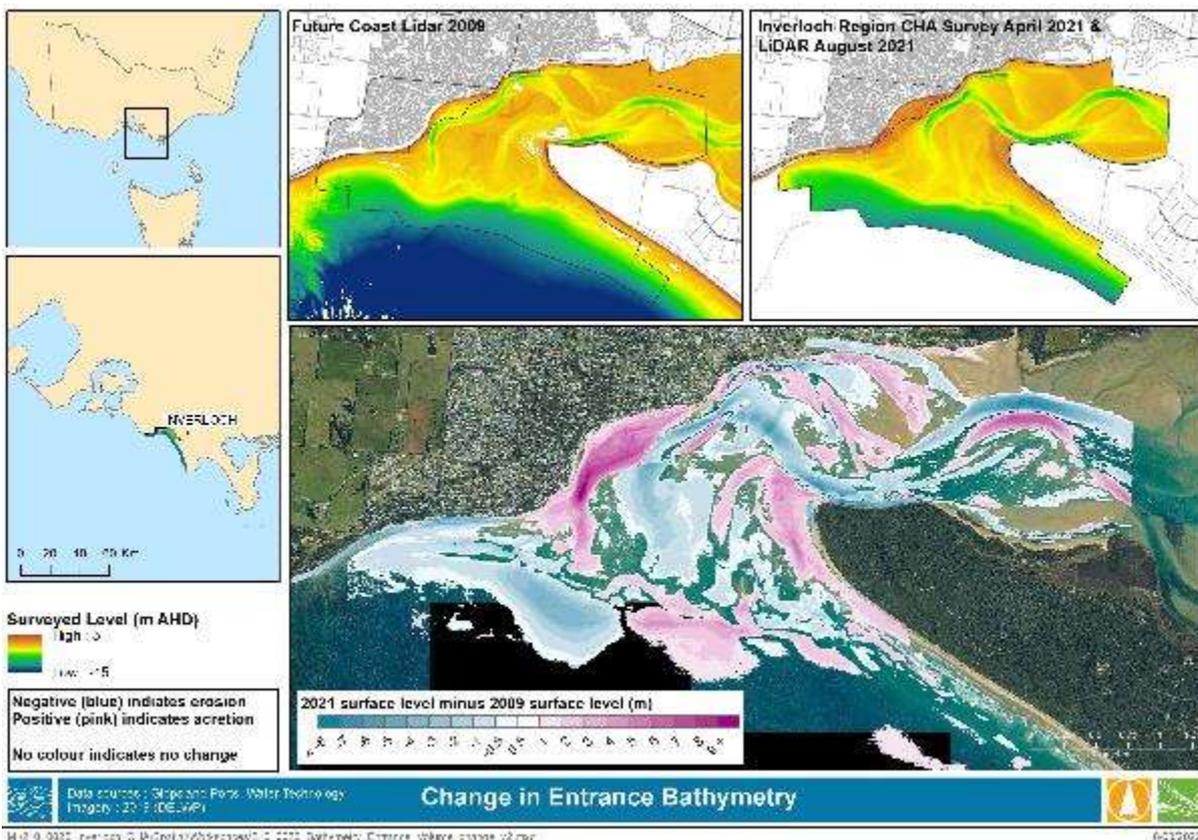
Significant change has occurred in the bathymetry of the entrance between the 2008/09 LiDAR capture and the present day. Survey was collected across the entrance for the CHA, providing an update of the new conditions in the entrance. A massive amount of sediment has been lost from the overlapping survey areas – a net change of -1.8M m³ calculated from the datasets. Change is not even across the entrance – this volume would represent a change of only -0.15m across the entrance area – instead it is the balance of significant areas of volume loss such as from Surf Beach and the ebb tide delta, and significant volume gain, such as the sediment enclosing Ayr Creek lagoon. Entrance channels have, in general, become deeper and wider within the entrance, however the main channel is wider and shallower across the outer bar. Significant loss of material is noted at the upstream extent of the overlapping survey – it is unknown if this reduction in bed level continues upstream within the Inlet or is limited to the entrance area. The net change in the entrance bathymetry is shown in the figure below.

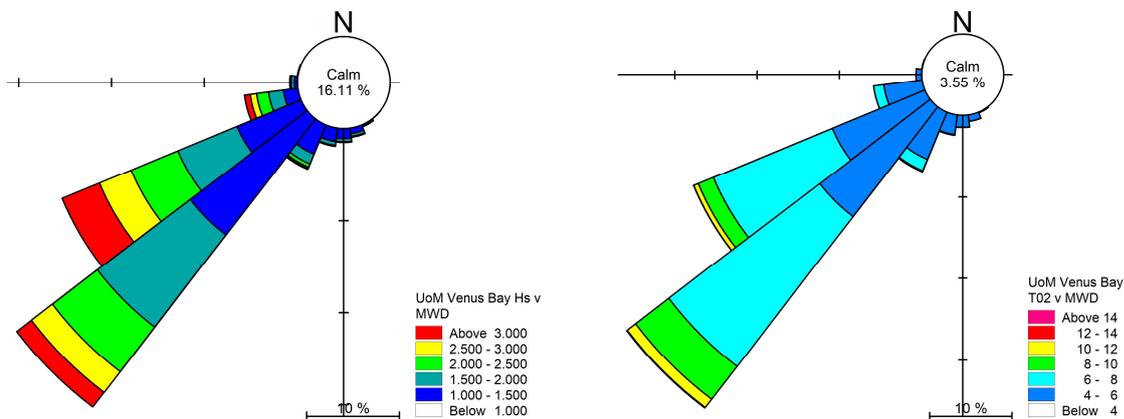
Wave timeseries from a hindcast wave model provided by the University of Melbourne was used to represent wave conditions within the Study Area (Lui, 2022). The hindcast wave data indicated a recent trend towards stronger waves and stormier ocean wave conditions. The hindcast wave rose and the design offshore wave conditions derived from the hindcast are shown below.

1% AEP	5% AEP	10% AEP
Offshore Significant Wave Height (m)	6.6	6.1	5.9

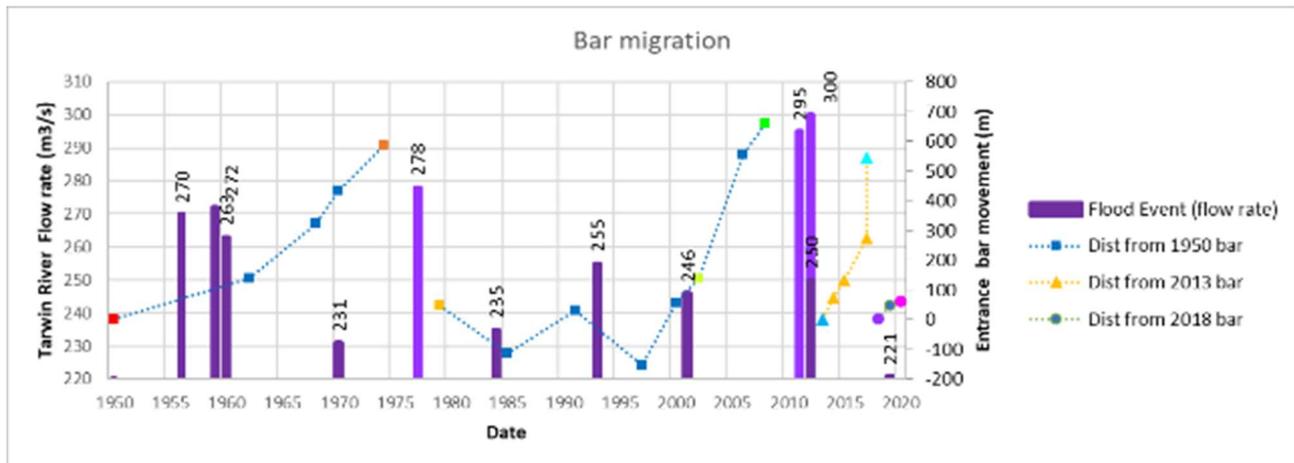
Within the entrance, tidal currents (along with wave energy) form the shape and depth of the entrance channels and bars. The timeline of aerial imagery of the entrance shows a pattern of increasing channel meander (similar to a low gradient river) as the channel increasingly shifts north and east. The channel meander length increases until a point-bar erosion cut is made and the meander length reduces. The channel meander processes are also interrupted in a loose correlation with significant flood events in the Tarwin River. The figure below shows the north-eastward progression of the channel over time through the increasing distance

of the entrance bar from the 1950, 2013 and 2018 bar over time and the impact on this distance of new channels cutting through the expanded entrance bar following significant flood events such as 1977 (<5% AEP event). In these cases, the high flows erode the sandy material and temporarily generate a straight channel. Similar changes in channel position are noted after the 2011/12 floods, which included close to a 1% AEP flood event. A more significant change in channel arrangement in 2012 follows what could be the tipping point of the channel meander length, forming a new channel. A new channel arrangement is also observed in 2018, again occurring after a long channel meander had formed, indicating a potential cut-off level of the meander length.

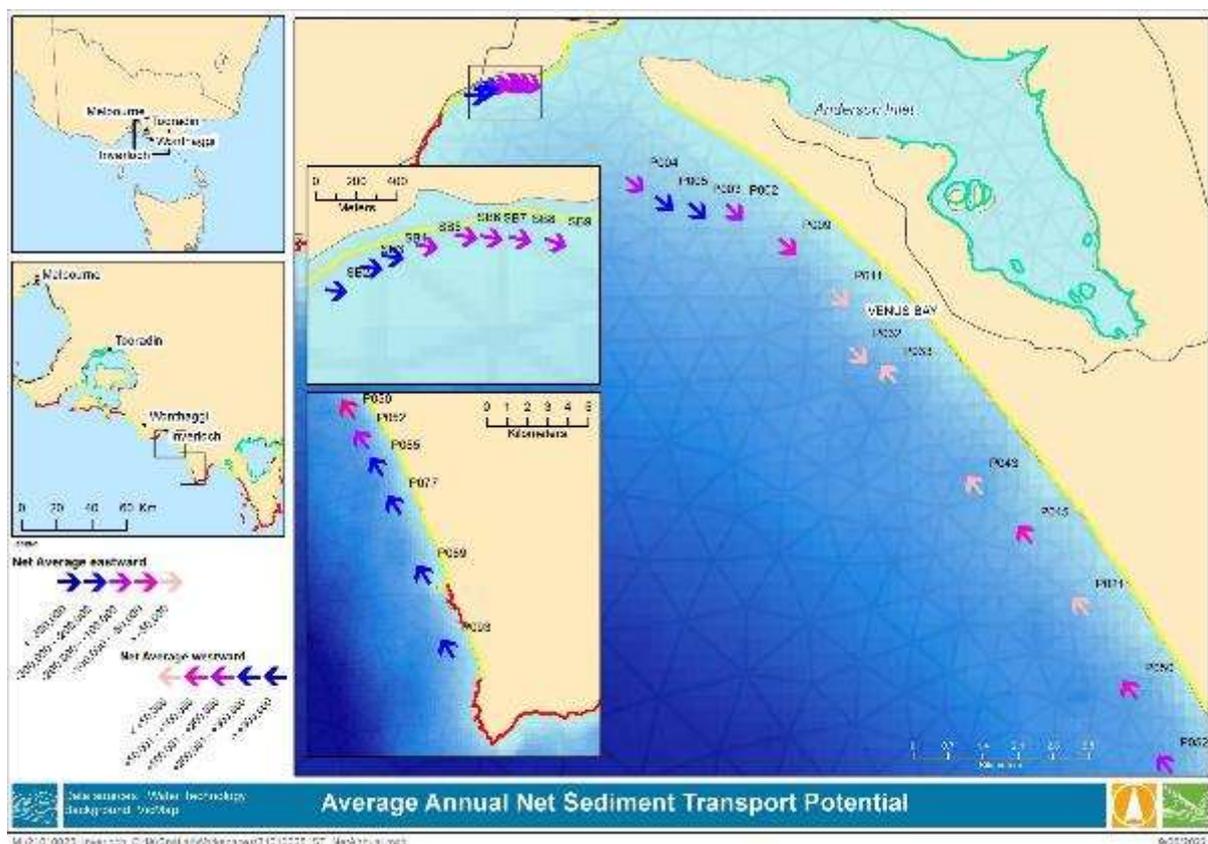
Sediment transport along Point Smythe and Venus Bay indicates a net transport away from Point Smythe, in contrast to the geological development of the Point, indicating the spit has reached its maximum position under the current wave climate, having been generated by waves from a more southerly direction driving sediment westward. Sediment transport potential reduces eastward to the Venus Bay settlement, east of which the net transport rate becomes increasingly westward. This follows the changing orientation of the beach along this coastline. Sediment transport potential between 200,000 and 300,000 m³/ year were simulated for the south-eastern extent of the Study Area, similar in magnitude to other exposed coastal locations in Victoria.

Analysis of the sediment transport modelling results showed the seasonal and decadal changes also noted in the wind and wave climate. Greater sediment transport eastward was noted during winter months with the higher number of significant south-westerly storms across Bass Strait.

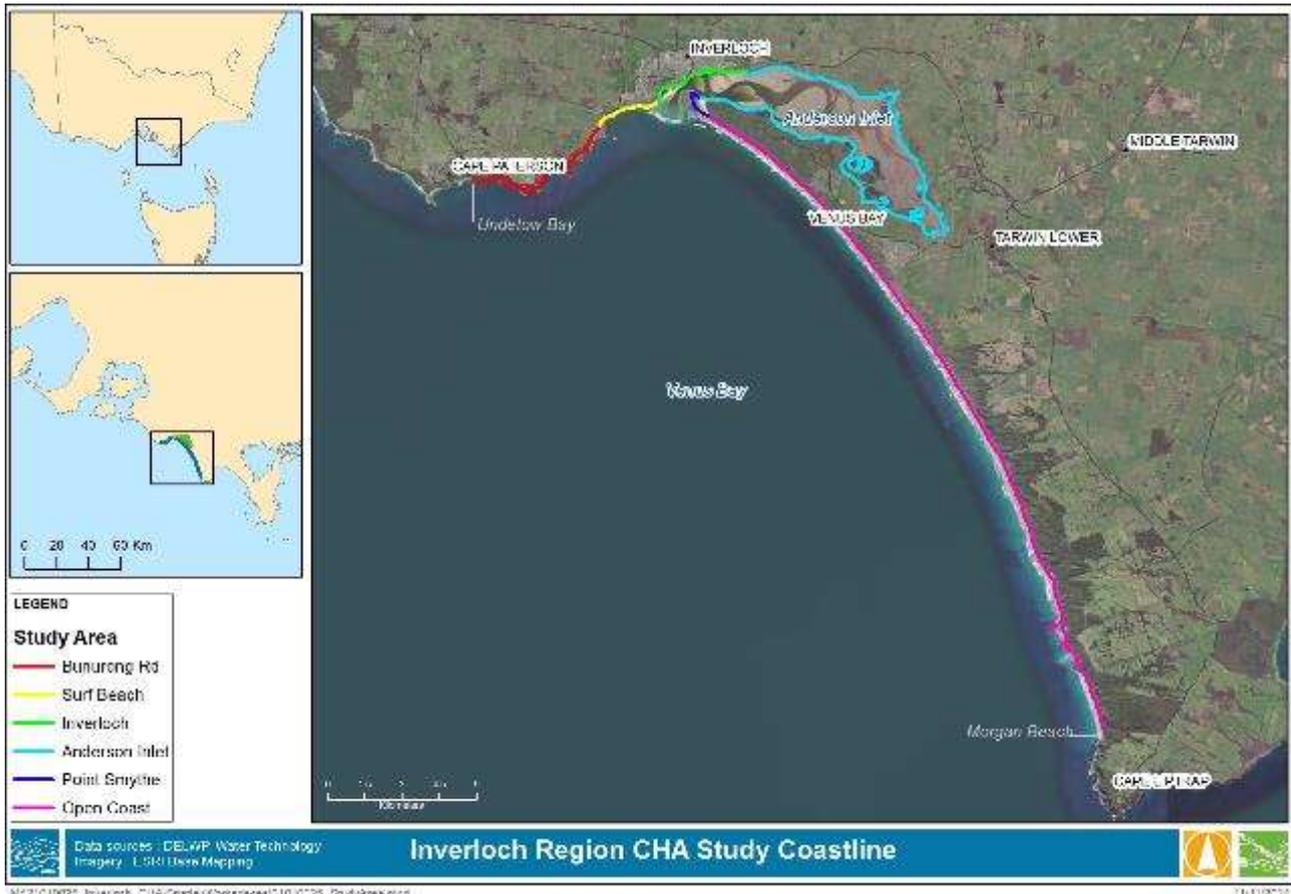
Figure 1-2 Study Area Coastline

The project study area extends from the eastern end of Cape Patersons most eastern beach “Undertow Bay” to the eastern end of Morgan Beach, located just west of Cape Liptrap. The project includes the shorelines of Venus Bay and Anderson Inlet, as presented in Figure 1-2.

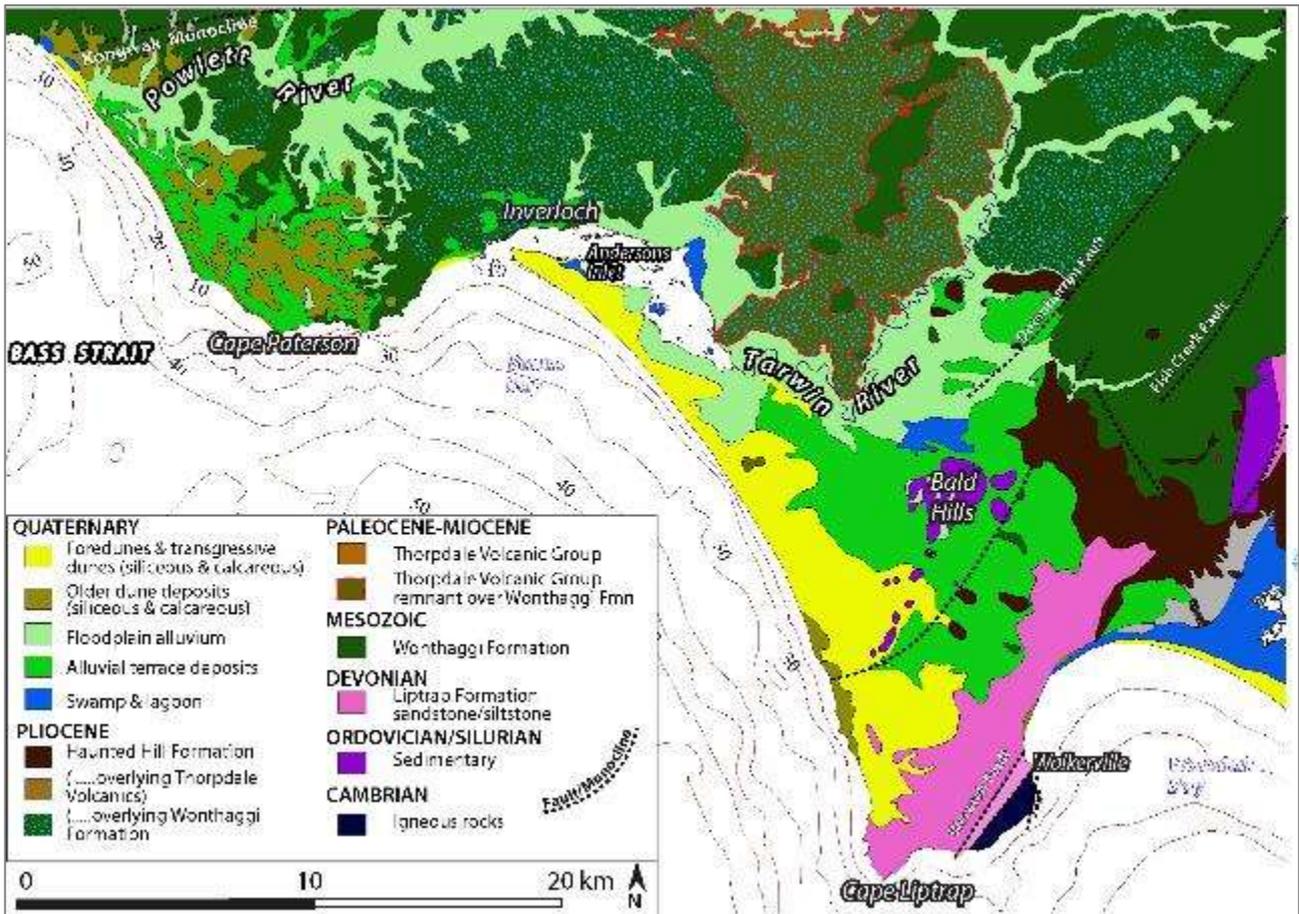
Figure 2-1 Geology of West Gippsland (Rosengren, 2021)

The general geology of the study area is presented in Figure 2-1, from the oldest Palaeozoic basement rocks (540 million years BP to 250 million years before present (BP), including the Cambrian, Devonian, Ordovician, Silurian), through the Mesozoic (250 million to 66 million years BP) and then to the more recent Cenozoic period (66 million years BP to present, including the Palaeocene - Miocene, Pliocene, and Quaternary).

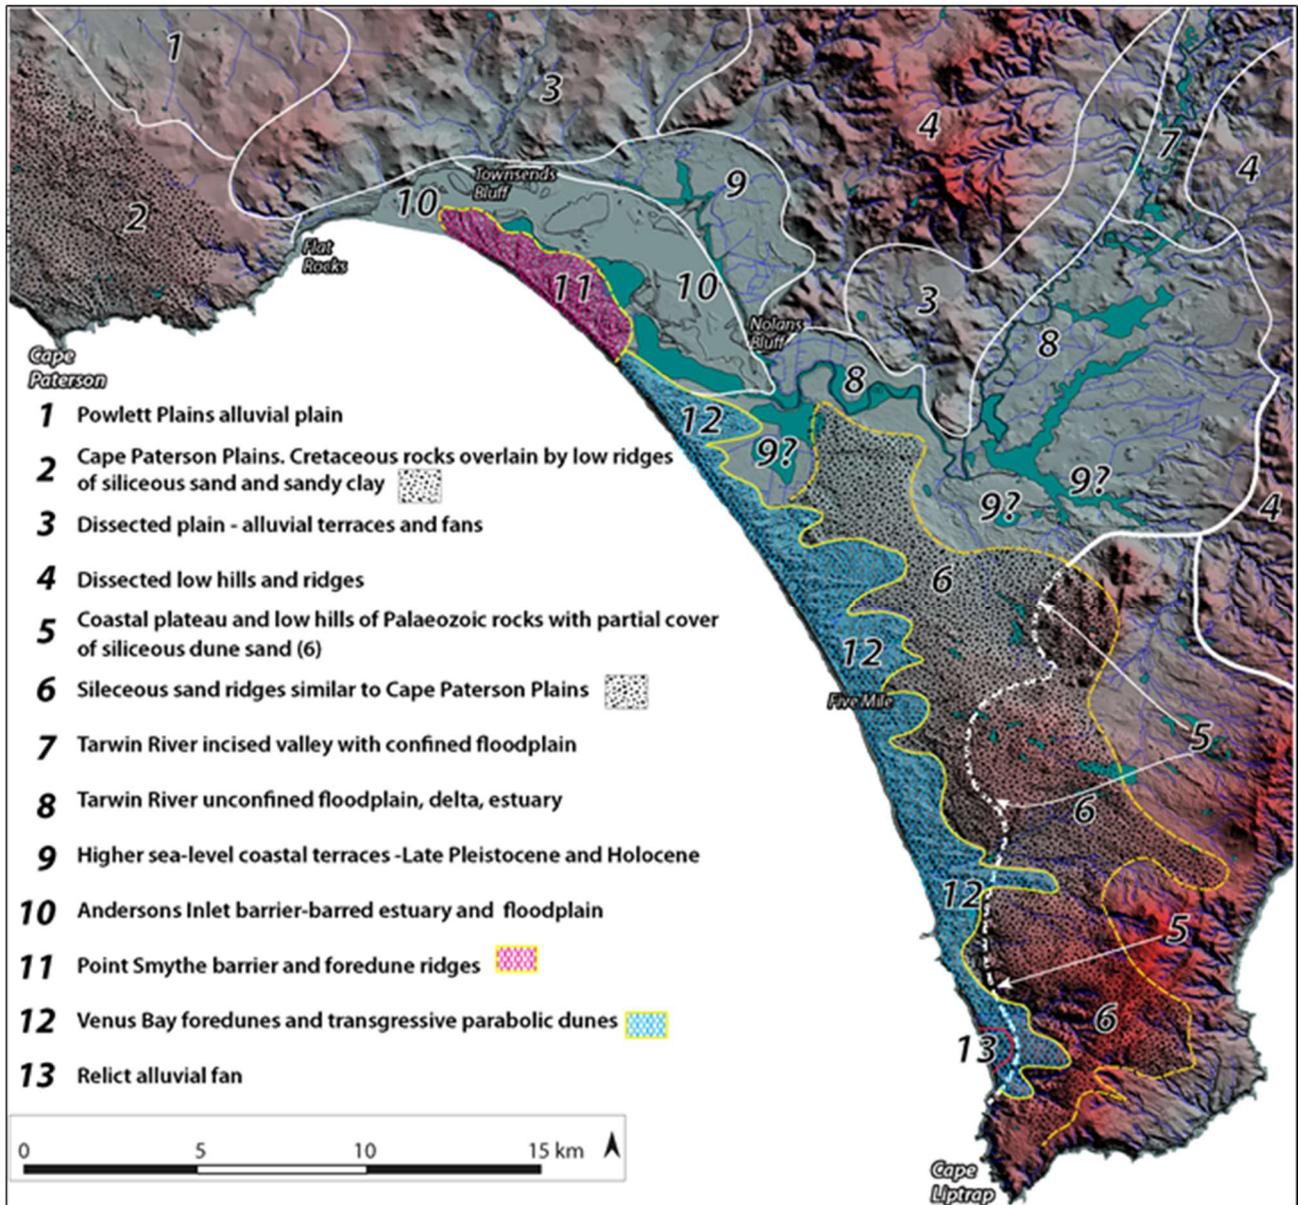
Figure 2-2 Spatial Extent of Geomorphological Landform Units in the Study Area (Rosengren, 2021)

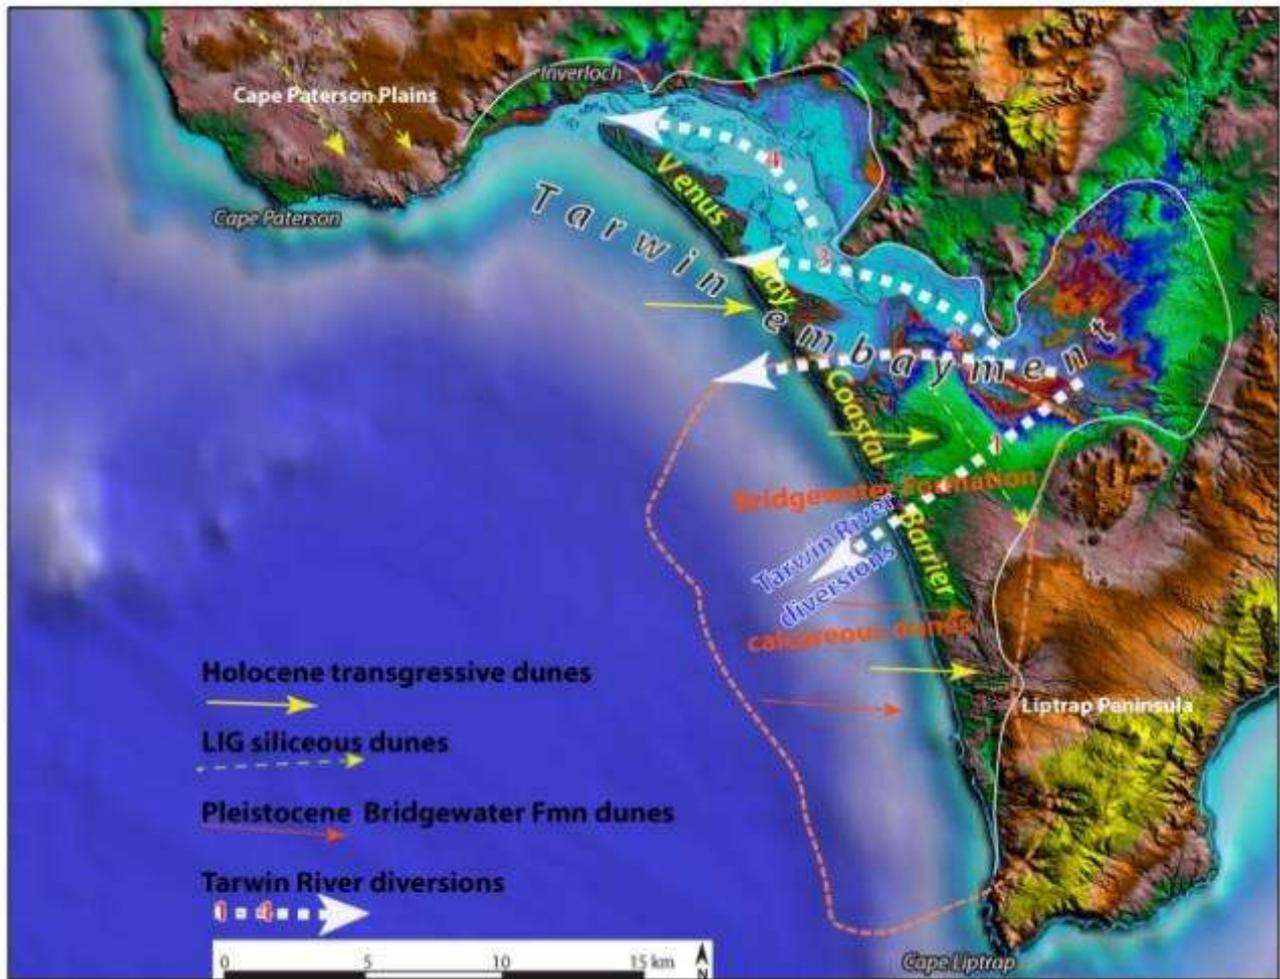
Figure 2-3 Coastal Evolution of the Venus Bay barrier (Rosengren, 2021)

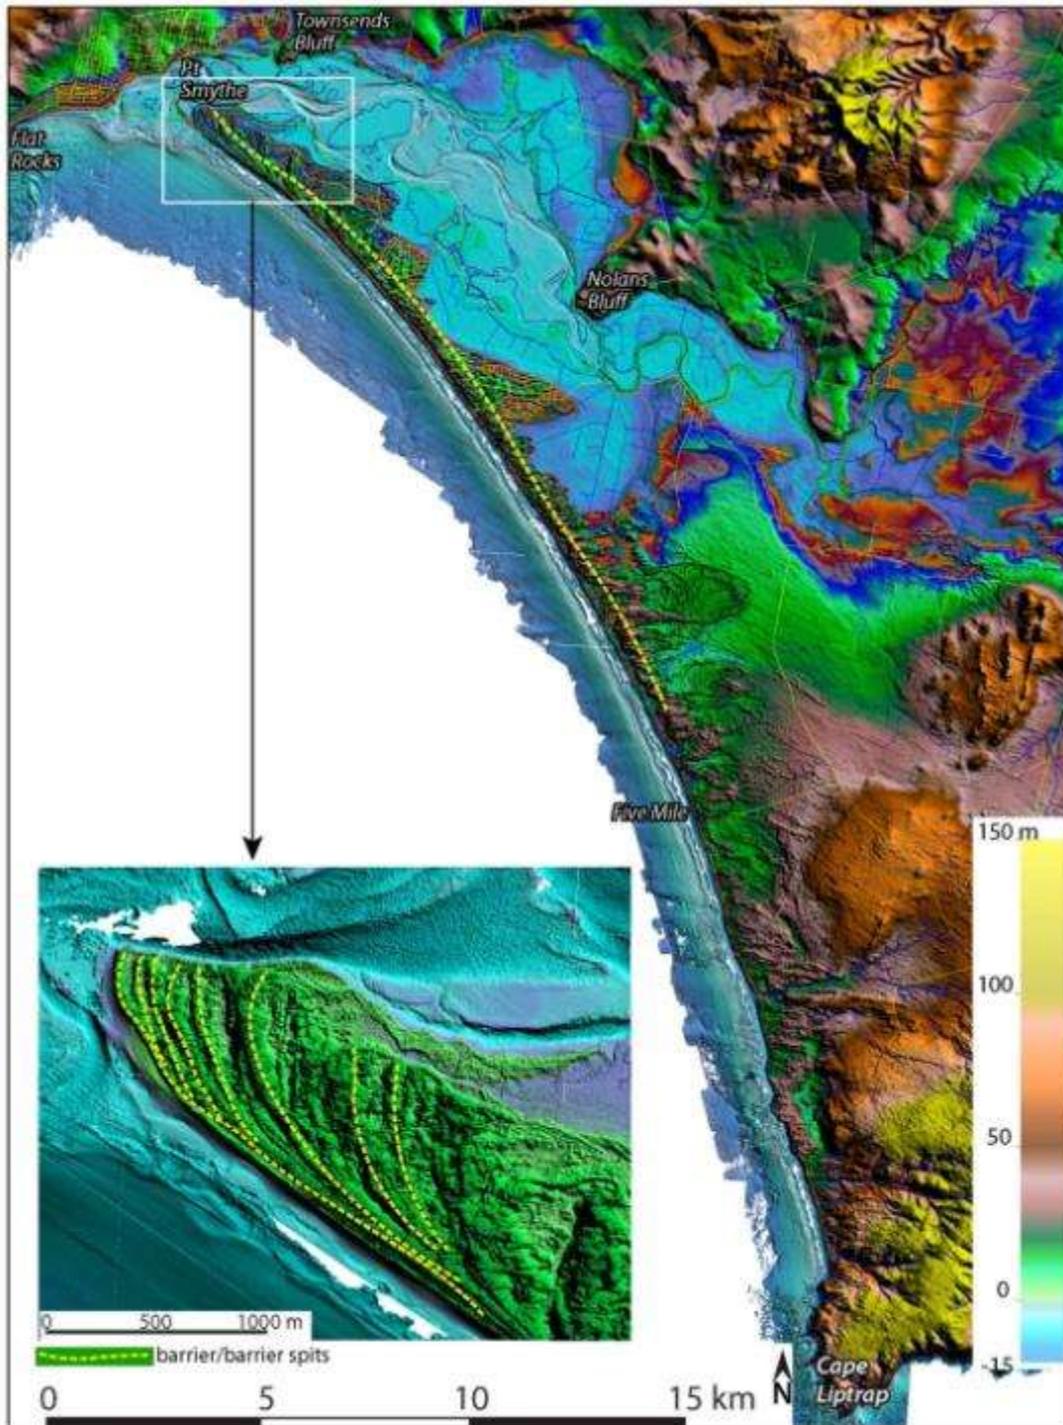
Figure 24. Coast barrier of eastern Venus Bay extending north from Five mile and enclosing Andersons Inlet (red lines are beaches). The inset shows the change in configuration of the barrier as recurring spits north of Venus Bay 2nd Estate

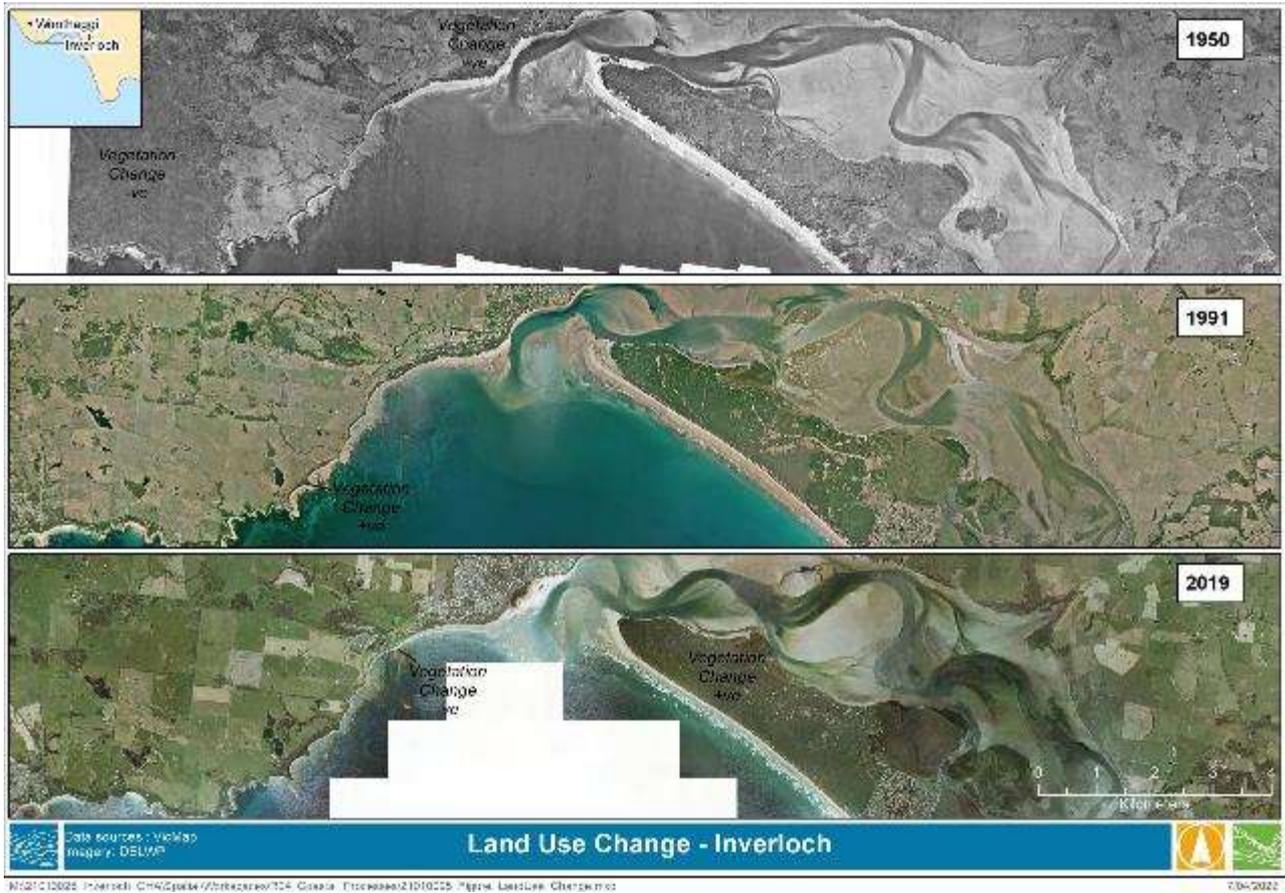
Figure 2-6 Land use and management change since 1950

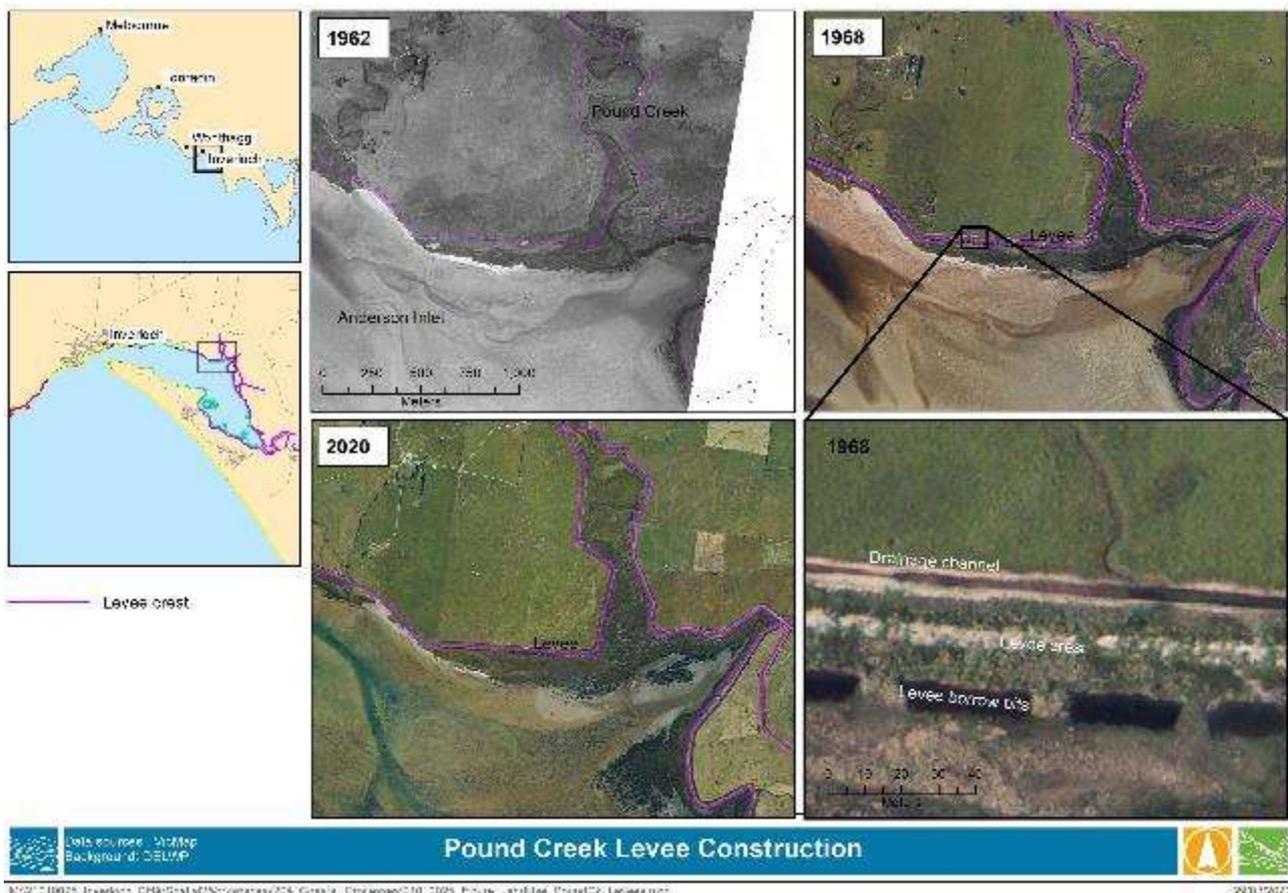
Around Anderson Inlet the construction of the majority of the earthen levees preventing ingress of coastal waters onto the low-lying land occurred between 1962 and 1968 (based on aerial imagery analysis). The levees appear to be rudimentary structures, with the borrow pits used to construct the levees still present in places on the land- and sea-ward side of the structures (Figure 2-8). Anecdotal evidence from community consultation reports that levees were constructed to a height of “13 feet” (~4m) designed to prevent inundation to the “1938 flood” (thought to be the 1934 flood which resulted in significant inundation across much of Melbourne and southern Victoria). Based on the LiDAR survey, the levee crest actually varies in elevation from +1.5m near Venus Bay Settlement 1 and upstream in Pound Creek to above +4.0m AHD around Nolan Bluff. Additional levees along the Tarwin River are reported to have been constructed by European settlers in the 1850s and are generally lower in the range of +1.5m AHD to +2.5m AHD.

Figure 2-8 Levees and borrow pits for levee construction, Pound Creek

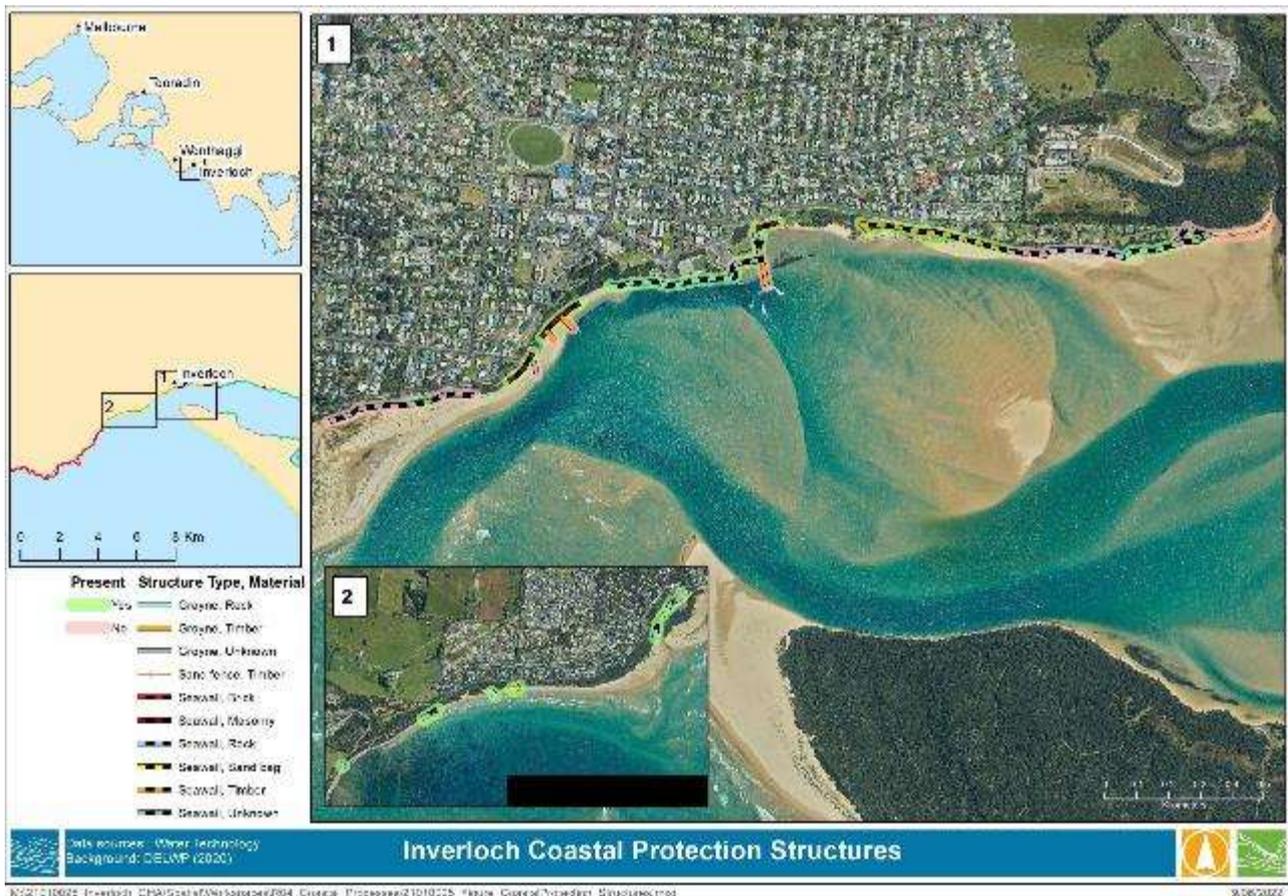
The location of present and past coastal protection works points to an area which at some stage faced erosion or inundation hazards causing risk to assets on the land. The presence and condition of coastal protection structures has been considered in the determination of coastal hazard extents described in Section 4.

Figure 2-10 Known Coastal Protection Works within Study Area

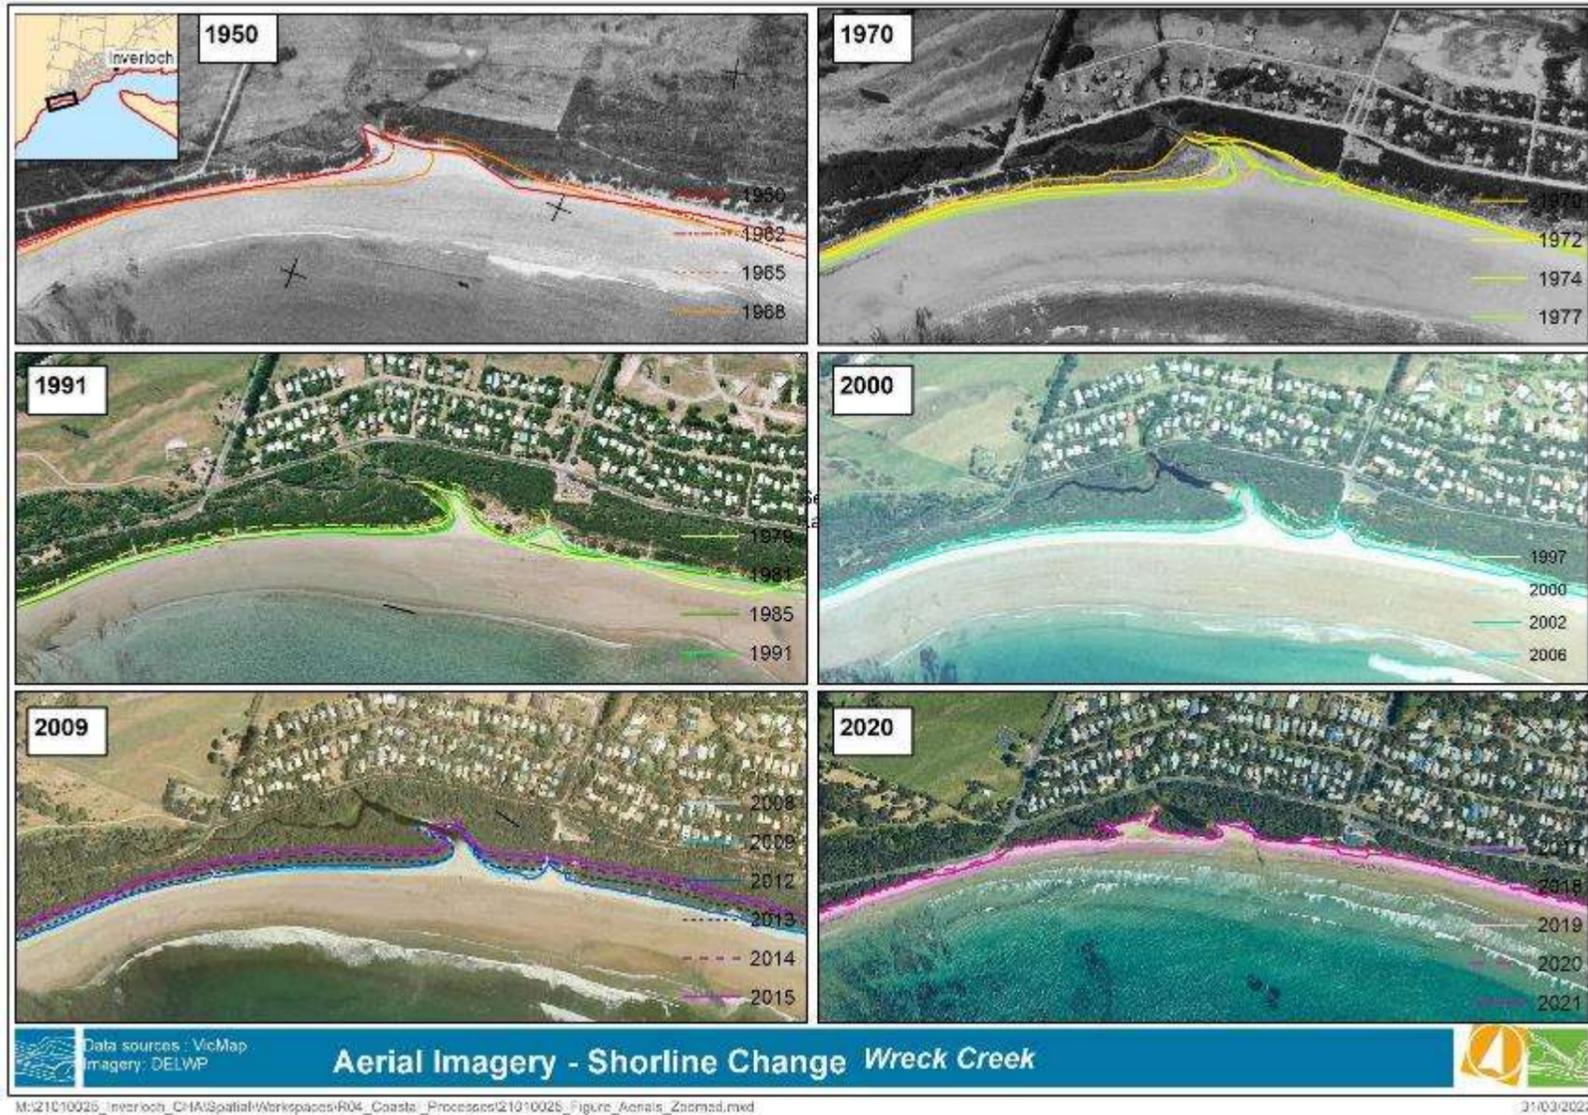
Figure 2-14 Shoreline Change – Wreck Creek

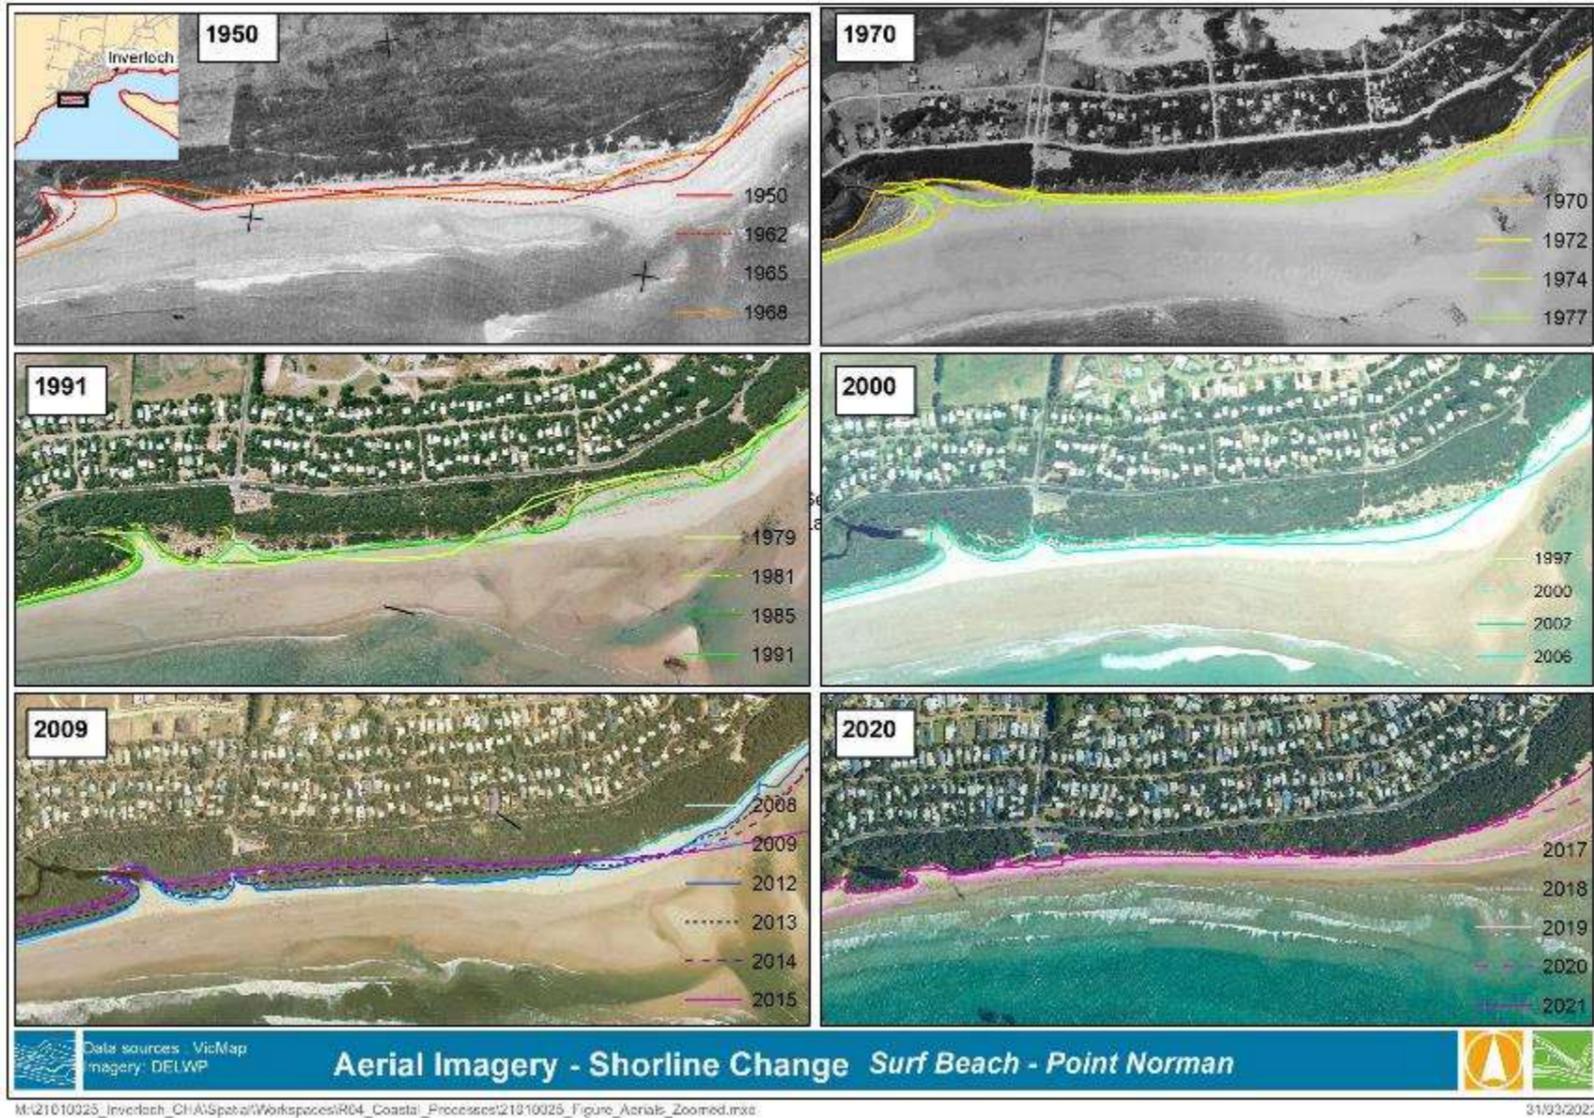
Figure 2-15 Shoreline Change, Surf Beach and Inverloch

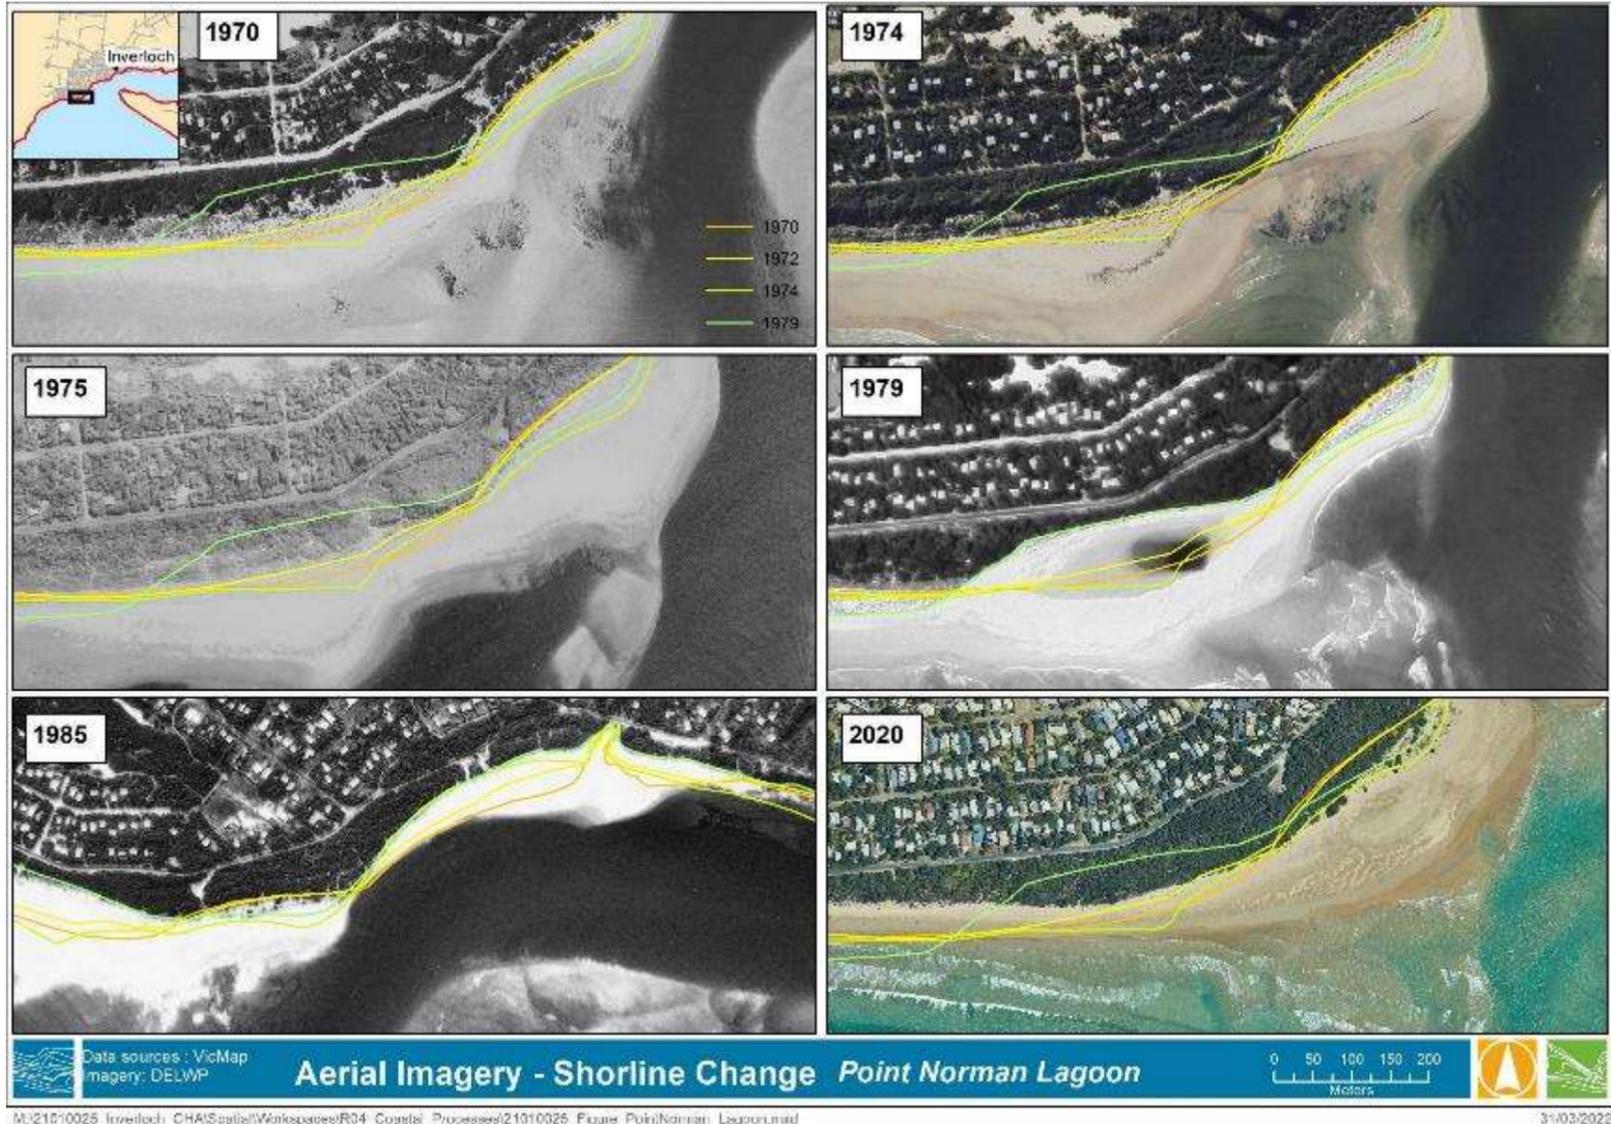
Figure 2-16 Shoreline Change – Point Norman Lagoon

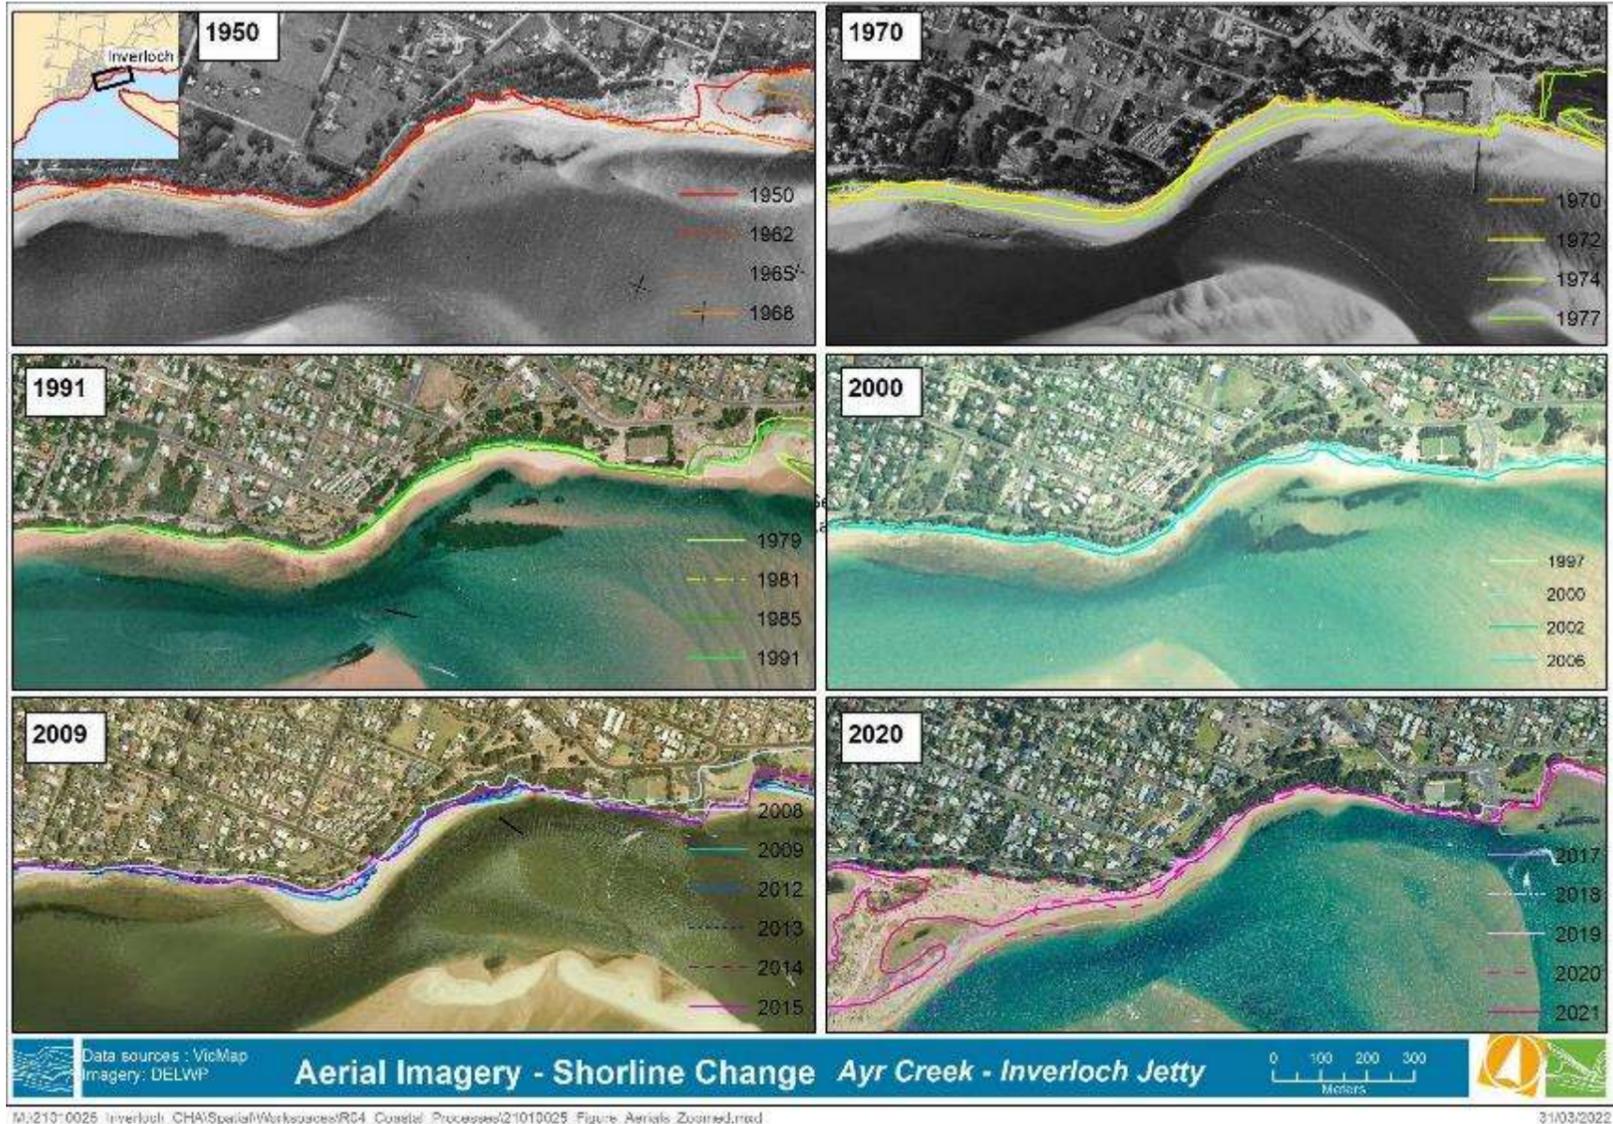
Figure 2-19 Shoreline Change, Ayr Creek – Inverloch Jetty
