Project Name	Inverloch Region Coastal Hazard Assessment – Coastal Processes & Erosion Hazard Assessment
Client	Department of Environment, Land, Water and Planning
Client Project Manager	Cass Philippou
Water Technology Project Manager	Elise Lawry
Water Technology Project Director	Dr. Andrew Mc Cowan
Authors	Elise Lawry, Christine Lauchlan Arrowsmith
Document Number	21010025_R04v03a_InverlochCHA_CoastalProcesses.docx

EXECUTIVE SUMMARY

This report details the past and current coastal processes and coastal drivers which have formed the existing coastline. The report also describes the potential impact of coastal processes on the coastal environment into the future and the influence of climate change on coastal drivers and processes. The impact of the coastal processes, current and future erosion zones and zones of coastal recession are presented and discussed within the report.

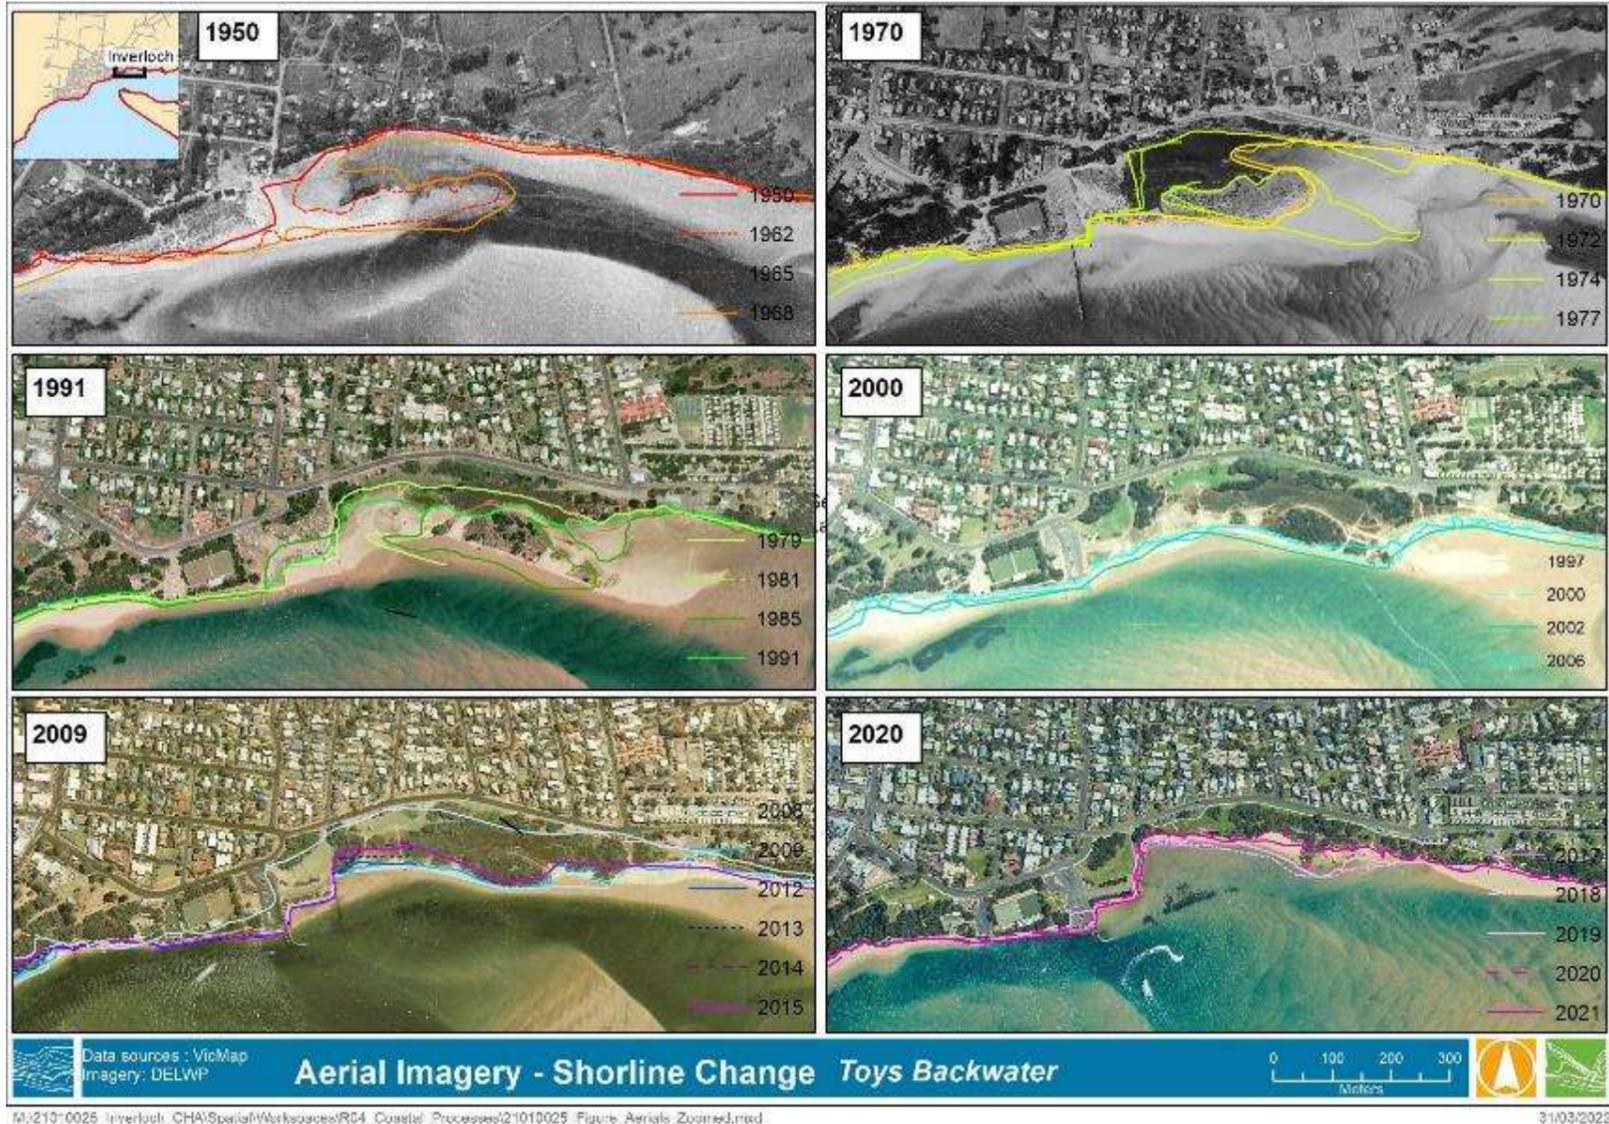
Figure 2-20 Shoreline Change, Toys Backwater

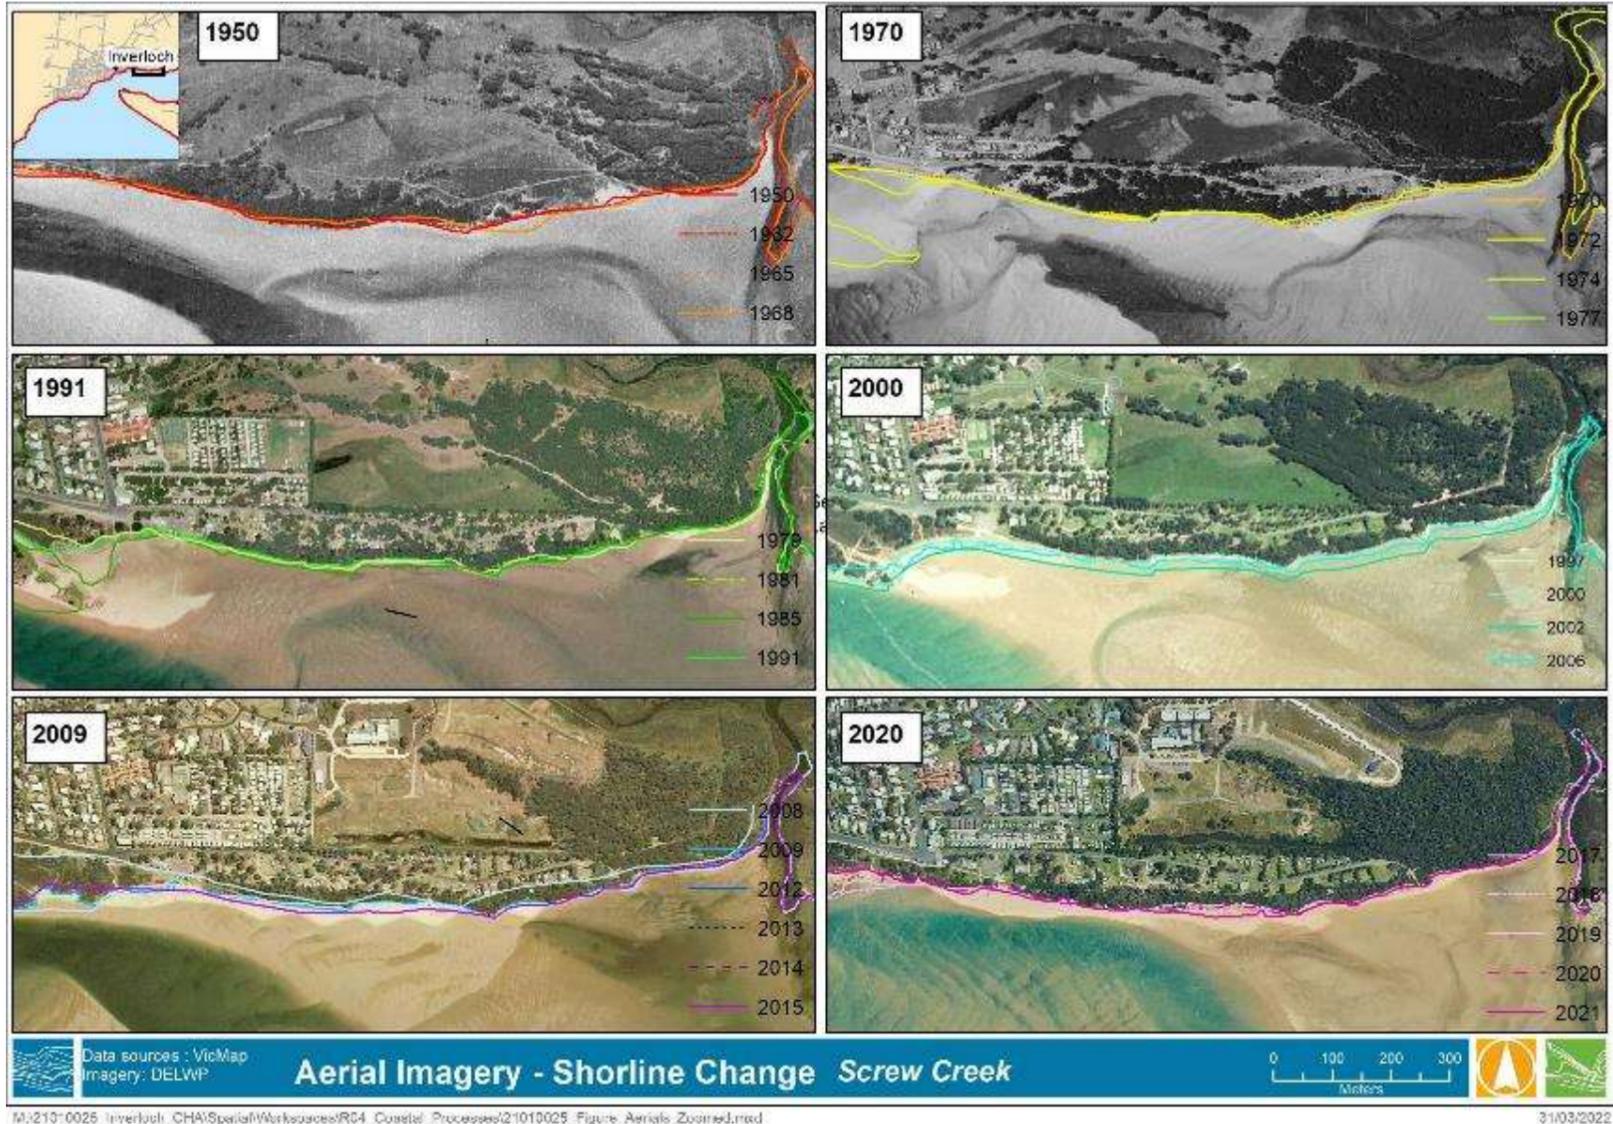
Figure 2-21 Shoreline Change, Screw Creek

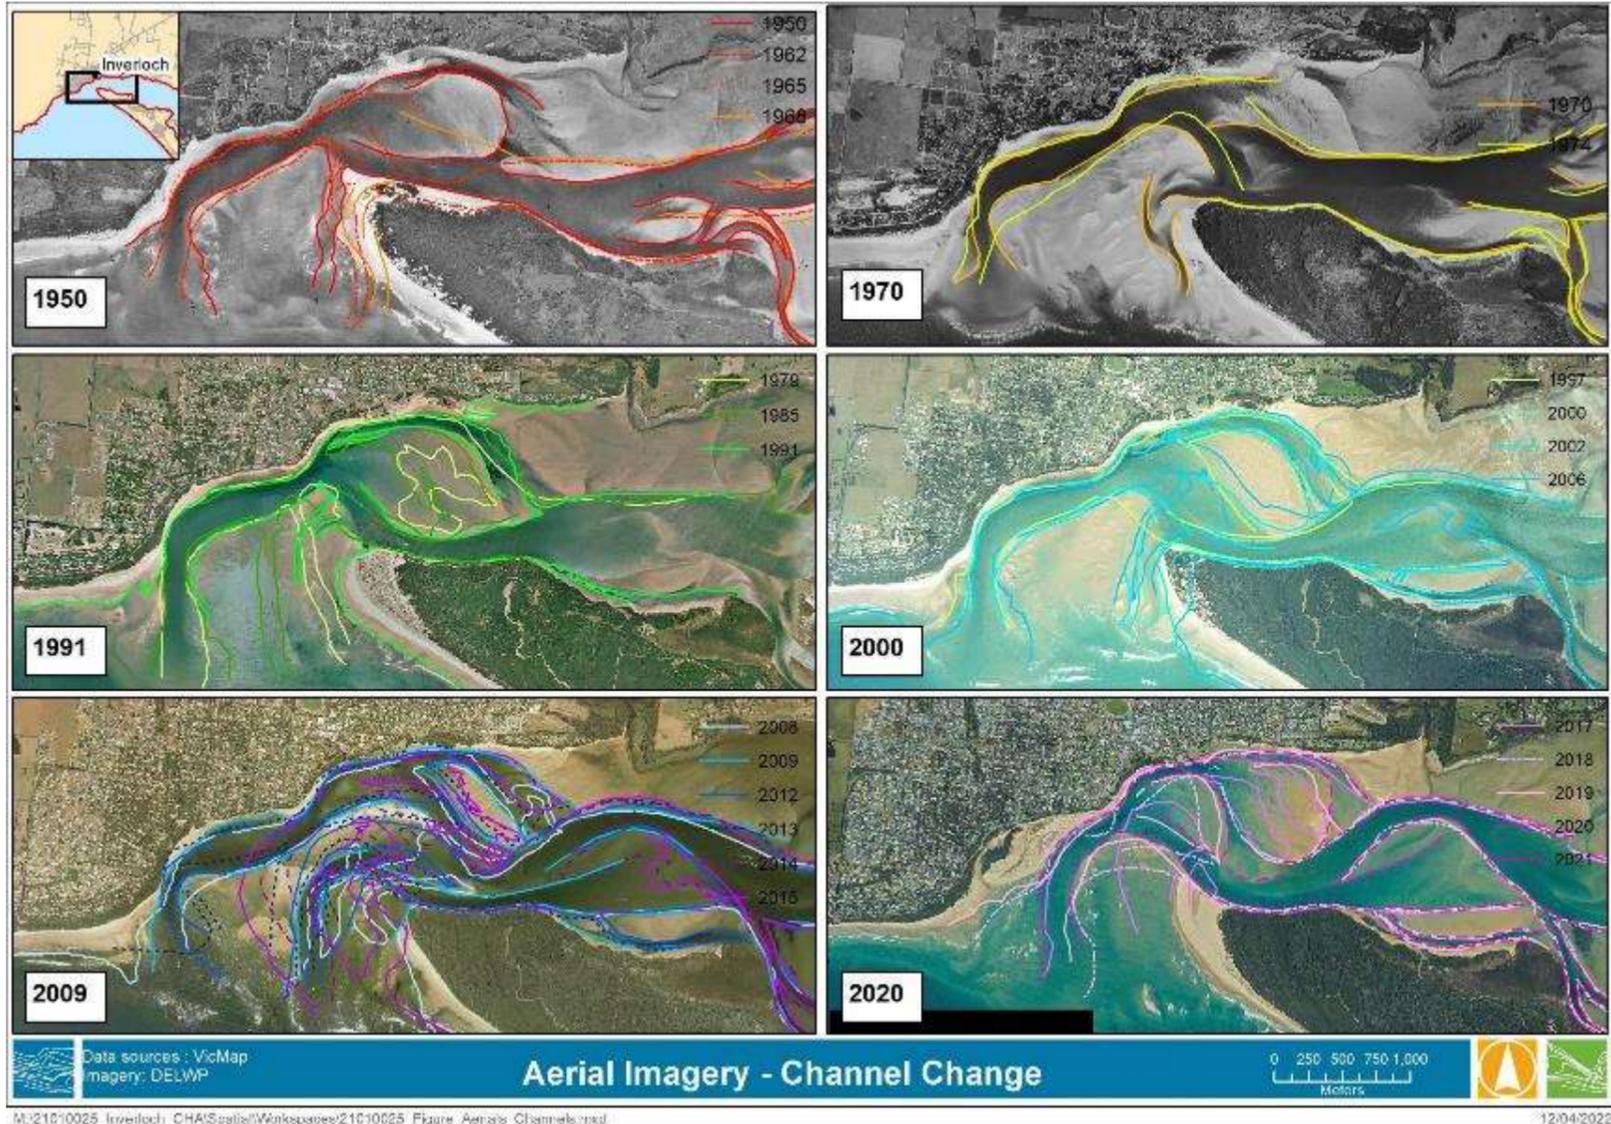
Figure 2-23 Channel Change, Entrance

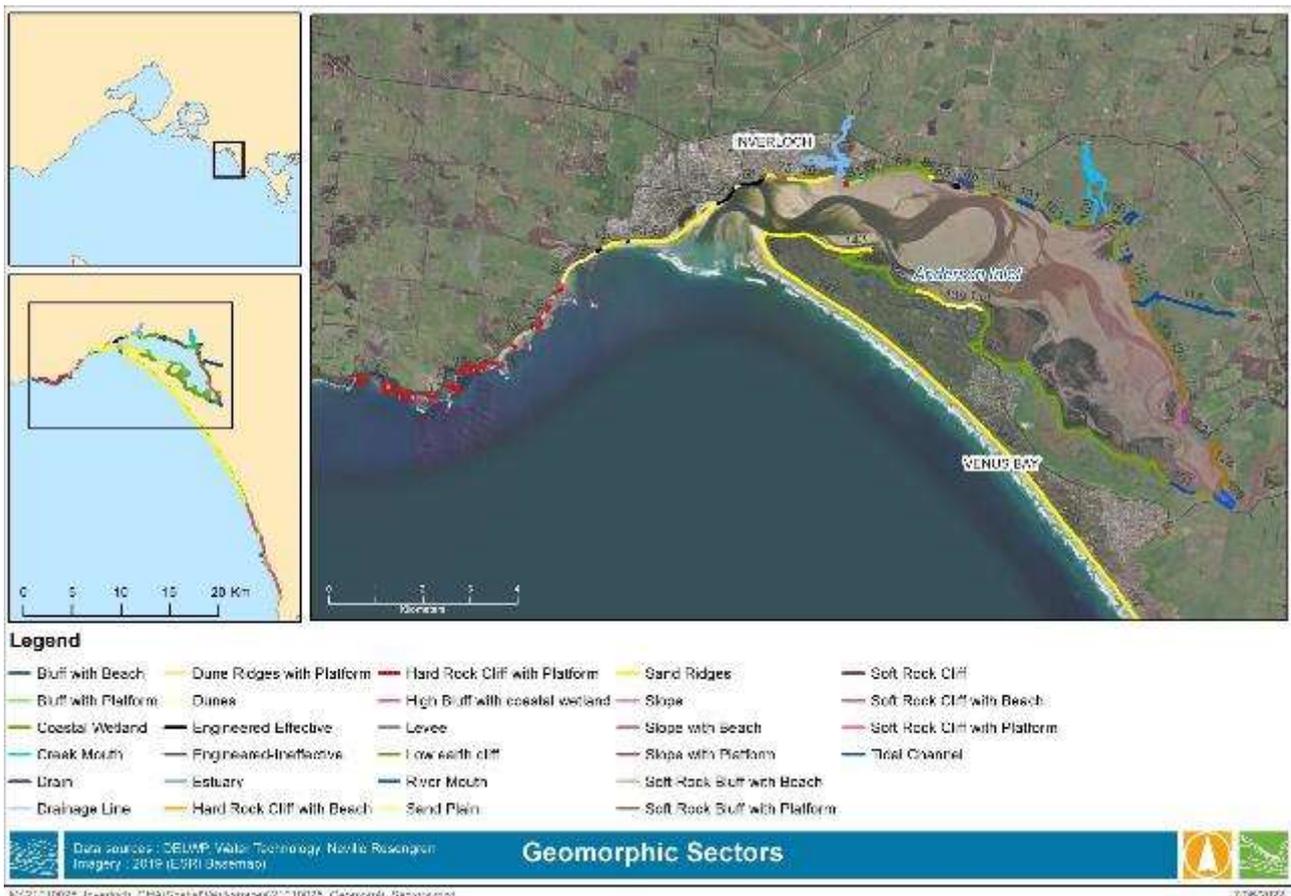
A coastal geomorphic sector (CGS) is a discrete length of coast that comprises a mappable unit with key differences to adjacent sectors. Within the recently released *Victoria's Resilient Coast - Coastal Hazards Extended Guideline* (DELWP, 2022), the coastal geomorphic section is referred to as the Shoreline Sub-Class, in recognition that the CGSs are grouped together to form Shoreline Classes. Lateral variation in one or more key characteristics of a shoreline sub-class / CGS defines the boundary between sectors. A differentiator between adjacent sectors is their response to coastal processes and how they respond to changed water levels and wave energy. Each sector comprises a description of the shoreline and backshore landforms, for example a sandy beach in front of a low coastal bluff or a shore platform at the base of hard rock cliff. Along the study area a total of 181 CGSs were defined.

Figure 2-25 Coastal Geomorphic Sectors of the Study Area

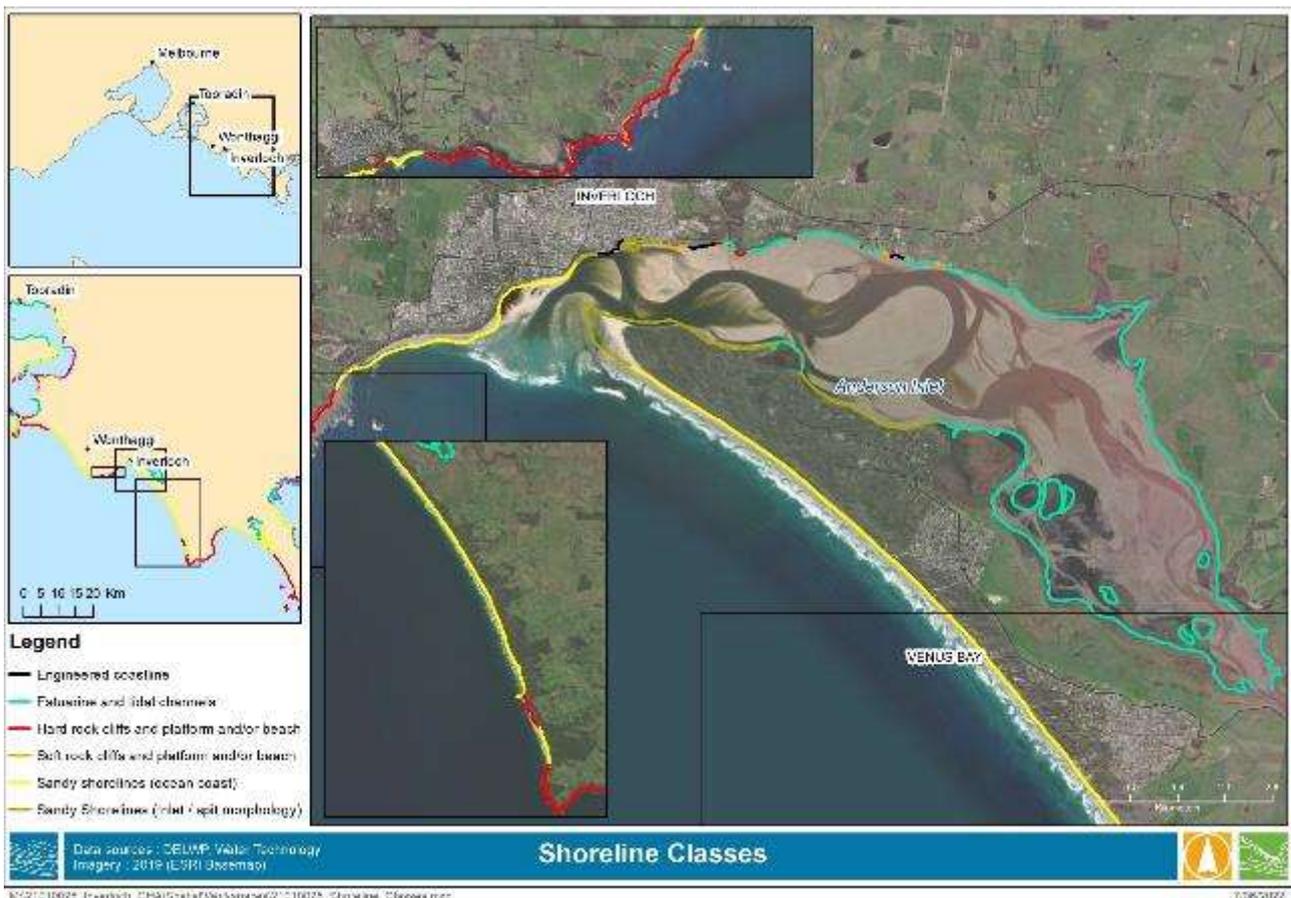
The CGS and CGD have been reviewed and five (5) Shoreline Classes have been derived to support the methodology for determining coastal erosion hazard (see Report 3). These five Shoreline Classes are consistent with those used in the *Victoria's Resilient Coast - Coastal Hazards Extended Guideline* (DELWP, 2022). The spatial extent of the shoreline classes is presented in Figure 2-26 and the proportion of the extent of each class within the Study Area shown in Table 2-3. The sandy shoreline class has been split to show the sandy shorelines exposed to the open ocean and the sandy shorelines where spit morphology and inlet processes dominate.

Figure 2-26 Shoreline Classes in Study Area

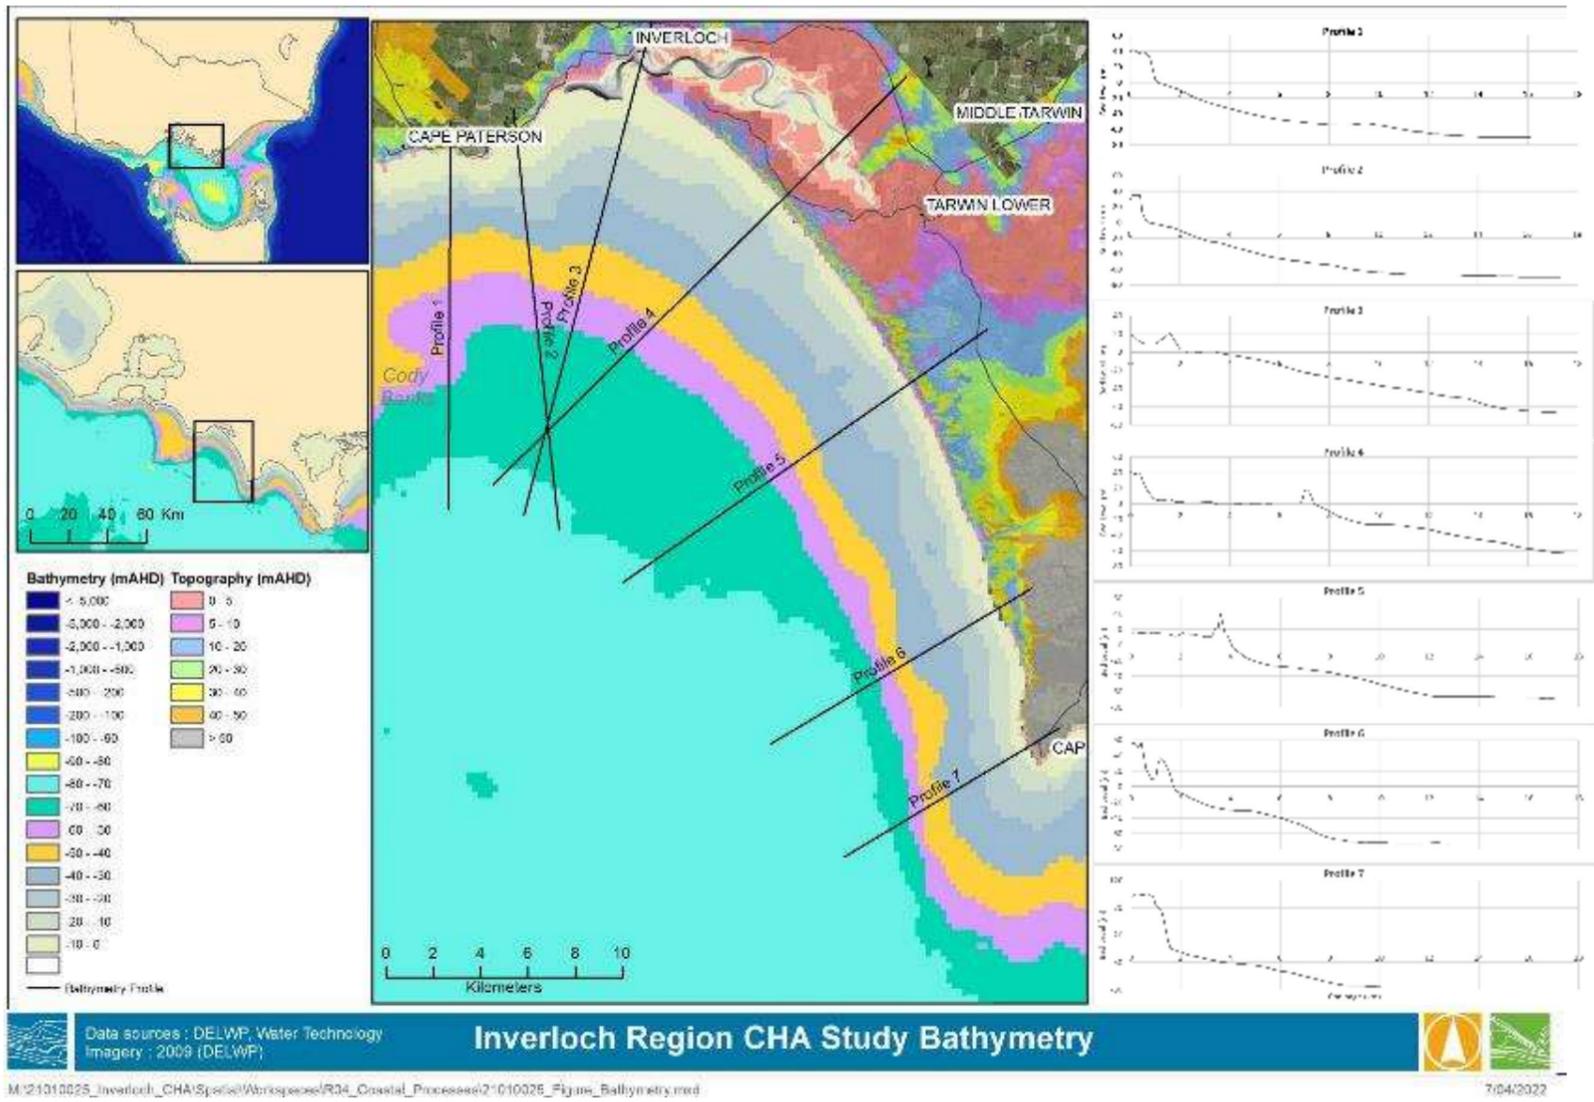
The pattern of sand bars and rip channels is evident from Profile 4 east to Profile 7 along the Venus Bay open coast, typical of exposed ocean beaches. The depth between channels and bars can vary up to a meter and are visible in the bathymetry in depths between -0.5m AHD and -4m AHD. Beyond the nearshore zone the bed slope at Profile 4 is close to concave and extends close to 2.5km before reaching depths of -20m AHD. In contrast, the bed slope further from the entrance is much steeper with the -20m contour closer to 1km from the shoreline.

Figure 2-27 Bass Strait / Open Coast Bathymetry & Topography

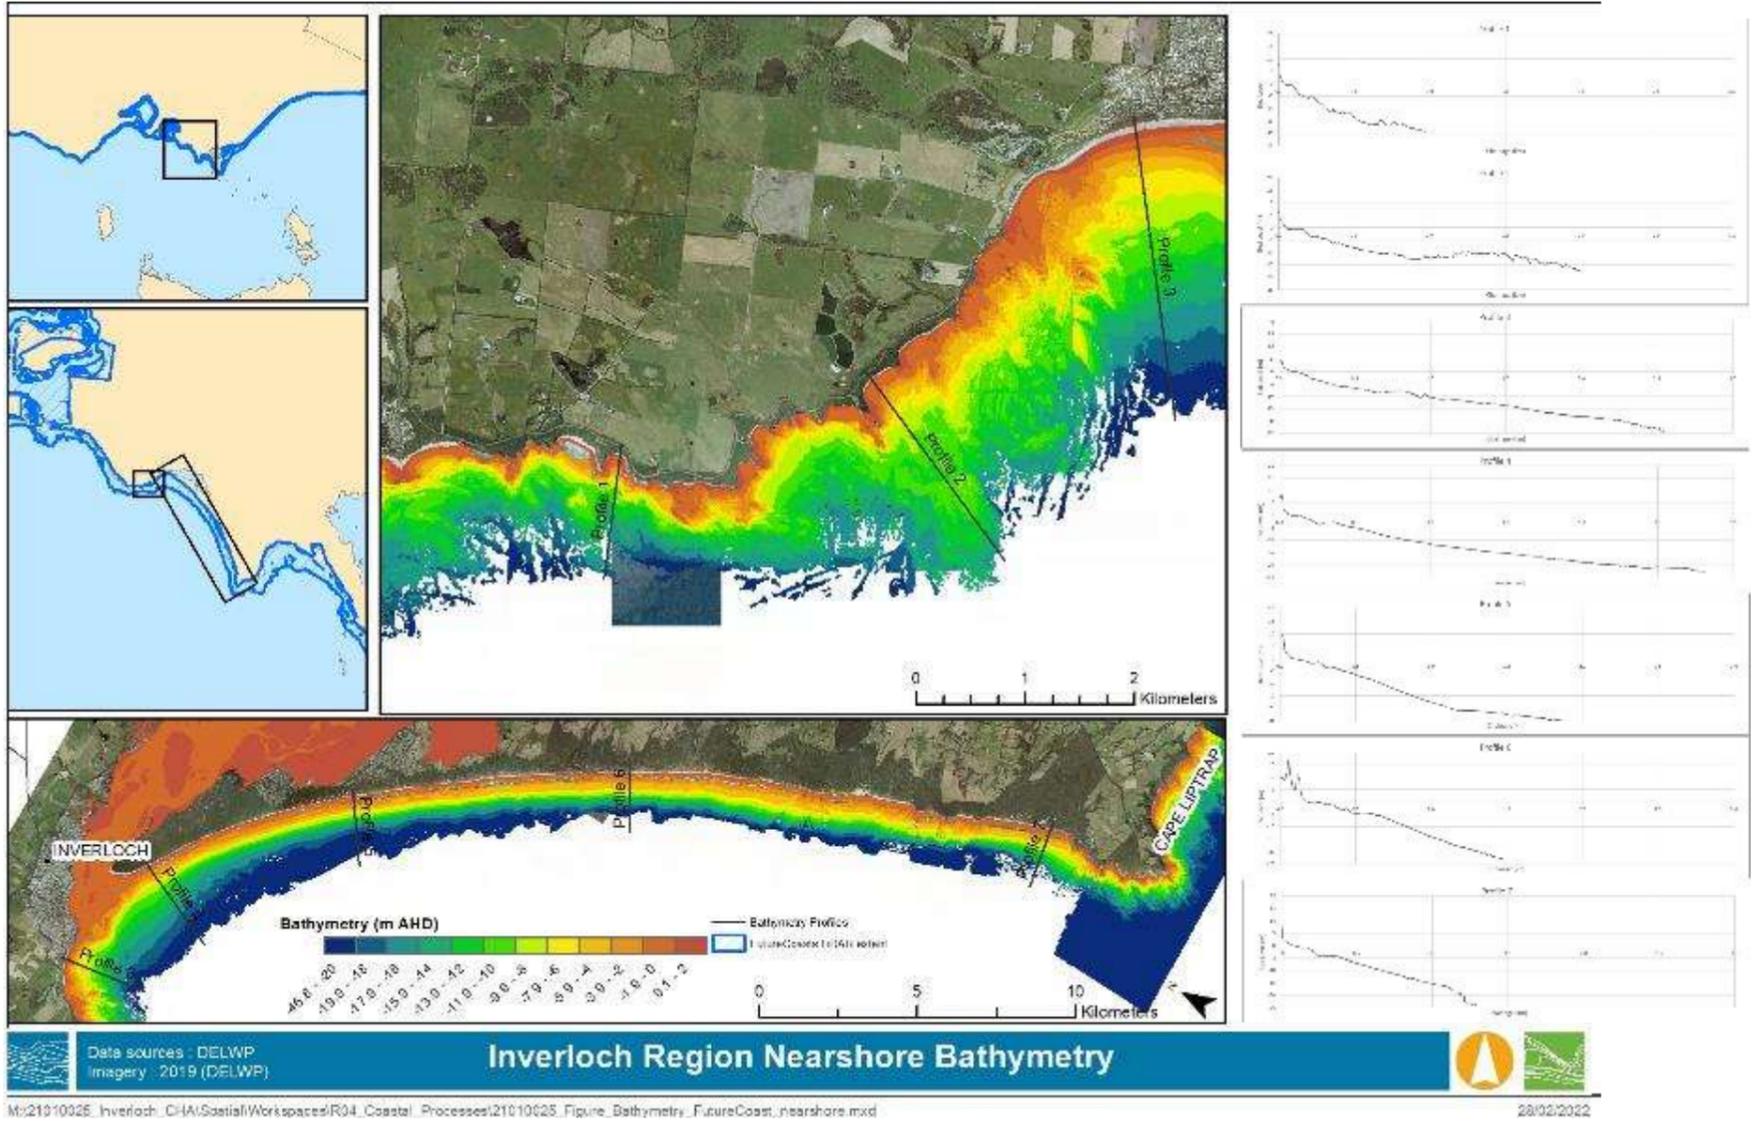
Figure 2-28 Study Area Nearshore Bathymetry

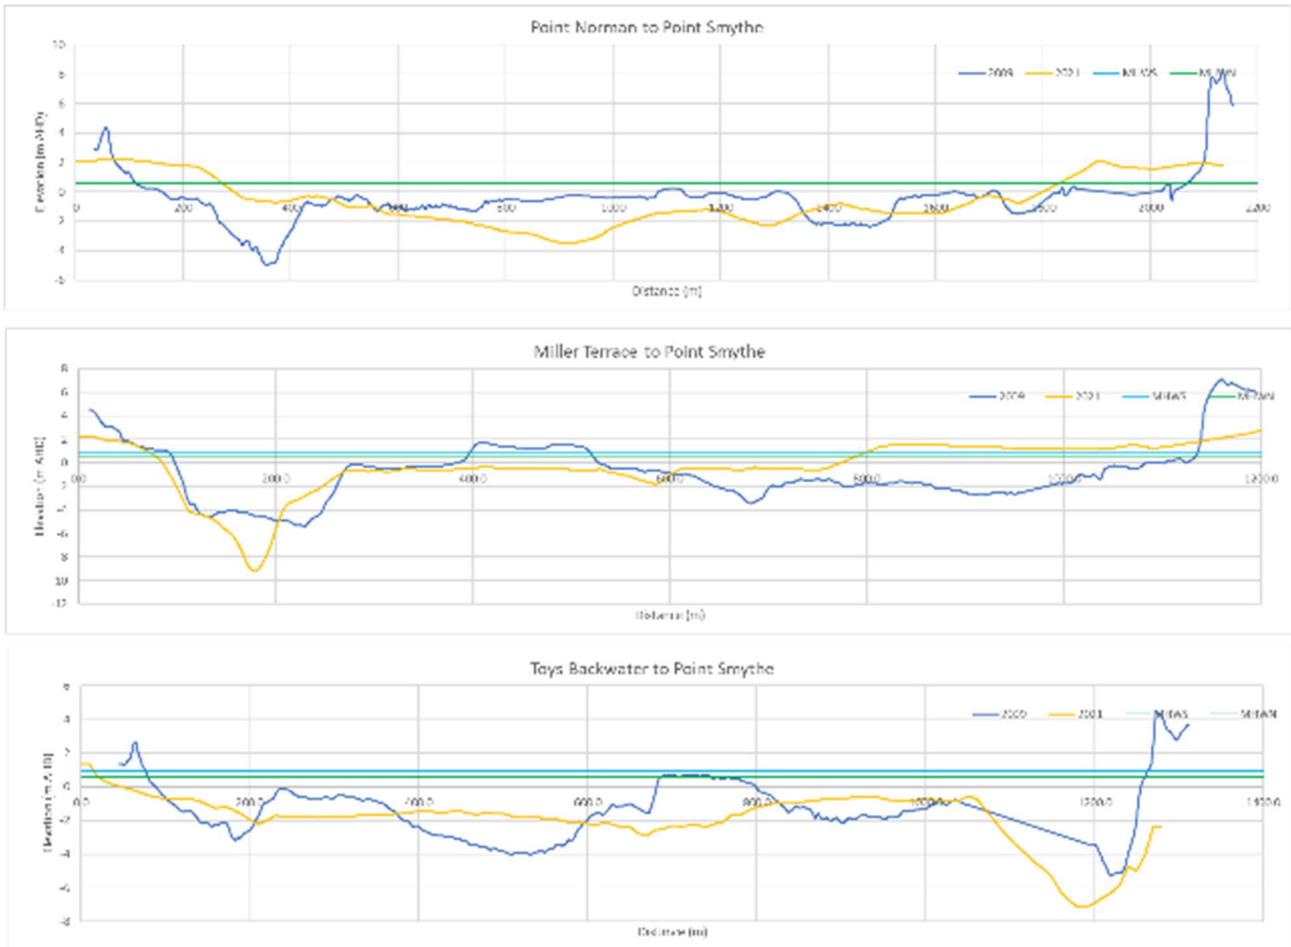
shown in the 2013 and 2021 survey where the toe of the delta is less than half the distance from the adjacent toe of the bar.

Figure 2-29 Entrance Cross Sections (looking upstream), 2009 v 2021

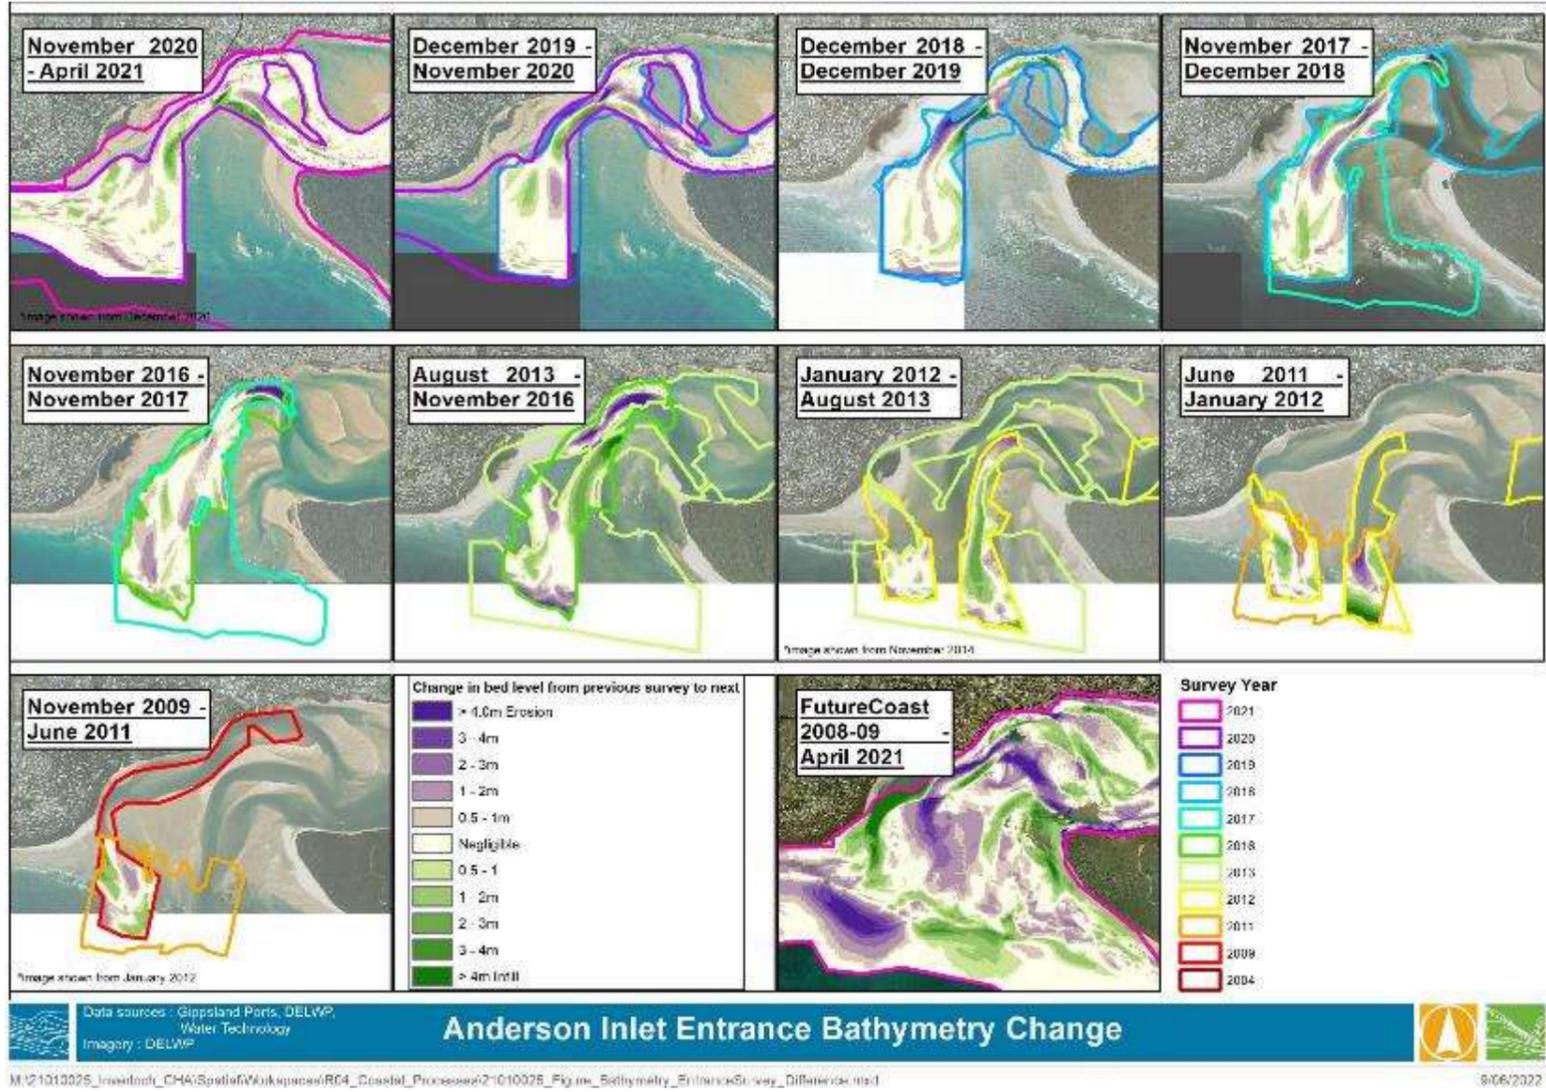
Figure 2-31 Bed level change between survey of the entrance to Anderson Inlet

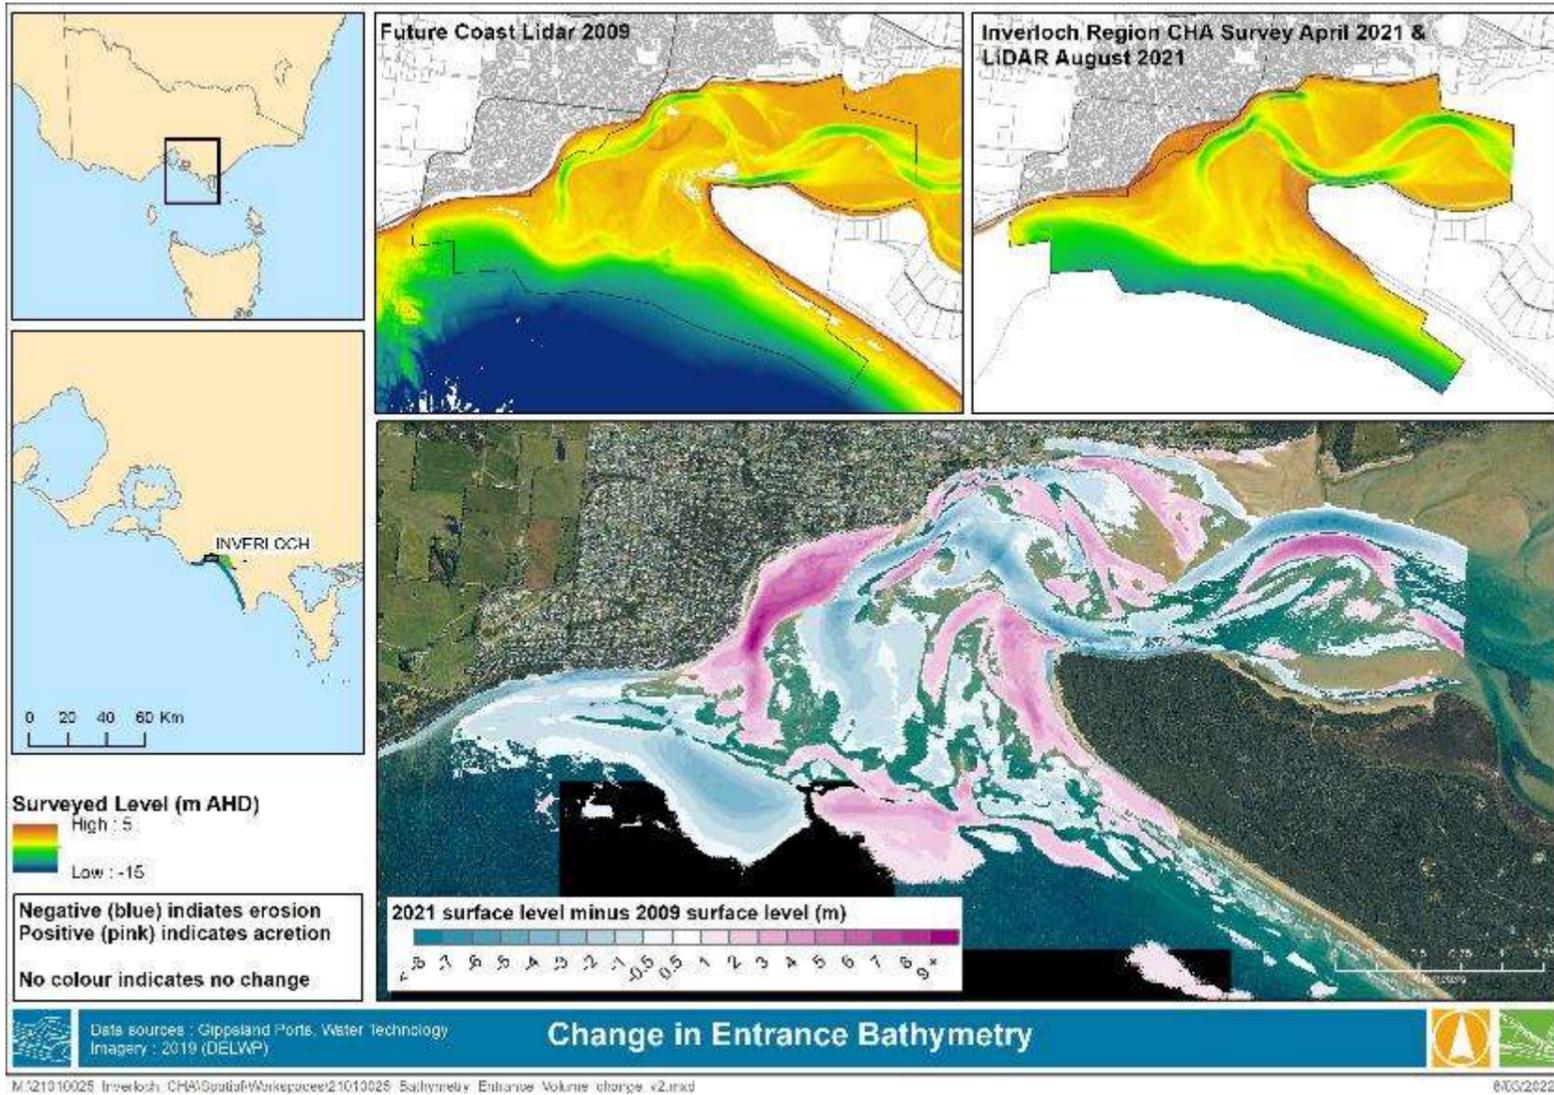
Figure 2-32 Depth of change in entrance (2009 to 2021)

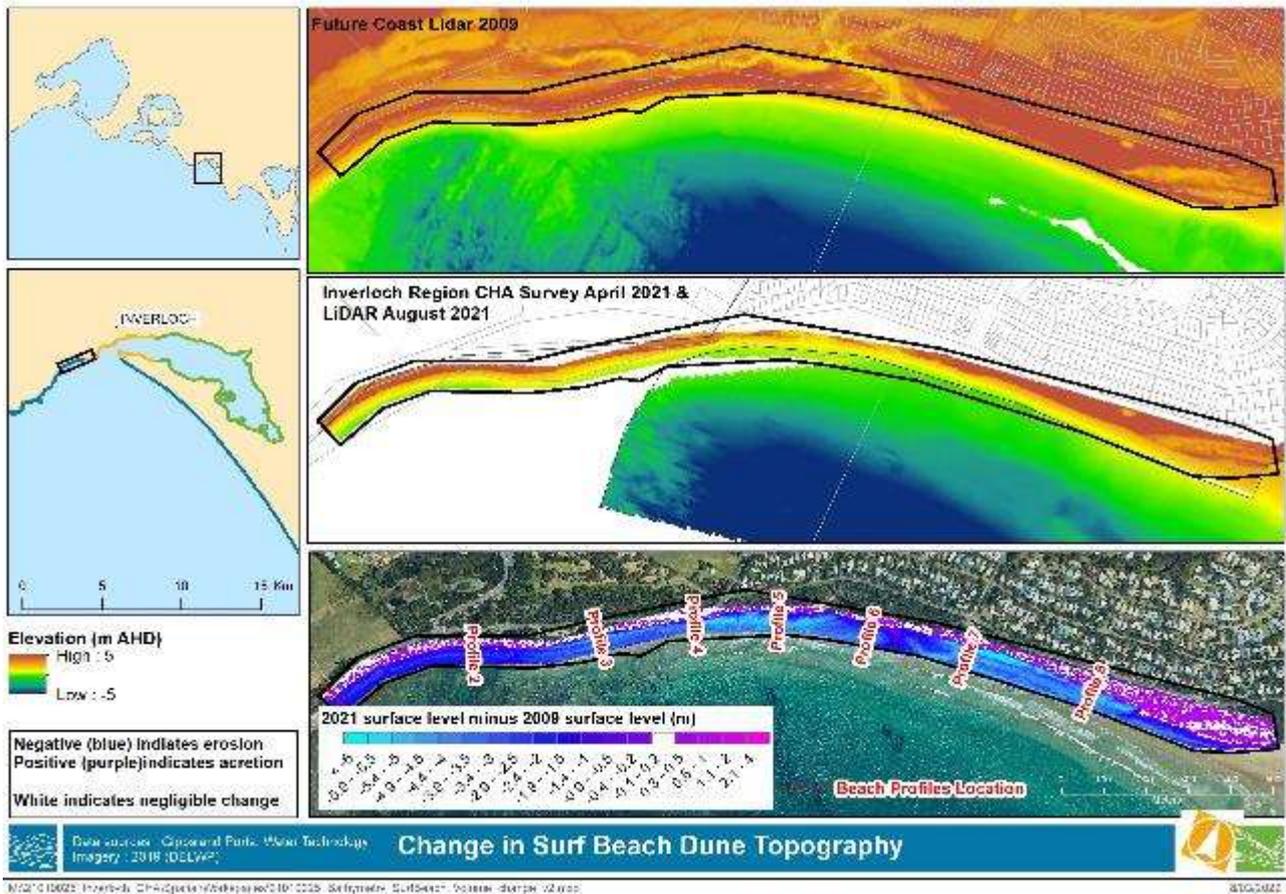
The ongoing photogrammetry captured on Surf Beach through the VCMP during 2021 and into 2022 has shown some recovery of beach levels following the significant lowering of the beach level and recession of the coastal dune through 2019. The seasonal pattern of beach construction during the calmer summer months and erosion during the stormier winter months (Section 2.3.3.3) is also observed in the more frequent VCMP dataset.

Figure 2-33 Surf Beach Topographic Survey

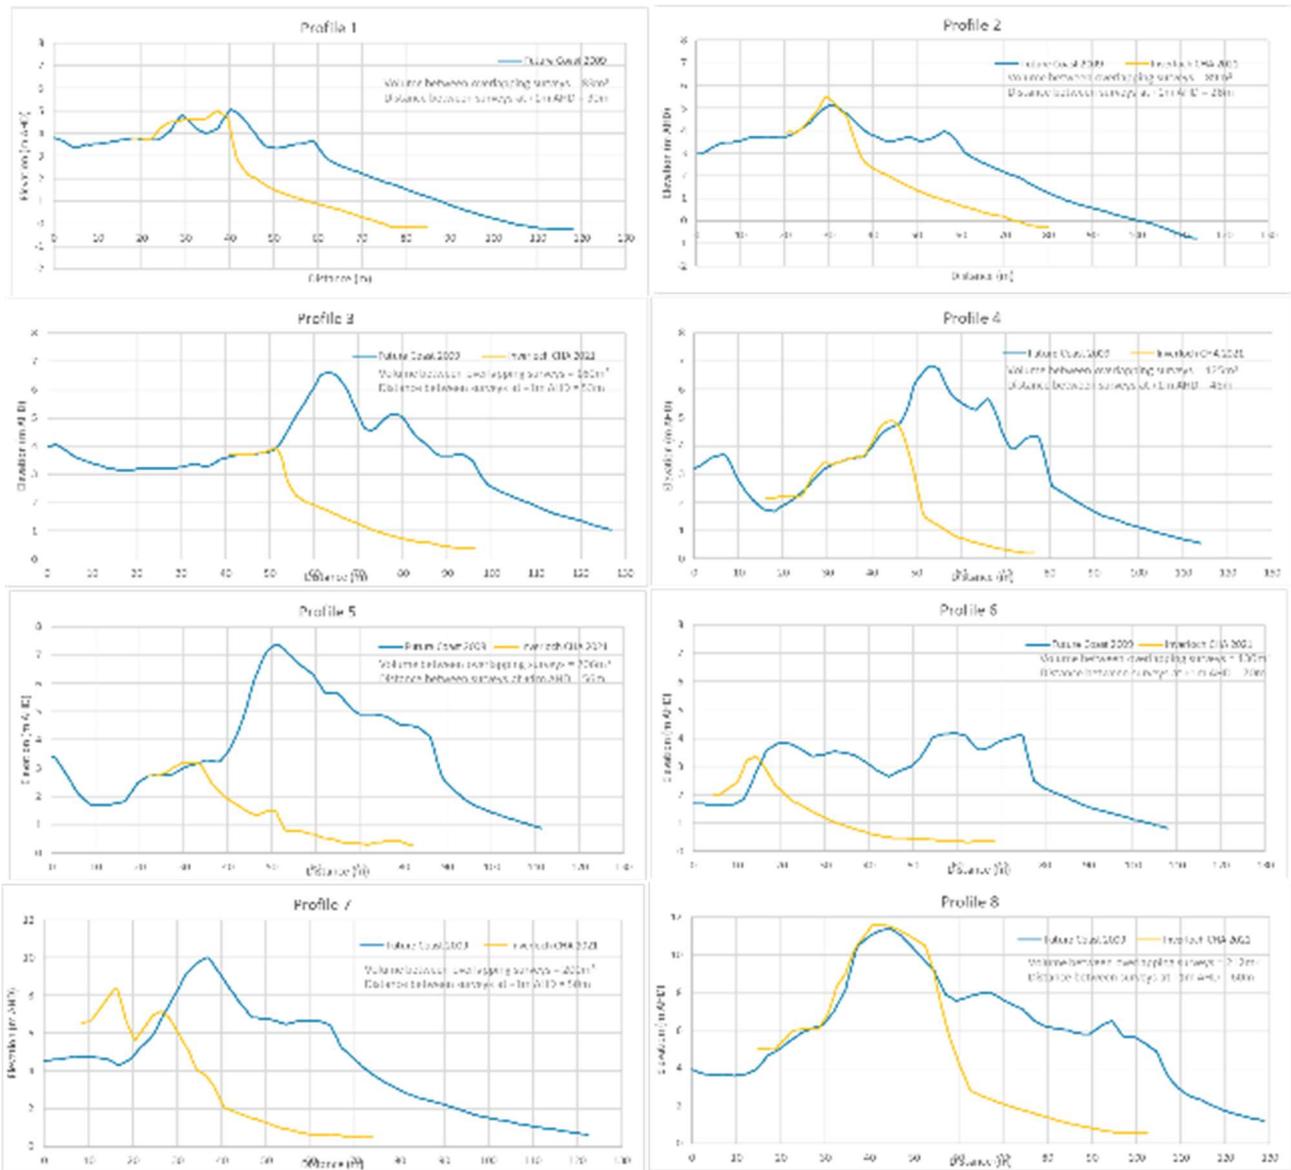
Figure 2-34 Surf Beach LiDAR Cross-sections

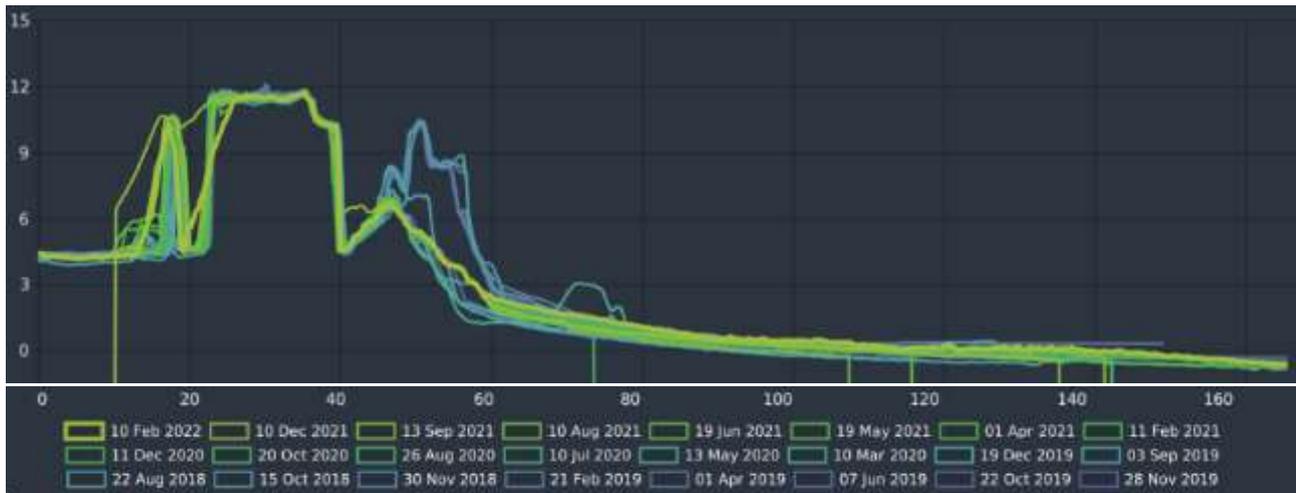
Figure 2-35 Surf Beach Photogrammetry Beach Profiles (Propeller portal extraction, 2022)

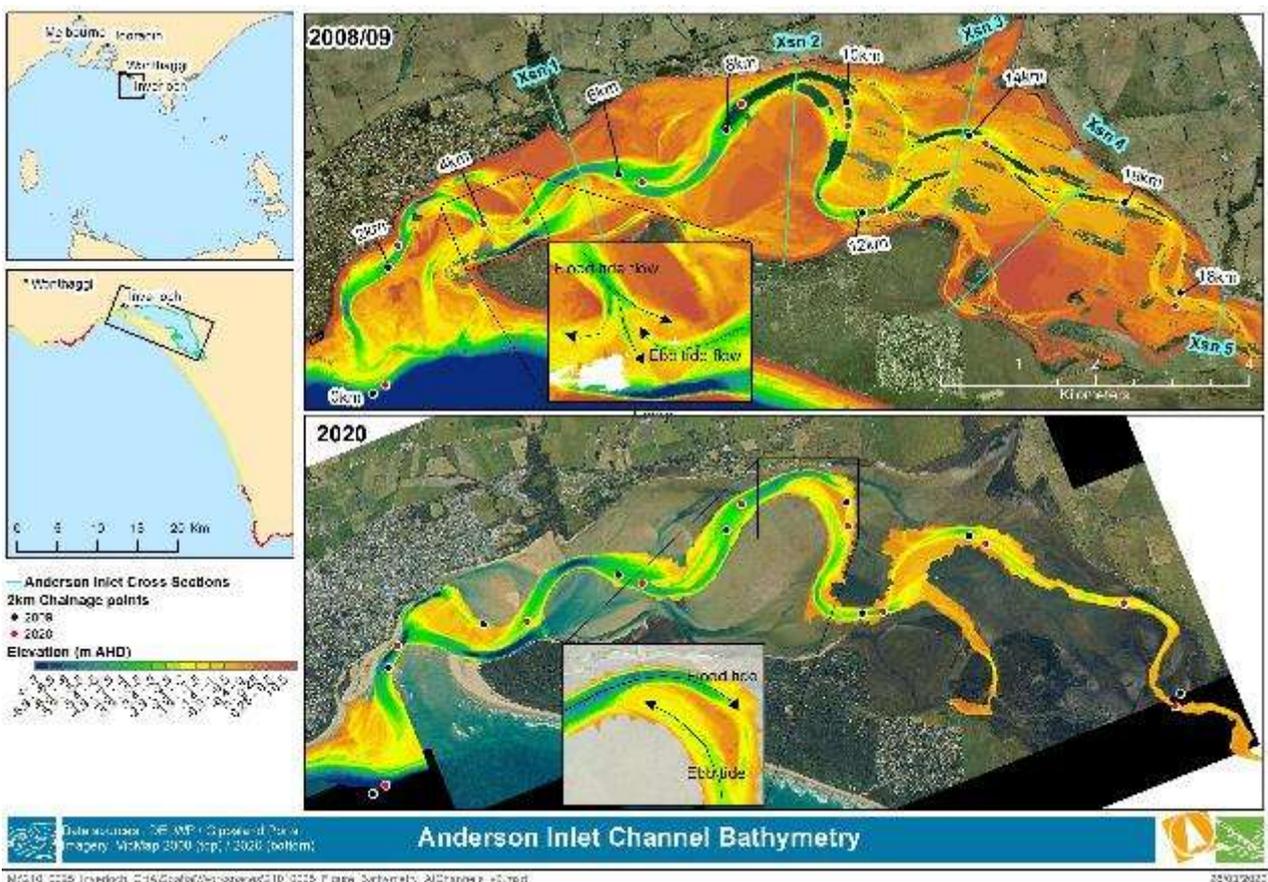
Figure 2-36 Anderson Inlet Bathymetry – 2008/09 v 2020

Cross sections showing bathymetry variation across the width of the Inlet are presented in Figure 2-38 for the locations noted in Figure 2-36. As noted, the data is only available for the earlier 2008/09 survey. The cross sections show the elevation of sand bars and intertidal areas remains low within the estuary, only increasing above +0.5m AHD in the upper extent of the estuary around Venus Bay Settlement 1 and at the mouth of the Tarwin River. The single channel is a major feature in the cross section, with minor secondary channels evident along the southern side of the Inlet (right hand side of the chart). The width of the channel remains relatively constant at ~170m, narrowing only slightly to 150m at the mouth of the Tarwin River. Consistent with the profile in Figure 2-37 depths of the channel decrease from -6m AHD at Cross Section 1 to -1.5m AHD at the mouth of the Tarwin (Cross Section 5), noting the patchiness of the data in this area described above.

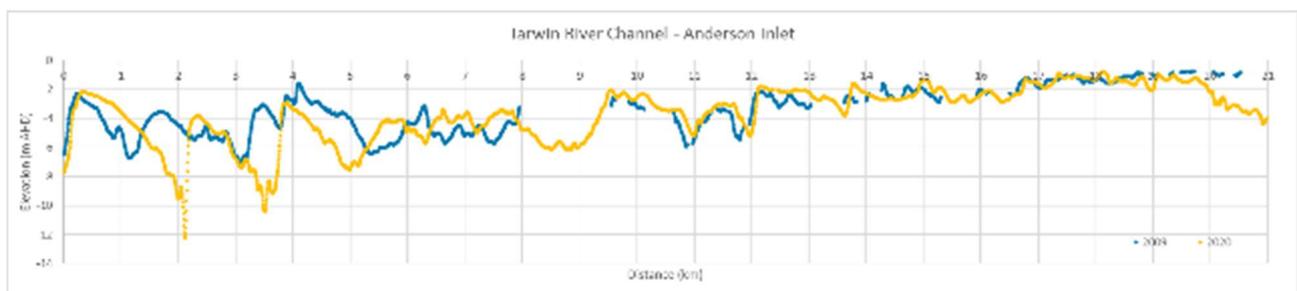
The thalweg long section shows these features as the steep changes in the bathymetry, prominent in the entrance in both surveys as the channel changes from flood to ebb tide dominant. Upstream of Townsend Bluff (around 5km) the channels show less change between the surveys (noting the gaps present in the 2008/09 data, starting at around 8km) and the location of the troughs and bars is similar. Bed levels within the channel upstream of Pound Creek (14km) are limited to greater than -3m AHD, increasing to no less than -2m AHD at 17km at the mouth of the Tarwin River. Survey from the 2008/09 LiDAR is incomplete here due to high turbidity within the river, however the recent bathymetric survey, collected with single-beam echosounder provides better data through the fresh and brackish water and shows the shallow water at the river mouth extends for around 3km before depths increase notably in the Tarwin River upstream of the connection to Anderson Inlet.

Figure 2-37 Anderson Inlet Channel Thalweg Bathymetry – 2008/09 v 2020
