Project Name	Inverloch Region Coastal Hazard Assessment – Coastal Processes & Erosion Hazard Assessment
Client	Department of Environment, Land, Water and Planning
Client Project Manager	Cass Philippou
Water Technology Project Manager	Elise Lawry
Water Technology Project Director	Dr. Andrew Mc Cowan
Authors	Elise Lawry, Christine Lauchlan Arrowsmith
Document Number	21010025_R04v03a_InverlochCHA_CoastalProcesses.docx

EXECUTIVE SUMMARY

This report details the past and current coastal processes and coastal drivers which have formed the existing coastline. The report also describes the potential impact of coastal processes on the coastal environment into the future and the influence of climate change on coastal drivers and processes. The impact of the coastal processes, current and future erosion zones and zones of coastal recession are presented and discussed within the report.

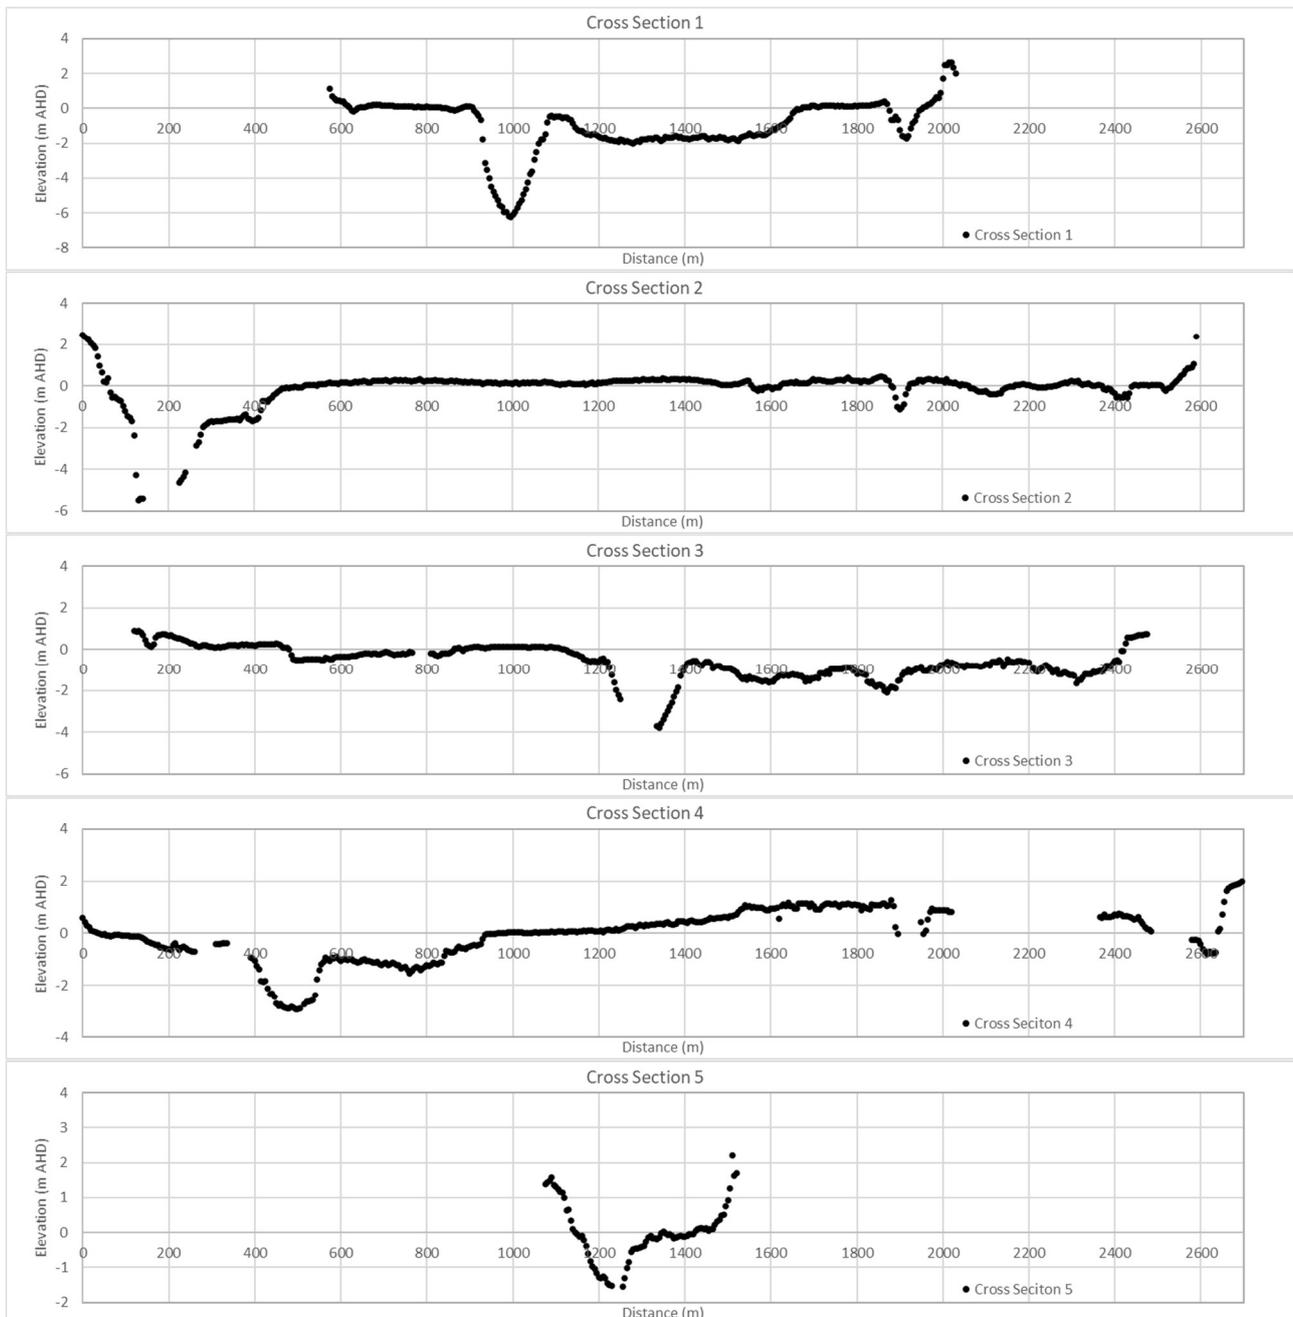
Cross sections showing bathymetry variation across the width of the Inlet are presented in Figure 2-38 for the locations noted in Figure 2-36. As noted, the data is only available for the earlier 2008/09 survey. The cross sections show the elevation of sand bars and intertidal areas remains low within the estuary, only increasing above +0.5m AHD in the upper extent of the estuary around Venus Bay Settlement 1 and at the mouth of the Tarwin River. The single channel is a major feature in the cross section, with minor secondary channels evident along the southern side of the Inlet (right hand side of the chart). The width of the channel remains relatively constant at ~170m, narrowing only slightly to 150m at the mouth of the Tarwin River. Consistent with the profile in Figure 2-37 depths of the channel decrease from -6m AHD at Cross Section 1 to -1.5m AHD at the mouth of the Tarwin (Cross Section 5), noting the patchiness of the data in this area described above.

Figure 2-38 Anderson Inlet Bathymetry Cross Sections

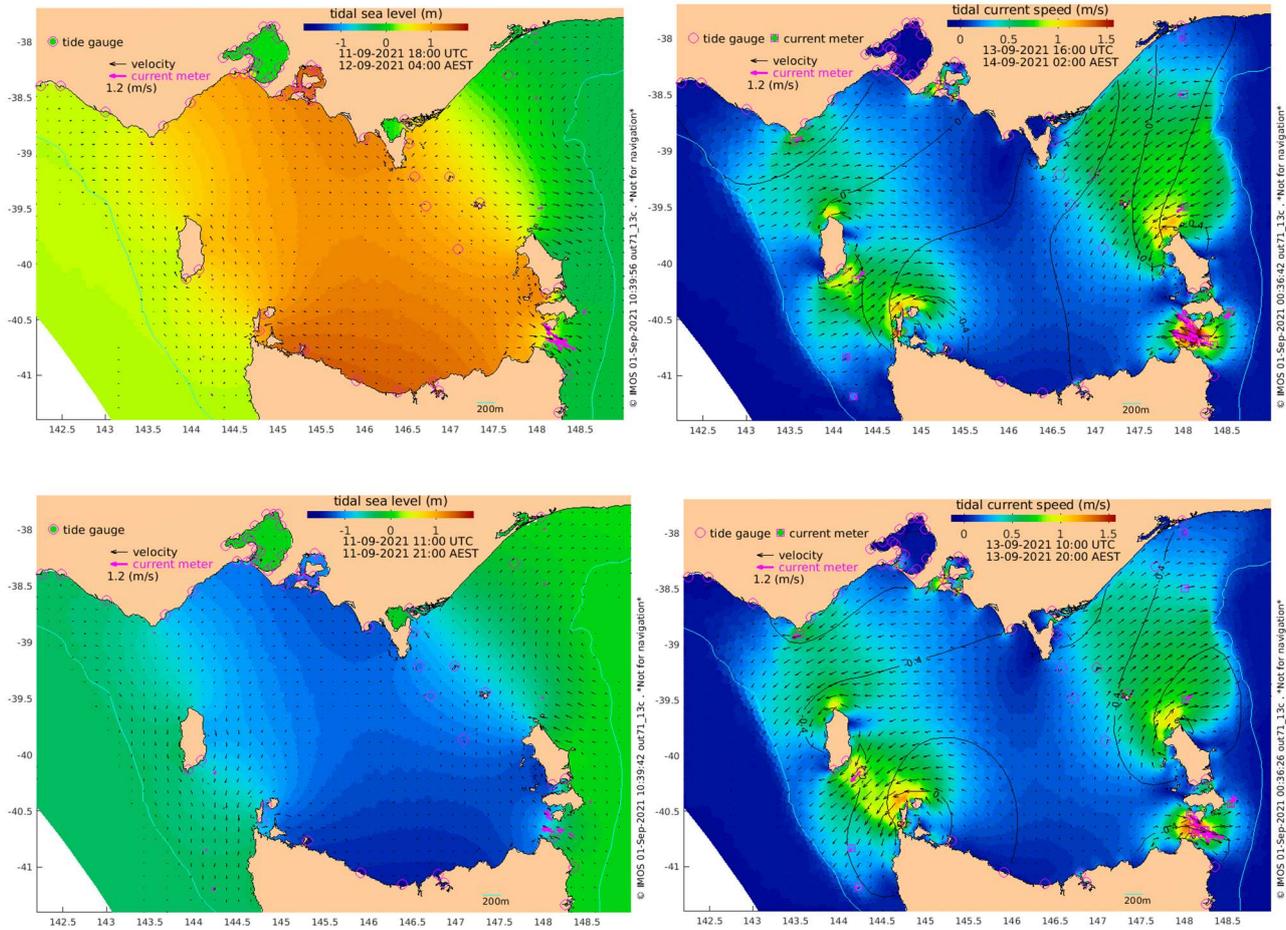
The meeting of the Southern Ocean and Tasman Sea tidal waves, and the high tidal amplitude within the study area, also coincides with an area of low tidal currents as the opposing waves come together. Tidal currents within Bass Strait peak through the narrower passes to the north and south of the King and Flinders Island groups (top and bottom right, Figure 2-39). The data shown has been sourced from Australia’s Integrated Marine Observing System (IMOS) *Ocean Current Portal* (IMOS, 2022). The low tidal currents in the area are an important factor in the coastal processes and sediment transport on the open coastline (discussed further in Section 2.4).

Figure 2-39 Peak spring high and low water levels (left) and peak tidal flood and ebb currents (right) within Bass Strait (IMOS 2021)

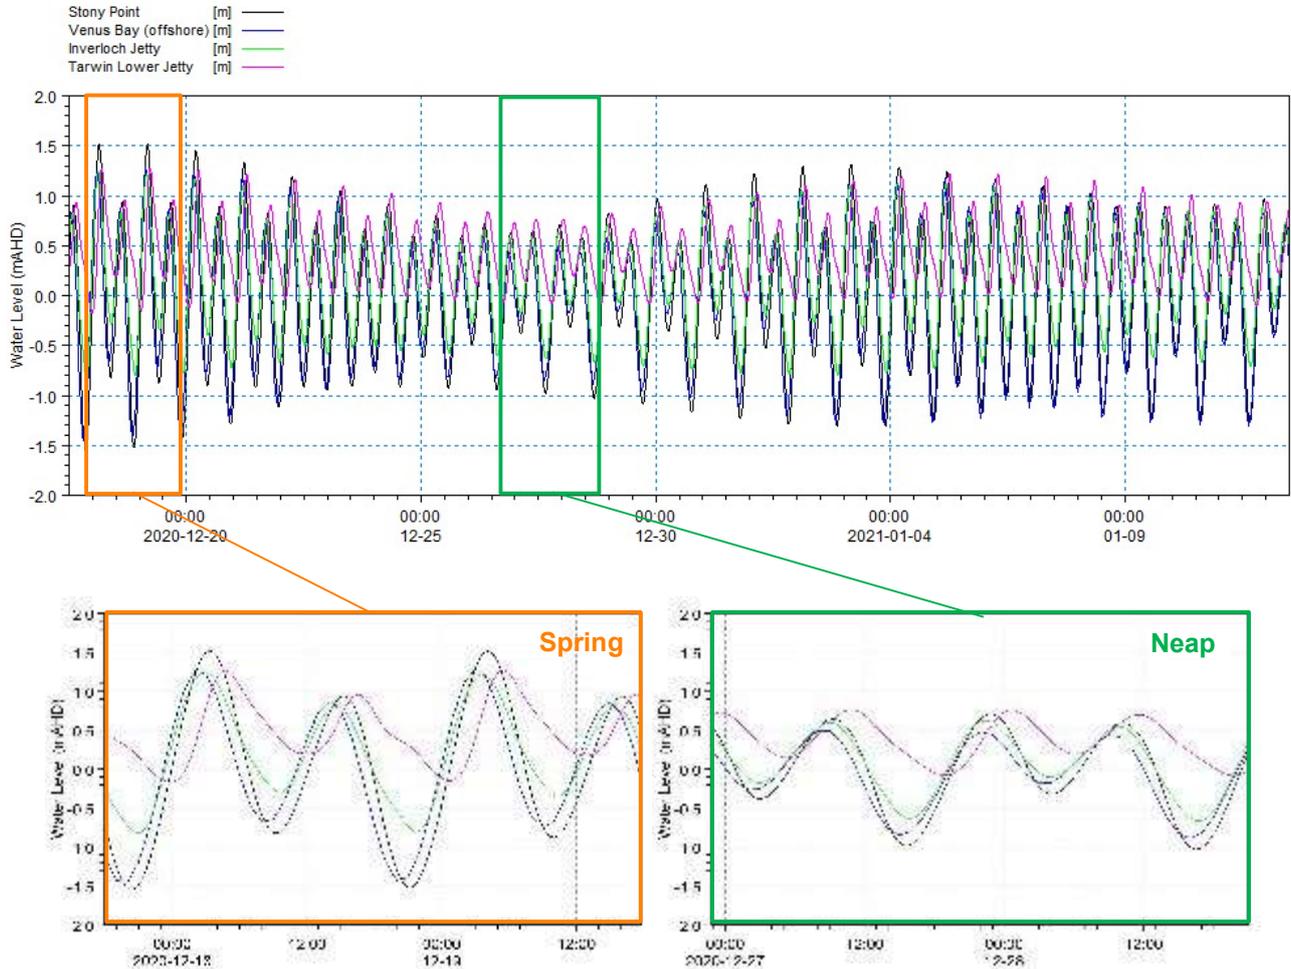
Figure 2-40 Astronomical Tidal Signal within the Study Area

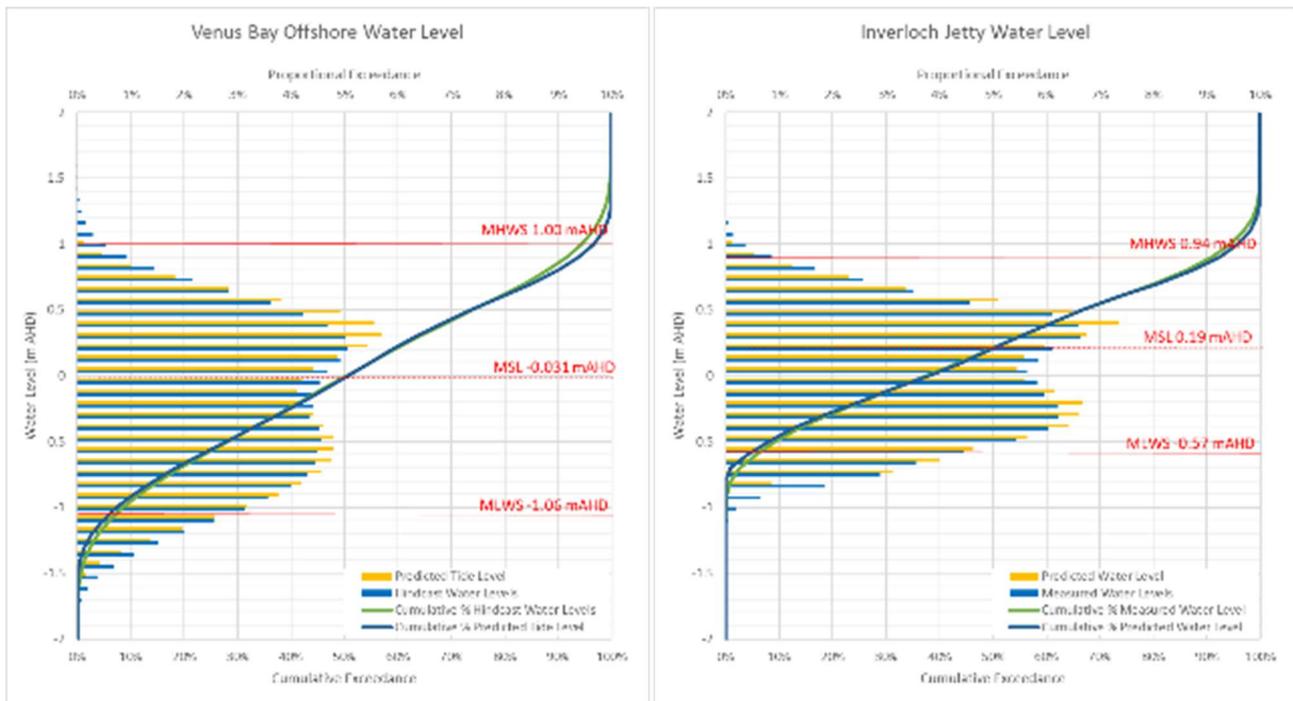
An exceedance curve for the astronomical tides which illustrates the frequency of exceedance of different water levels across a tidal epoch (a 19-year period) within the Study Area is presented in Figure 2-41. Tidal planes are noted for reference at the Inverloch Jetty and in the offshore waters.

Figure 2-41 Astronomical Tide Exceedance Curve, Venus Bay (left) and Inverloch Jetty (right)

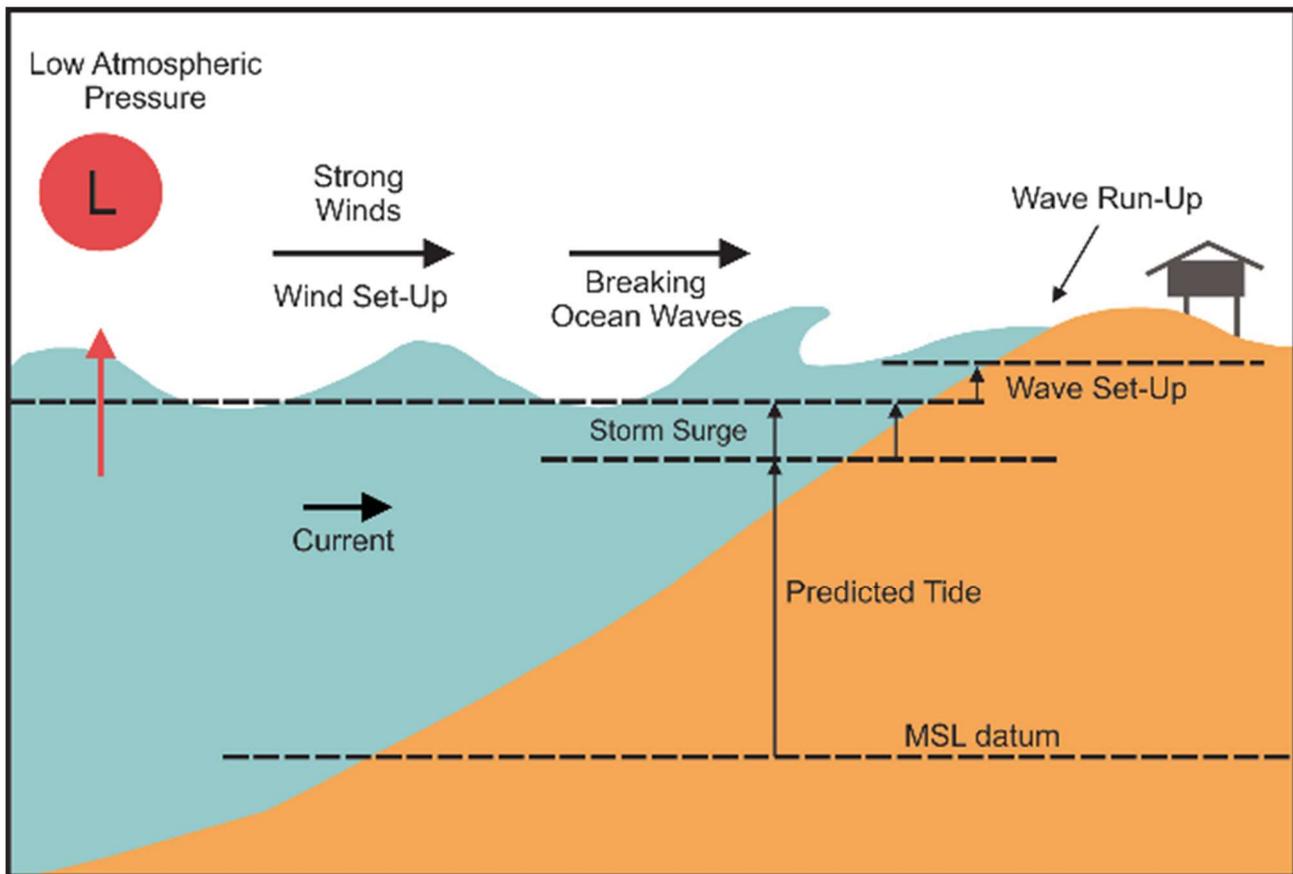
Variations in the coastal water level are caused not only by the astronomical tides, but also by phenomena such as atmospheric pressure, wind setup, wave setup, and oceanographic variations. Catchment run-off and the influence on coastal water levels are discussed in Section 2.3.5, and more widespread climate drivers which can result in changes to water levels are discussed in Section 2.3.6. The different water levels and components which make up the total coastal water level are presented in Figure 2-42.

Figure 2-42 Components of the Total Water Level (Bush, 2019)

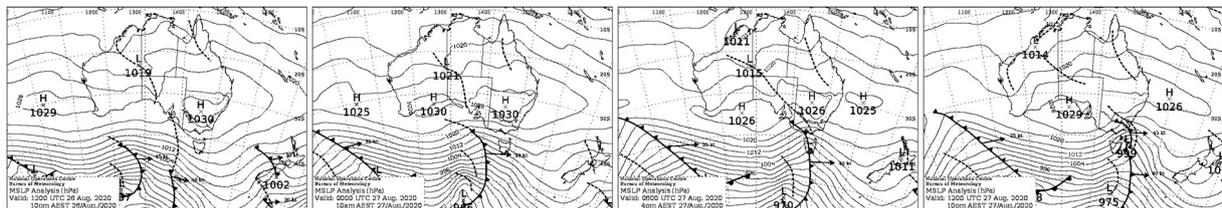
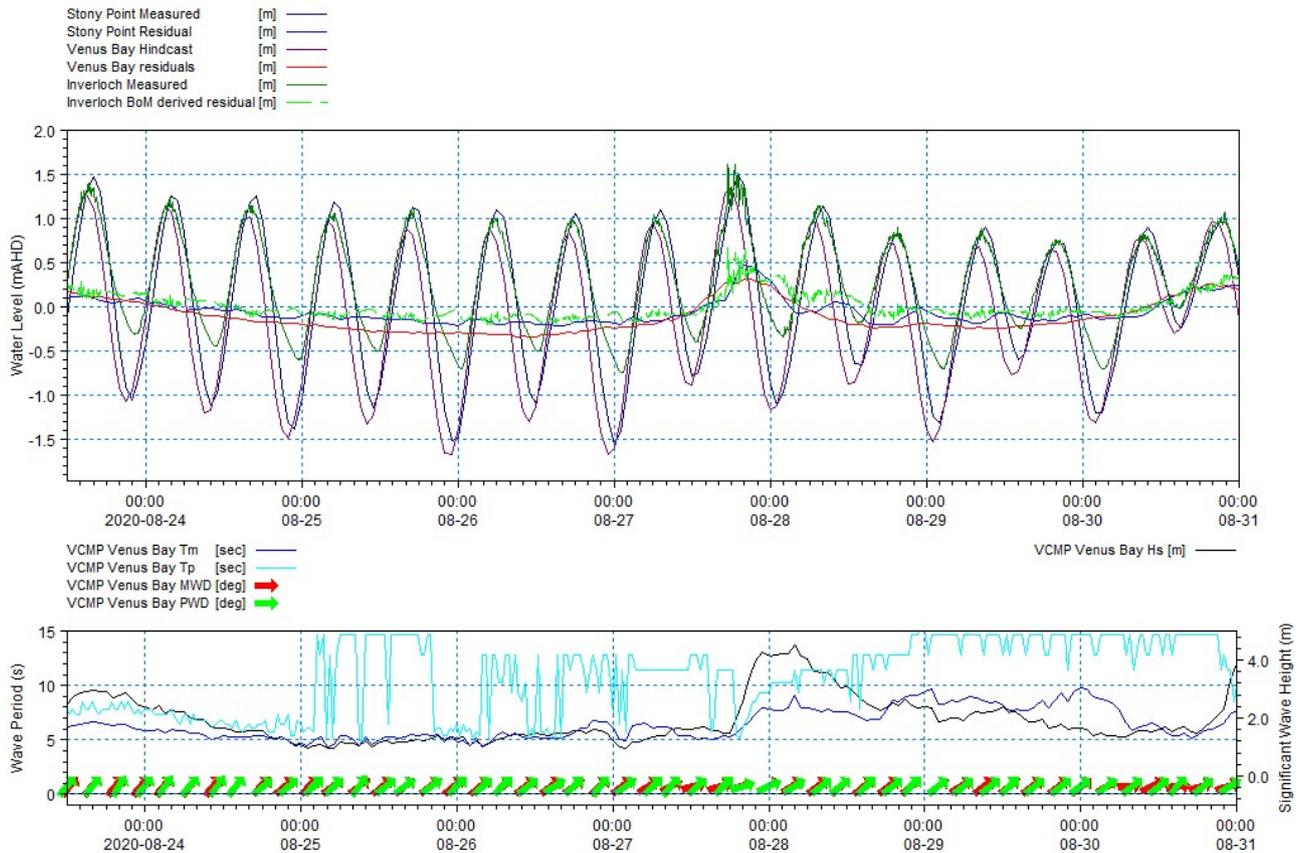
The storm surge and total water level at Inverloch and Stony Point are presented along with wave height, peak period and peak wave direction. The impact of the storm is visible in both the water levels and the wave height and period. A storm surge of close to 0.5m is observed and hindcast at Stony Point and Venus Bay respectively on the 27th August, with water levels over 0.5m above the predicted astronomical tide at the Inverloch Jetty gauge. Significant noise in the signal at the Jetty also indicates waves were acting on the jetty gauge. The wave heights measured at the VCMP buoy offshore in Venus Bay indicate wave heights close to 5.0m during the passing of the storm, with a direction between southwest and west-southwest. Prior to the storm, peak wave periods increased, although there is significant variability in the peak period record. As waves increased, the mean period also increased to close to 10 seconds.

Figure 2-43 Metocean Conditions – Storm 1: 27/08/2020

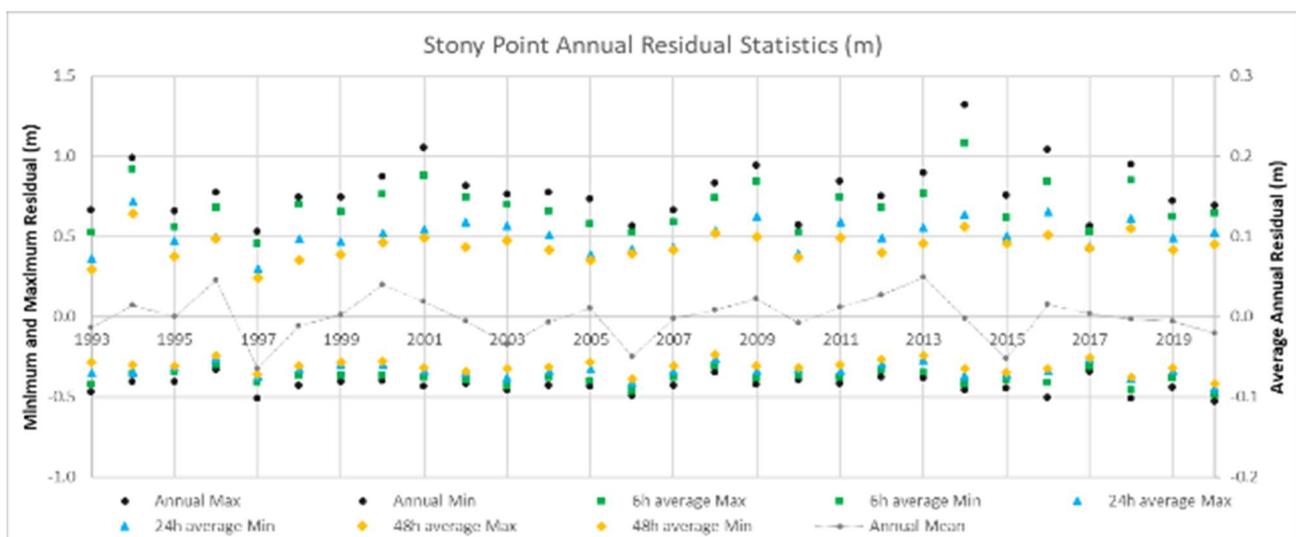
Figure 2-45 Stony Point Measured Storm Surge
