# Altona Seawall Remediation

Works to stabilise the Altona seawall and protect the foreshore

DEECA in collaboration with Hobsons Bay City Council carried out works at the Altona foreshore in November 2025 to stabilise a section of the Altona seawall near Laverton Creek. The works were undertaken to protect the seawall and reduce risks to nearby public assets including the Bay Trail, The Esplanade and the iconic Norfolk Island pine trees.

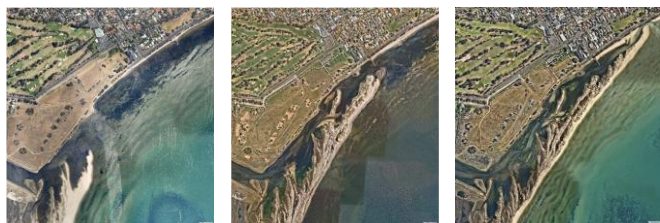
Over many years, a sand spit from the mouth of the Laverton Creek has migrated east along the Altona shoreline. In 2025 the spit moved towards the Altona seawall near G.H. Ransom Reserve narrowing the opening of the Laverton Creek. Historical mapping shows the spit has moved at rates of around 30-60 metres per year, with peaks of up to 80-100 metres per year (figure 1).

Figure 1. Migration of the Laverton Creek sand spit between 2009 and 2025

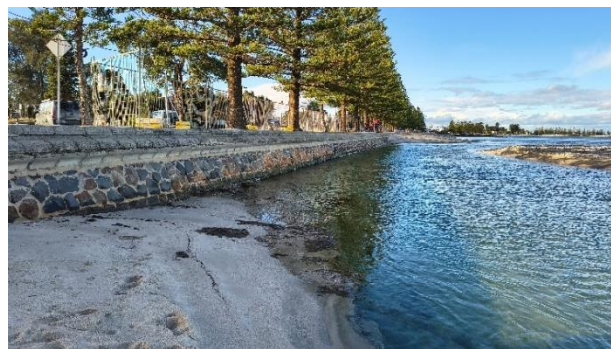
As the creek outlet moved towards the seawall and narrowed, tidal flows became concentrated between the sand spit and the seawall, eroding away the sandy beach in front of the seawall (figure 2). Due to the strength of water flow in this area, sand was removed from the base of the seawall, causing erosion.

Figure 2. Flows from Laverton Creek undercutting the Altona seawall

Engineer investigations found significant undercutting of the seawall caused by creek flows eroding material from underneath the base of the seawall. The undercutting extended more than 40 metres along the seawall and up to 1.4 metres beneath the wall leaving a section of the seawall foundation undermined and at risk of collapse if no action was taken (figure 3).

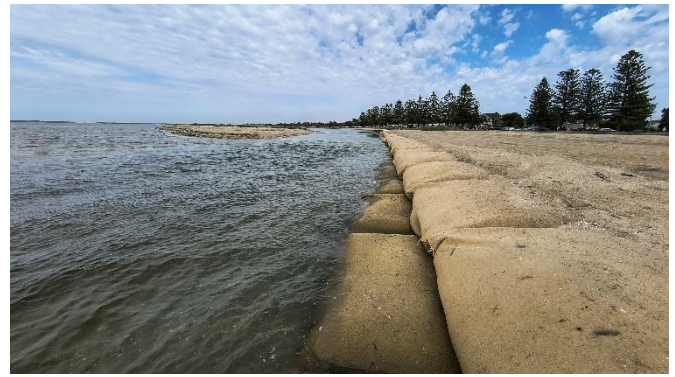
**Figure 4 Recently constructed geotextile training wall to redirect flows away from Altona seawall**

- cutting a new outlet through the sand spit to redirect flows from Laverton Creek away from the seawall
- constructing a geotextile training wall to stabilise the new channel (figure 4)
- reinstating the foreshore using sand sourced from the site (figure 5)
- infilling the discontinued channel next to the seawall to reduce erosion at the base of the wall.

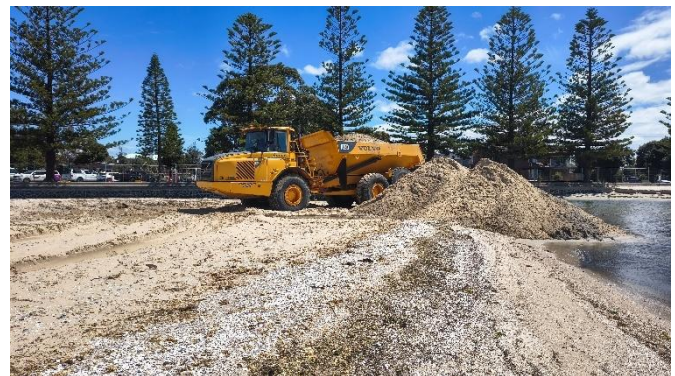
**Figure 5. November 2025 construction works, including reshaping of the Altona foreshore**

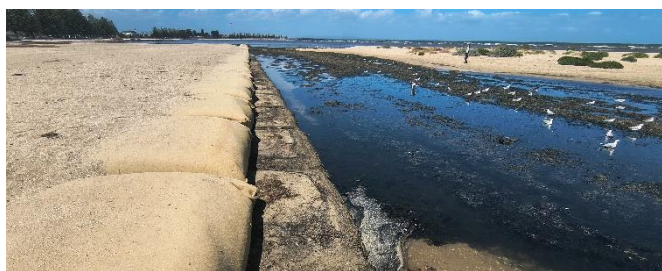
Some wrack temporarily accumulated in the outlet channel, reducing water exchange and contributing to occasional odour as the material breaks down (figure 6). These changes are not unusual in dynamic coastal environments, where creek flows, tides, winds and sediment movement regularly reshape the shoreline and creek entrance (figure 7). Seaweed decomposition is a natural process. The **Environment Protection Authority** has advised that the chemicals in decomposing seaweed can have a 'rotten egg' or 'cabbage-like' odour. People can smell these chemicals at levels lower than would harm health.

Figure 6. Laverton Creek outlet during a dry period prior to recent rainfall

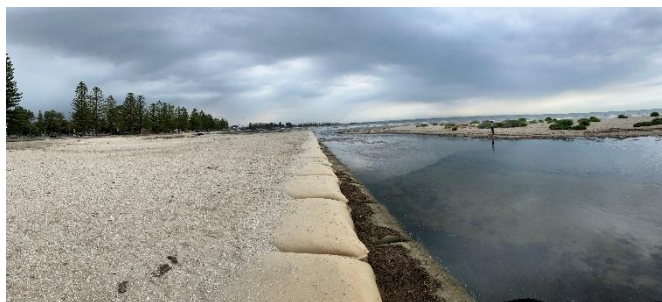
Figure 7. Laverton Creek outlet following rainfall, showing increased creek flows and a cleared outlet channel
